December 21, 2021
Project No. 2101-0252

Subject: Letter-Report of Site Assessment Services, PRC 421 Decommissioning Project,
Pier Access Road, Goleta, Santa Barbara County California

SITE PLAN

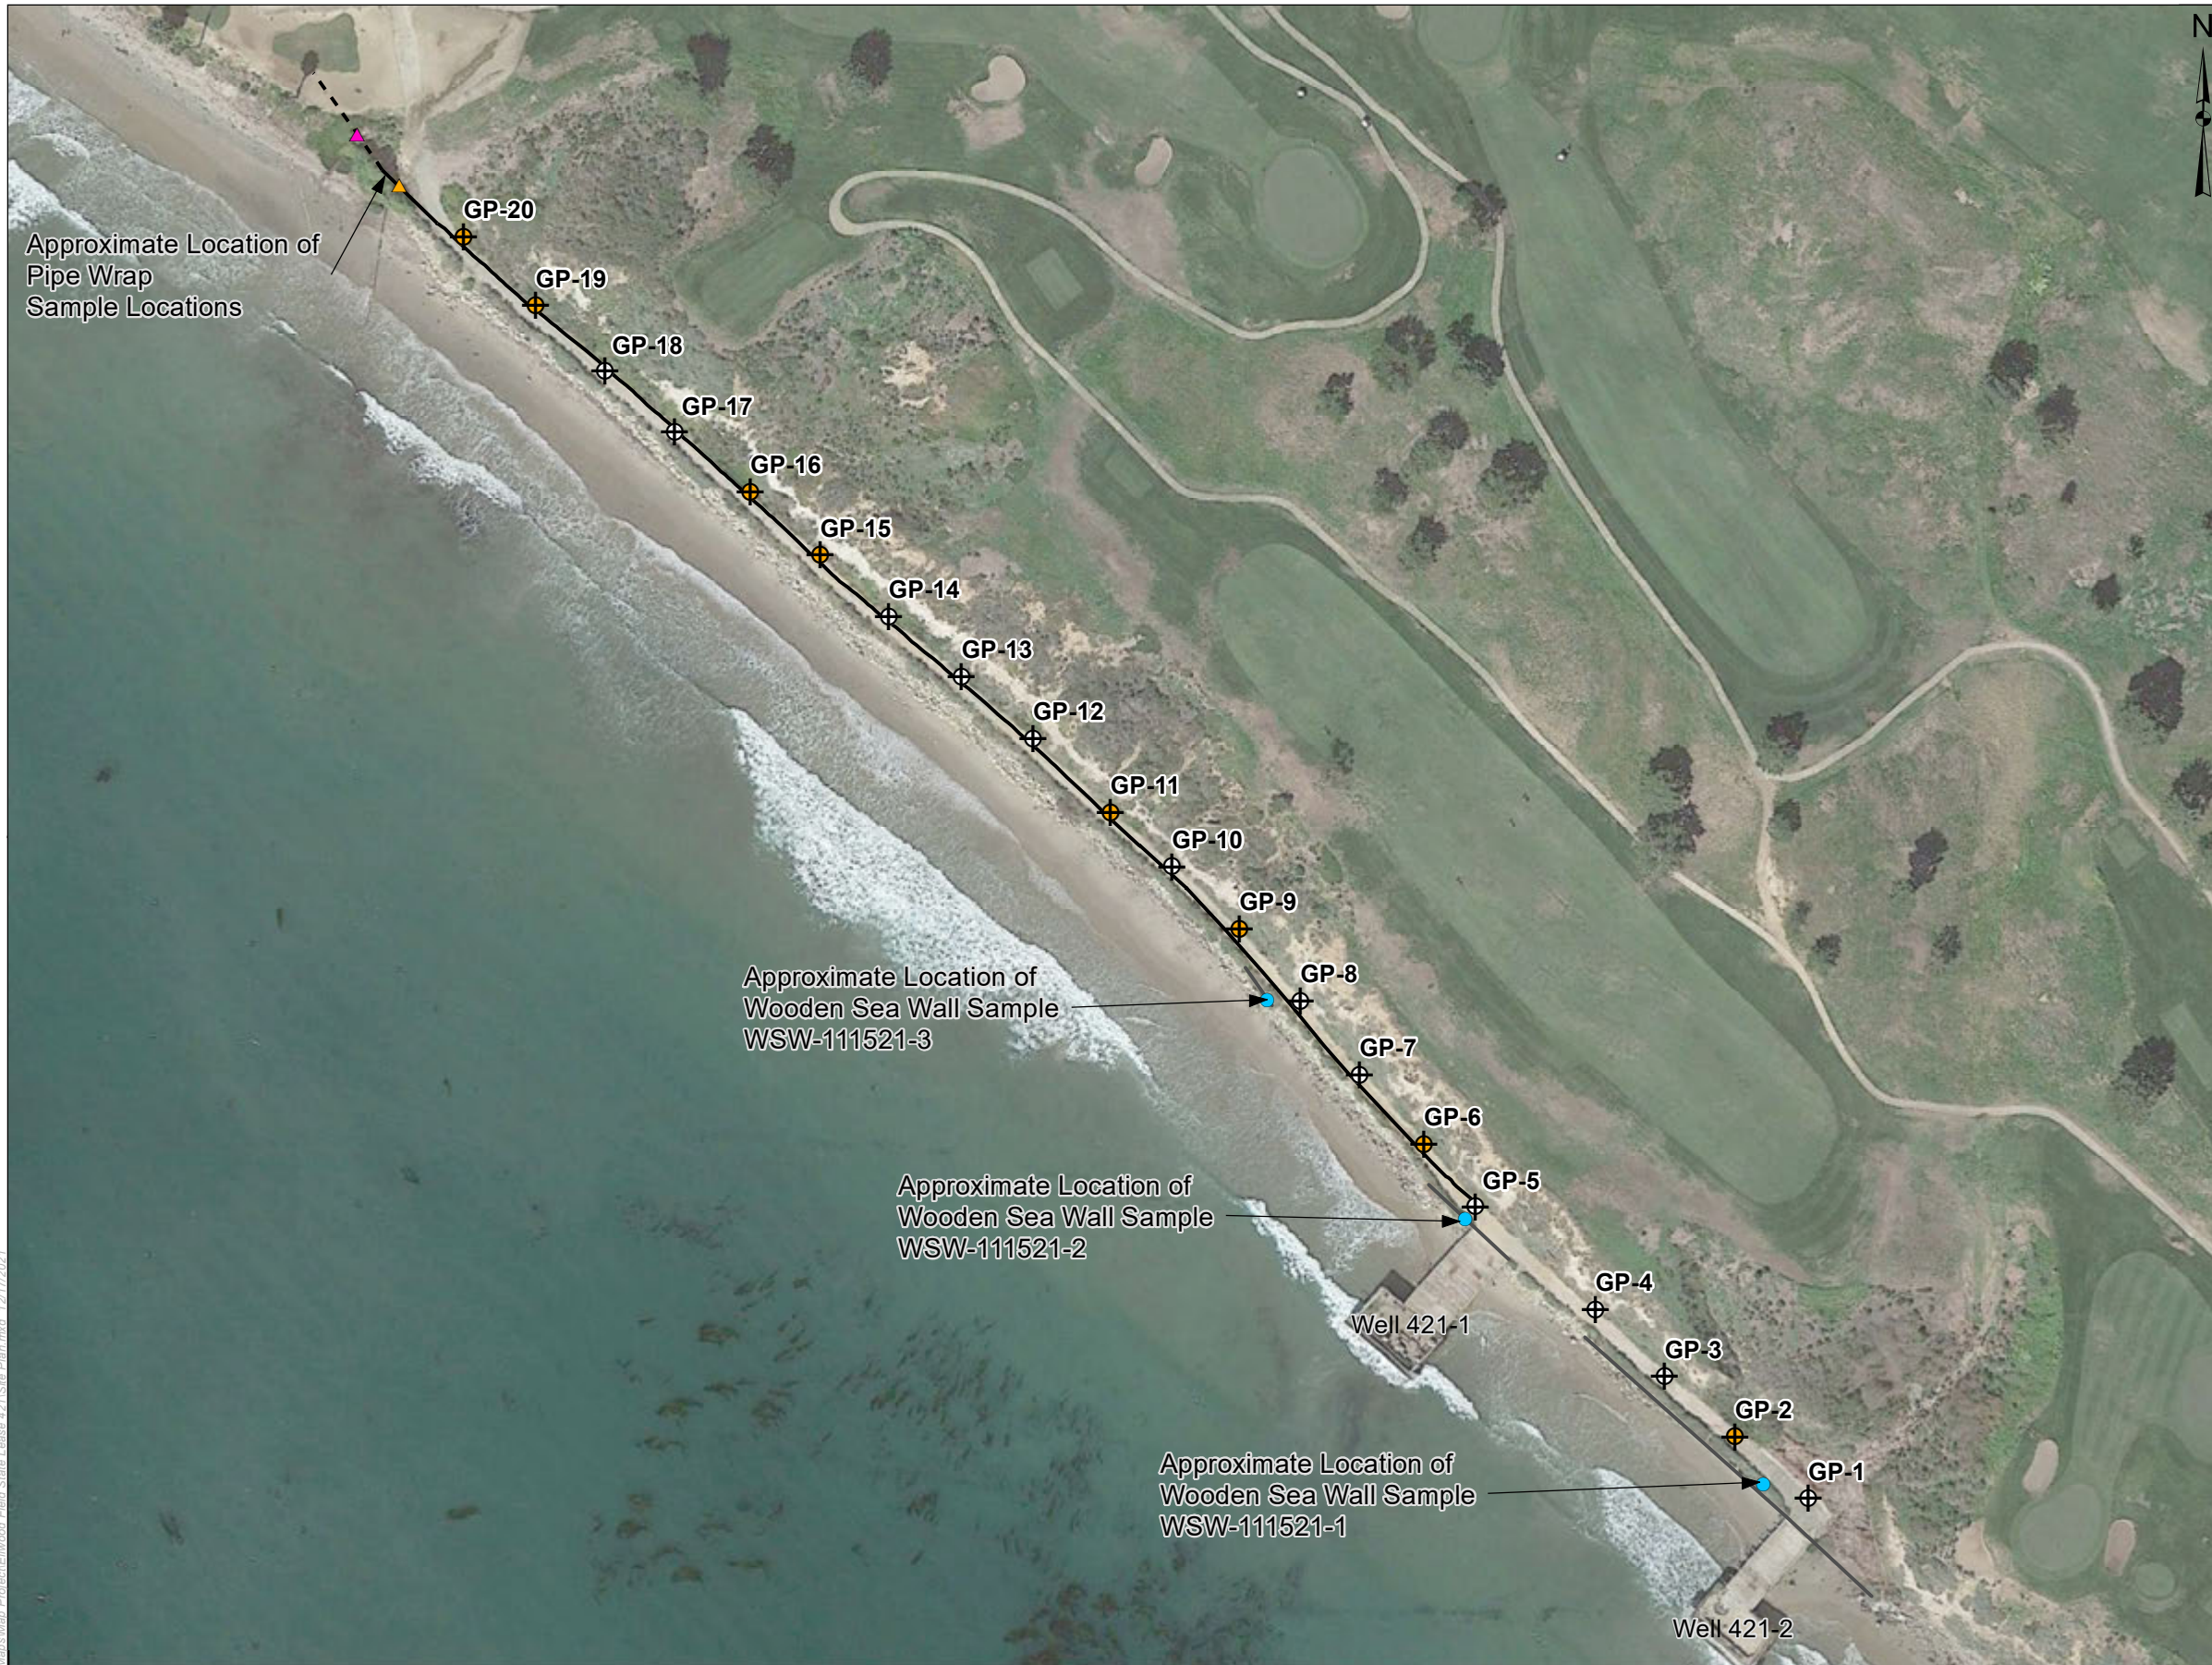
The as-built locations of each Geoprobe drill hole and each sample collected from the wooden sea wall was recorded by Padre using a hand-held GPS survey device with sub-meter accuracy. The sample locations are presented on Plate 2 - Site Plan.

Two soil samples (GP-11-4 and GP-20-8) were reported to contain TPH identified as diesel fuel (C₁₃-C₂₂) at concentrations in excess of the leaching to groundwater non-drinking water ESL (7,284 mg/kg). Soil sample GP-11-4 was collected from the artificial fill material at an approximate depth of 4-feet bgs, and soil sample GP-20-8 was collected from the Monterey Formation at an approximate depth of 8-feet bgs.
