# 2022

## PROGRESS REPORT

Coastal Hazard and Legacy  
Oil and Gas Well Removal  
and Remediation Program

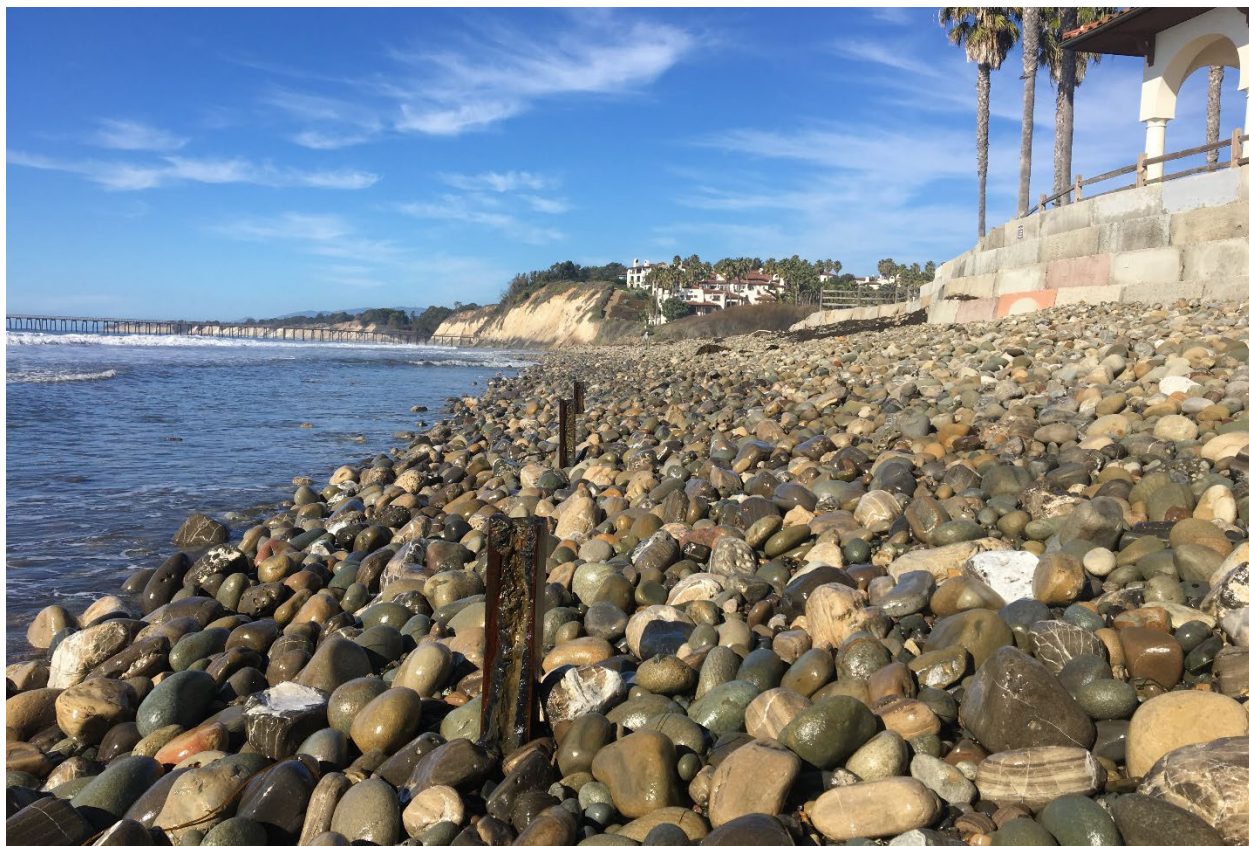
**Figure 2. Exposed railroad irons near Goleta Beach (photo by Padre Associates).**

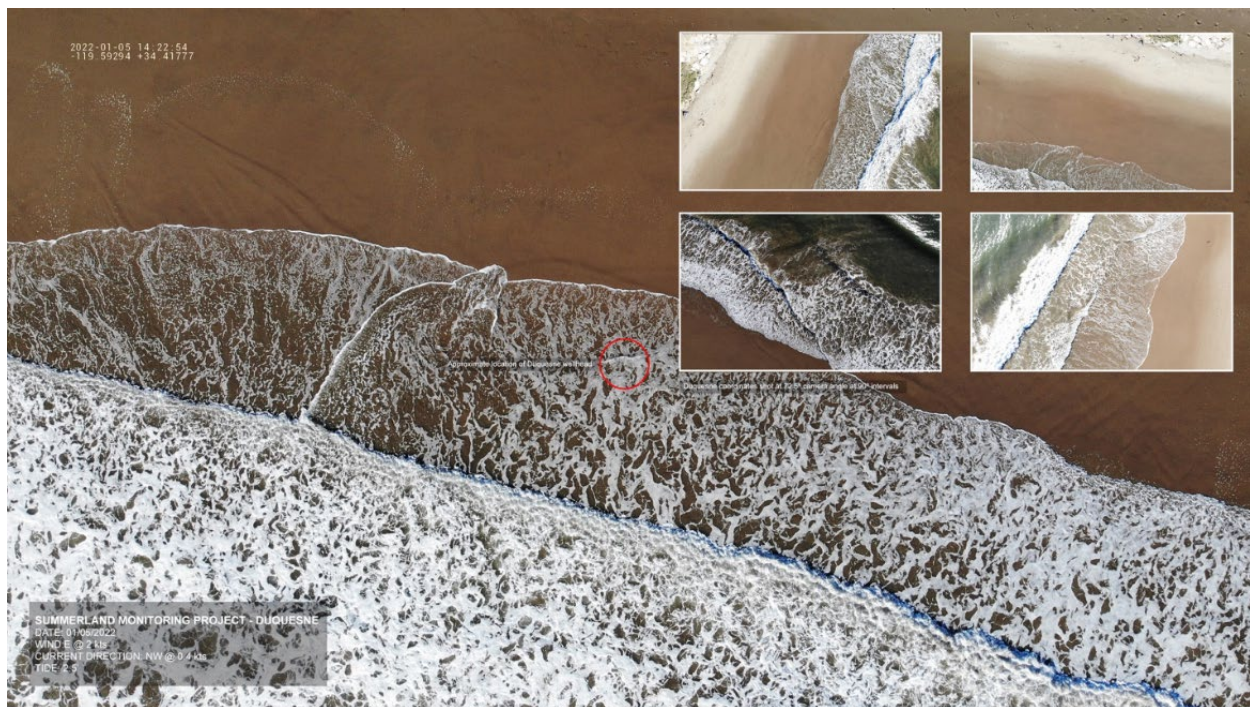
Figure 4. Duquesne-910 area shows no sheen (photos by On the Wave Productions).

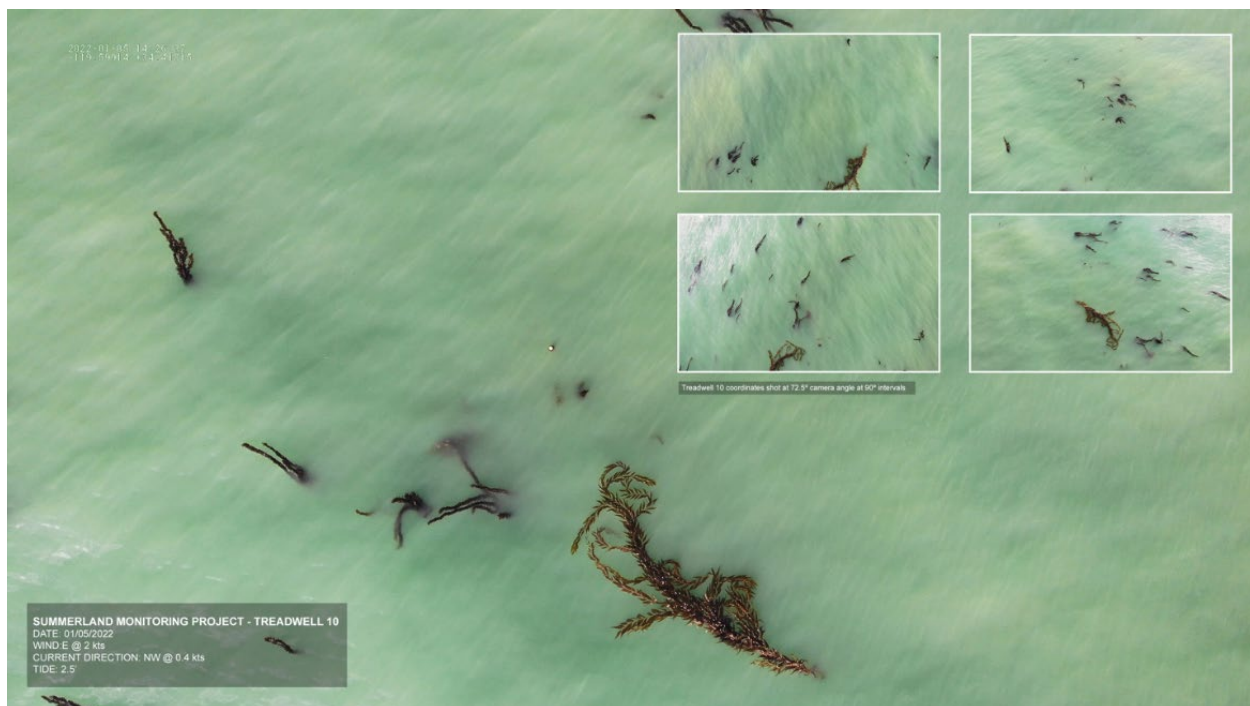
Figure 5. Treadwell-10 area shows no sheen (photos by On the Wave Productions).

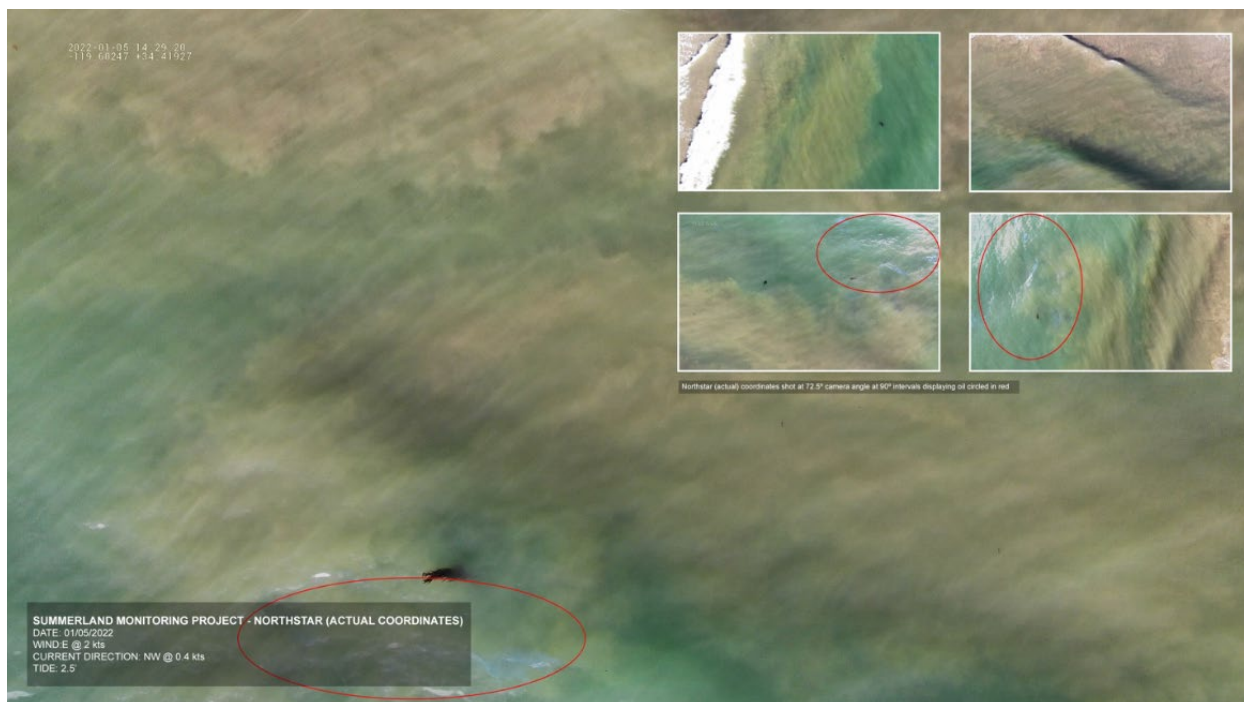
**Figure 6. NorthStar-815 area shows no sheen associated with the well (photos by On the Wave Productions).**

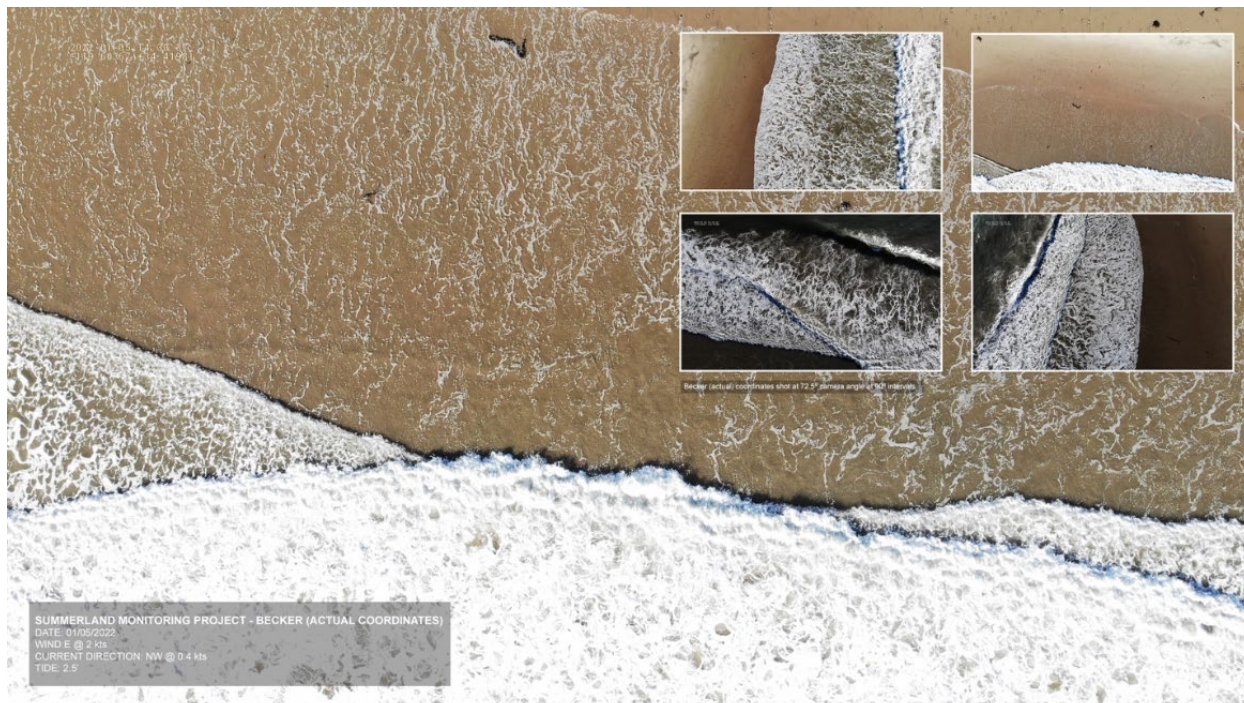
**Figure 7. Becker-1 area shows no sheen (photos by On the Wave Productions).**

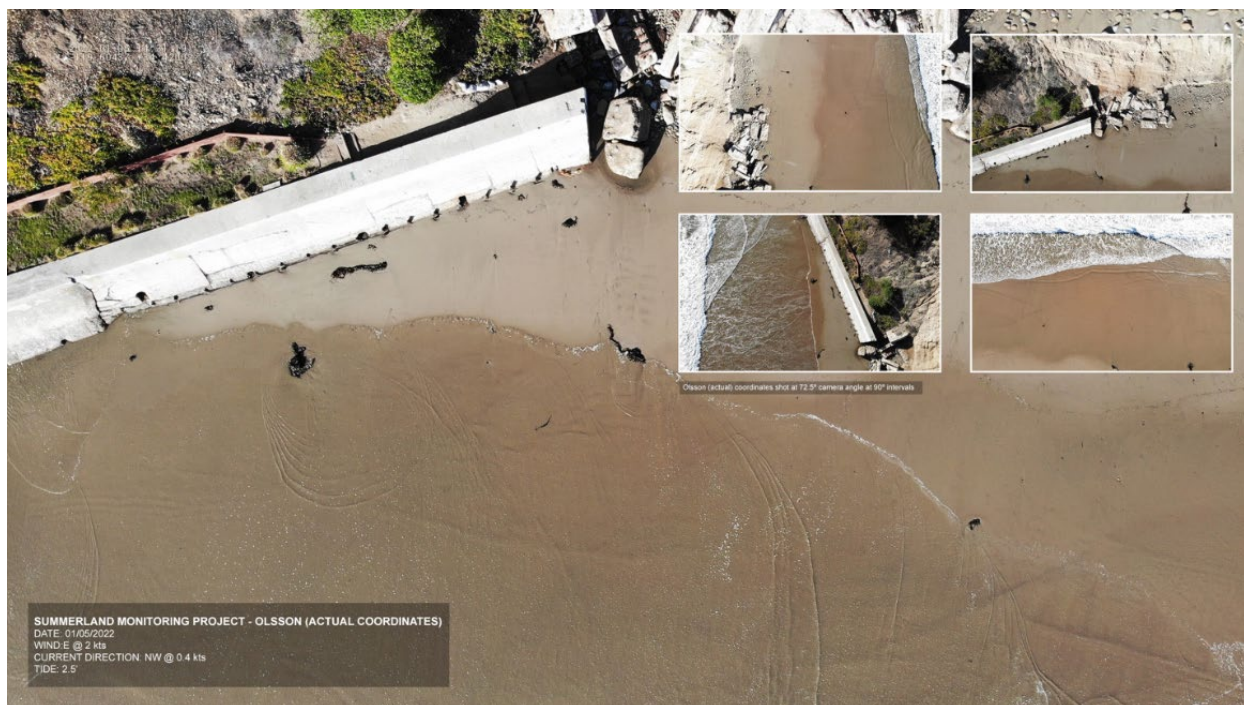
Figure 8. Olsson-805 area shows no sheen (photos by On the Wave Productions).

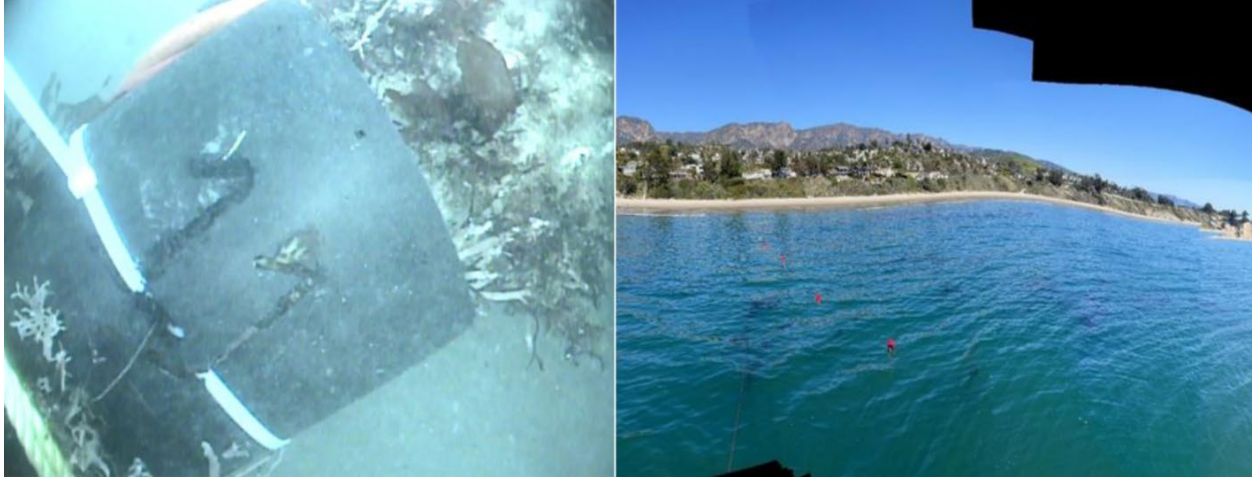
**Figure 11. Treadwell-11 tagged (right); buoy marker line for well location (left)**

<b>Well #</b>	<b>Casing dimension</b>	<b>Leak or Seepage</b>	<b>Debris notes</b>	<b>Distance above natural bottom</b>
11	9-inch with timber pile inside, bent over	No	Asphaltenes, river rock, timber pile, steel pipe	33 inches

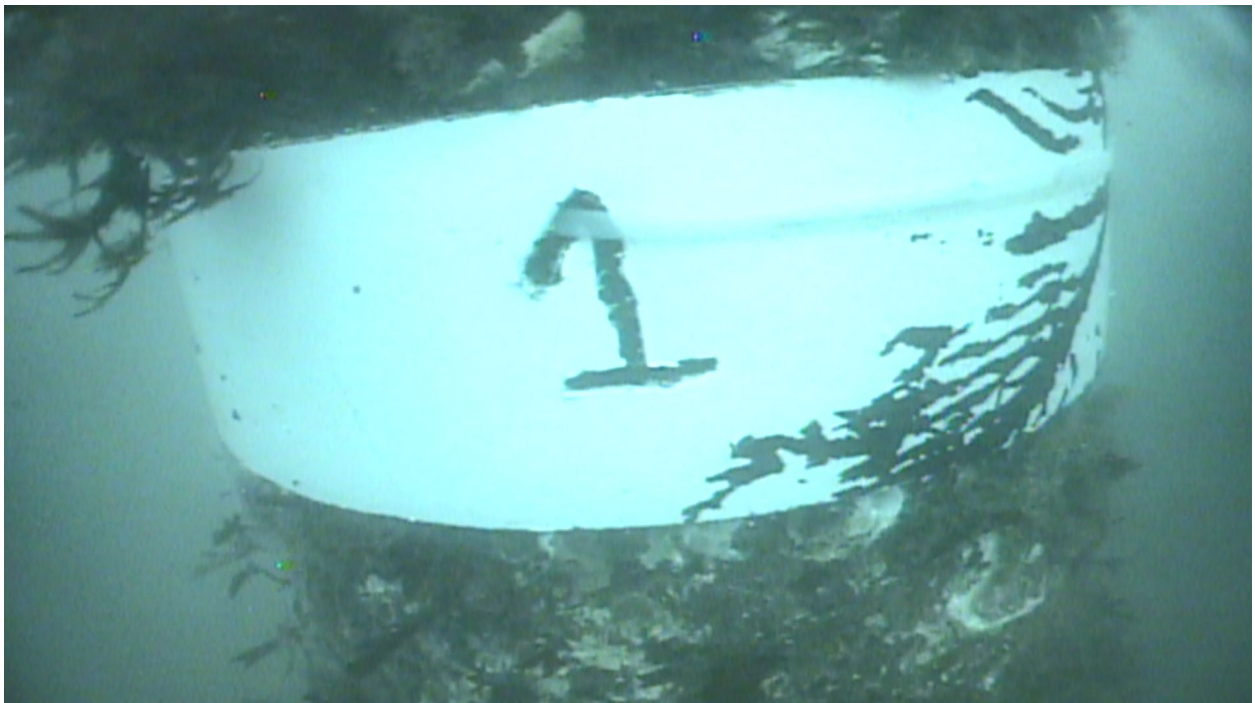
**Figure 14. Treadwell-1 labeled (photo by Global Diving).**

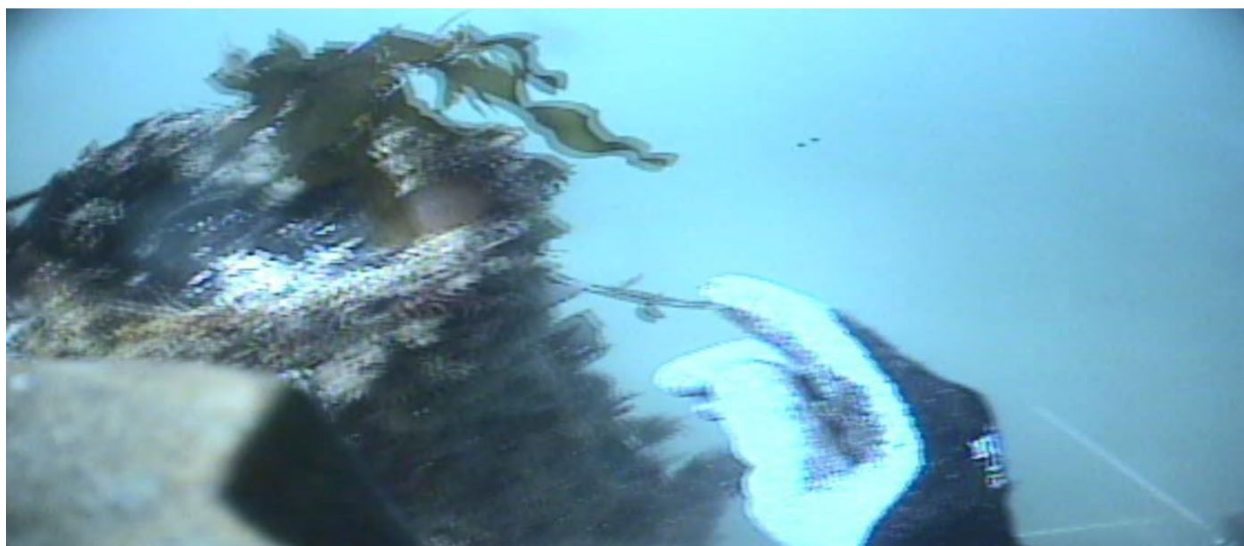
Figure 15. Intermittent leaking coming from Treadwell-1 (photo by Global Diving).

The two confirmed leaking wells, Treadwell-1, and Treadwell-5, still have vertical timber piles that need to be removed. This work, along with the re-abandonment, will occur in the second half of 2023 when SB 44 funds are available in that fiscal year. This work is somewhat delicate because the timber piles and other debris are encased in asphaltenes that are stuck to the outside of the well casings. Precautions are being developed to remove the debris and asphaltenes without tearing away any section of the casing where steel is thin; proper measures will avoid causing more oil leakage than what occurs presently. Dive crews piled debris in a few central locations underwater for easier recovery at a later point, either during re-abandonment or on a future dive campaign, for landfill disposal.

The re-abandonments of Treadwell-1 and Treadwell-5 are estimated to take 4-5 days for each well. The projected cost is around \$3 million. The proposed work will be similar to the Treadwell-10 and NorthStar-815 operations except that Treadwell-1 and Treadwell-5 protrude 8 and 5 feet above the mudline, respectively. The well casings will need to be cut off at the mudline before driving the pipe pile over the top. This work will be done within the confines of a temporary wet cofferdam, allowing divers to access the well location at the seafloor and serving as a containment device for any ongoing oil seepage. Onshore support will consist of oil spill response equipment staged in Lookout Park.

The Commission anticipates plugging and abandoning two additional offshore wells along the Treadwell Pier – Treadwell-1 and Treadwell-5. Staff will try to re-abandon both wells concurrently if funding allows. The plug and abandonment approach will be similar to the approach used in the Treadwell-10 and NorthStar-815 abandonments performed in 2020, with some improvements or modifications based on lessons learned from previous operations. The work will involve driving a pipe-pile around the well, like a sleeve, and filling the pipe with cement, entombing the legacy well. This work will occur, depending on funding availability, in the second half of 2023.

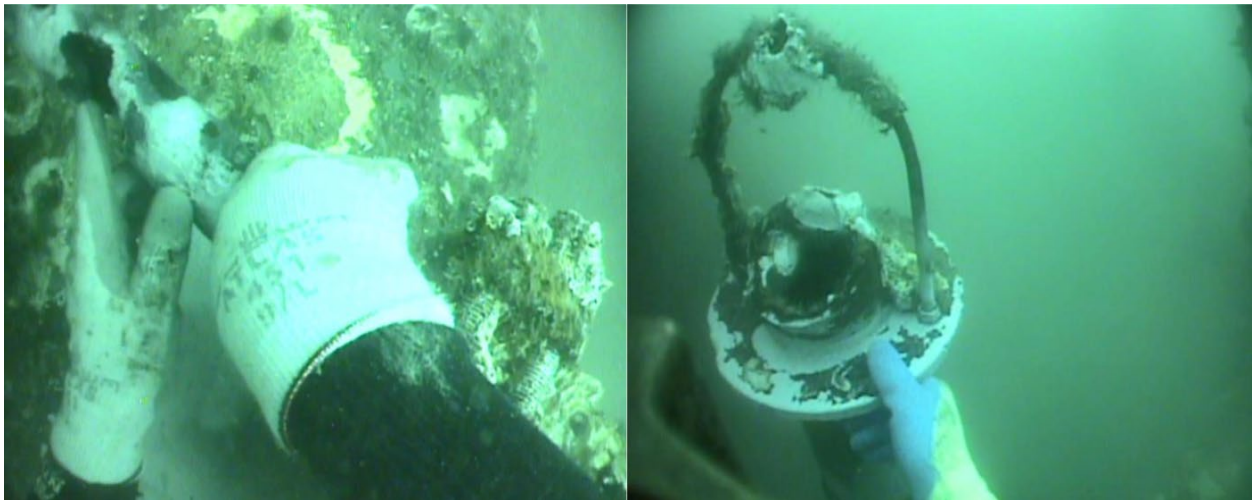
**Figure 17. 2-inch line (left) and top of wellhead tree 2-inch pipe (right) (photos by Global Diving).**

1. Document and verify via video the structure of the tree and casing.
2. Extensive documentation and modeling of seepage area(s).
3. Locate tools for a one-of-a-kind tree for testing valves during a follow-up dive.
4. Remove larger debris around future well casing targets for capping.

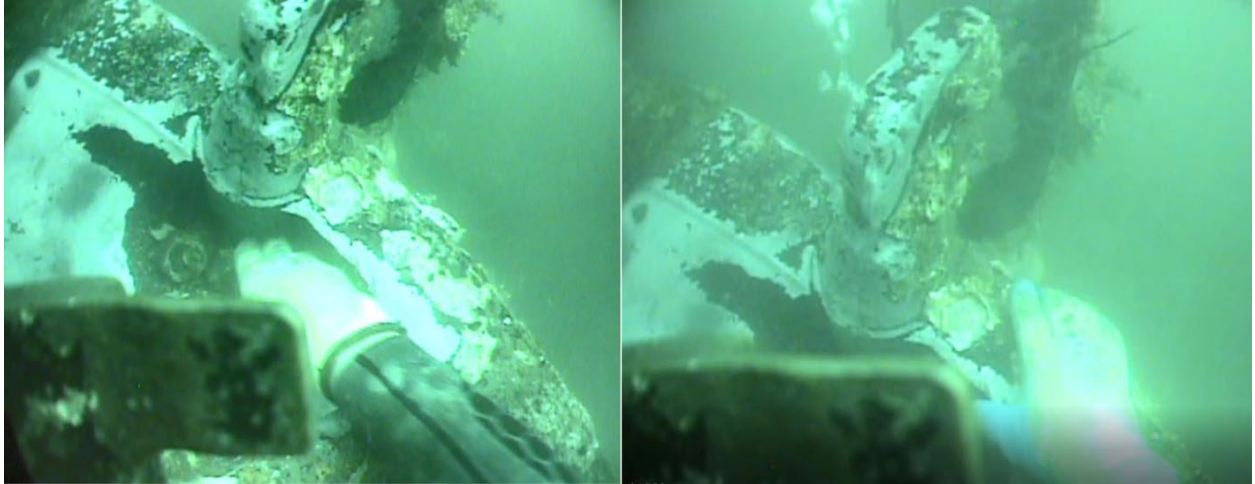
**Figure 18. Landing base pad eye (left) and gas bubbles (right) (photos by Global Diving).**

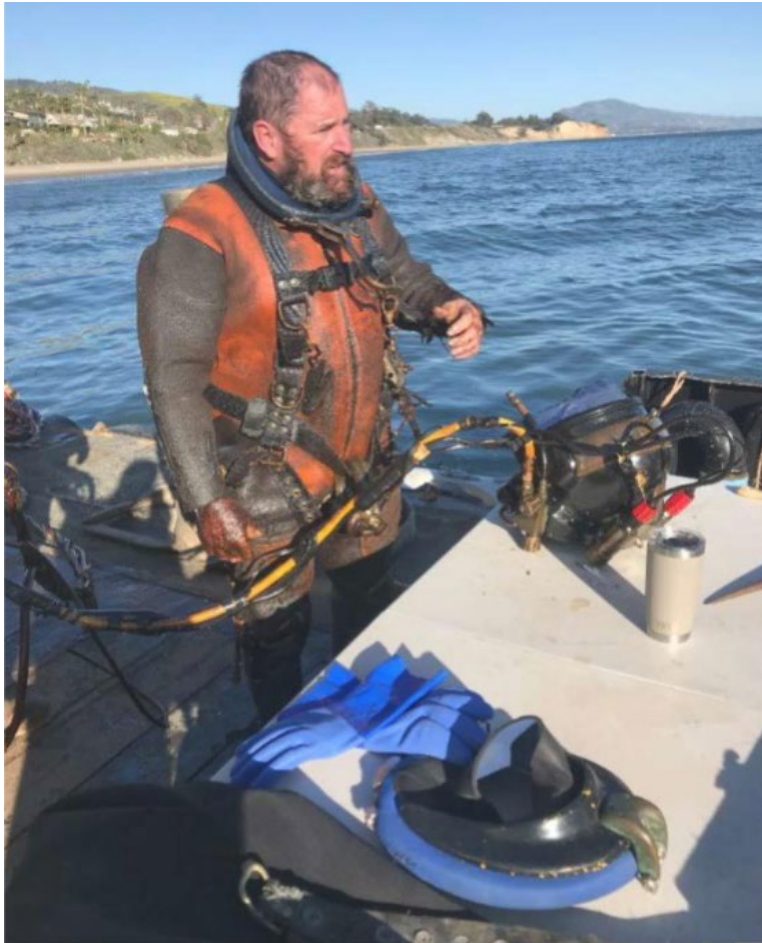
Interact notified the diving services firm (Global) of a surface sheen in the vicinity of the Moore-1 and Duncan-1 well locations off Summerland Beach. The dive team surveyed the area in March 2022. The dive team observed oil and gas bubbles on the surface of the water on coordinates provided by a drone operator. The support vessel Way Out dropped buoy markers for the *Danny-C* and divers to navigate from. The *Danny-C* anchored into position at the Moore-1 well location, which was in proximity to the shore, making for poor visibility and surging conditions. The divers used a metal detector to try and locate the well casings but were unable to pinpoint well locations. A hand jet was deployed to excavate at the buoy marker location. After extensive dredging of a grid area of 30 by 30 feet, divers located asphaltenes and oily sands, but did not find any debris or well casings.

**Figure 19. Diver on vessel after excavating in oiled sea floor (photo by Global Diving).**

1. A follow-up dive for Duncan Pier and Moore Pier to locate and determine if there are leaking well(s) or natural seeps.
2. Extensive documentation and modeling of seepage area(s).
3. Map and tag Moore and Duncan Piers.
