**RINCON PHASE 2 DECOMMISSIONING PROJECT –
EVALUATION OF EFFECTS AND EFFECTIVENESS OF THREE DIFFERENT TREATMENTS OF STATE
COASTAL CONSERVANCY PARCEL AT PUNTA GORDA,
VENTURA COUNTY COAST**

**GARY GRIGGS
CONSULTING COASTAL GEOLOGIST
321 ALTA AVENUE, SANTA CRUZ, CA. 95060
(831) 332-9318 – GRIGGS@UCSC.EDU**

INTRODUCTION – EVOLUTION AND PROTECTION OF THE STATE COASTAL CONSERVANCY PARCEL

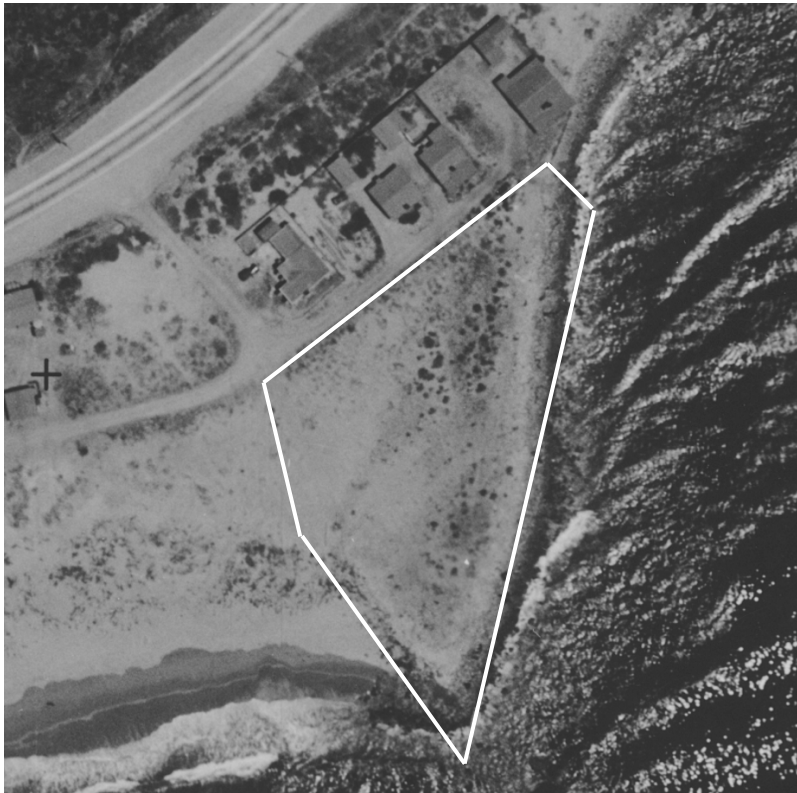
The oldest aerial photograph (1927) shows a slightly convex seaward shoreline extending about 400 feet downcoast from the end of Punta Gorda (Figure 4). The upper flat portion of the parcel appears to be mantled with some scattered vegetation and the sandy shoreline looks to be covered in part with rocks; it is much darker than the shoreline upcoast or west of Punta Gorda, which is a sandy beach backed by low dunes. Subsequent aerial photos from 1936, 1939, 1944 and 1945 indicate that the shoreline had eroded landward since the 1927 image and no longer extended as far out as the rock outcrop making up the end of Punta Gorda (Figures 5 & 6). In 1939, retreat along the east side of the point had reached 50 feet and by 1945, this had increased to about 100 feet. The shoreline was still mantled with scattered rocks in these pre-causeway installation (1959) photos.

Figure 4. Coastal Conservancy parcel in 1927. There appears to be some vegetation on the inner and higher portion of the site (approximate site boundaries in white).

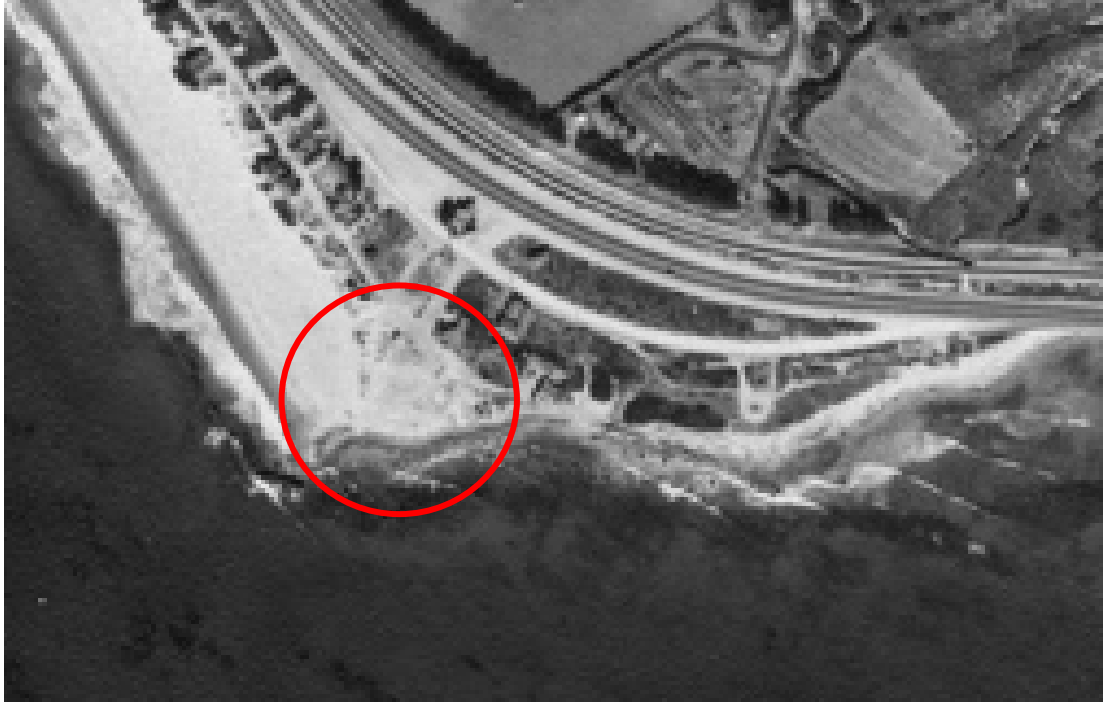
Figure 6. State Coastal Conservancy parcel (contained within red circle) in 1945 showing continued shoreline retreat east of the point.

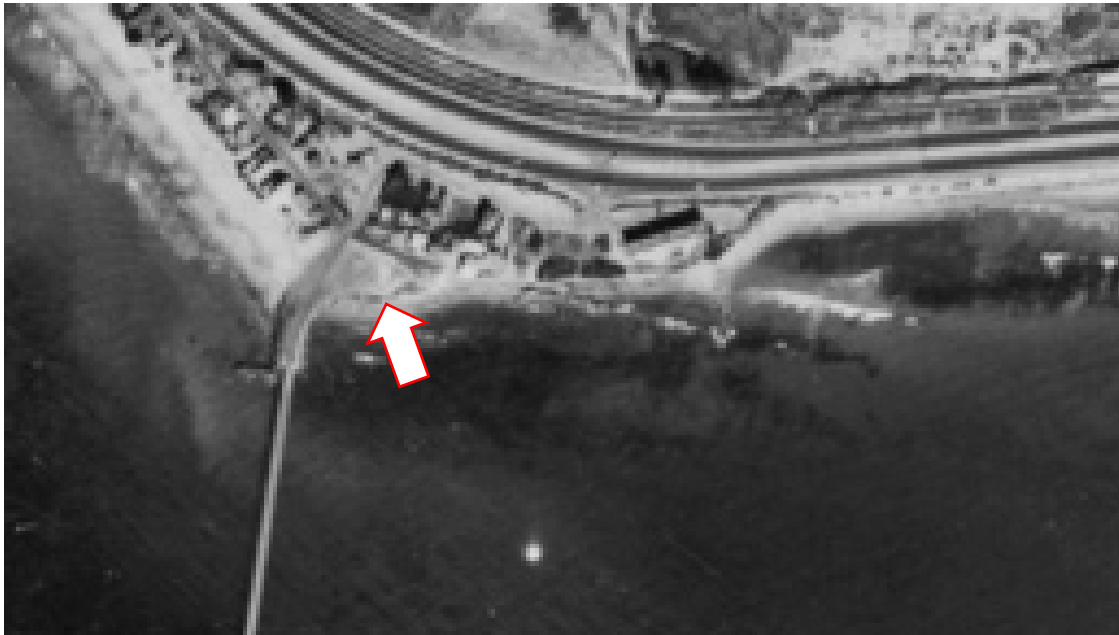
Figure 7. State Coastal Conservancy parcel in 1963 following 1959 construction of abutment and causeway. Dark area along the shoreline (arrow) appears to be rip rap that was placed in an arc extending from the abutment downcoast along the back beach.

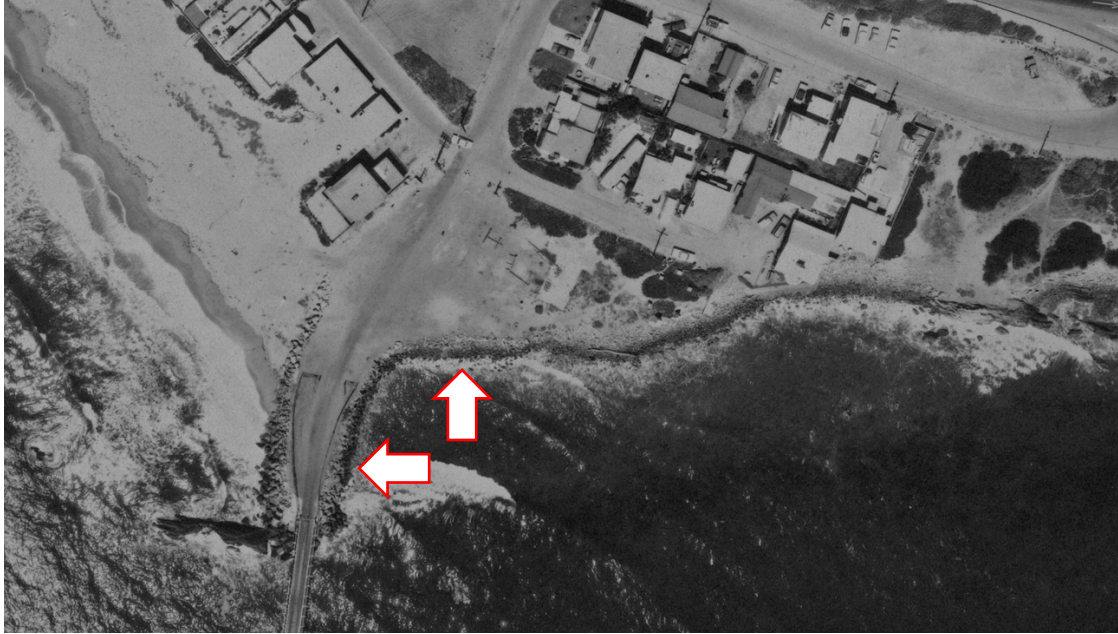
Figure 8. State Coastal Conservancy parcel in 1971 with riprap armoring the right side of the abutment and continuing downcoast in an arc along a portion of the shoreline (arrows).

The concrete abutment and protective revetment along with the causeway and island were constructed in 1959, although the aerial photograph from that year is of poor quality. By 1963, the shoreline next to the causeway abutment had retreated a total of about 160 feet (Figure 7). The seaward edge of the flatter upper surface of the parcel appears to be an eroded scarp. Eight years later, in 1971, the riprap is more evident and extends in an arc eastward for about 135 feet from the abutment across the downcoast shoreline (Figure 8).

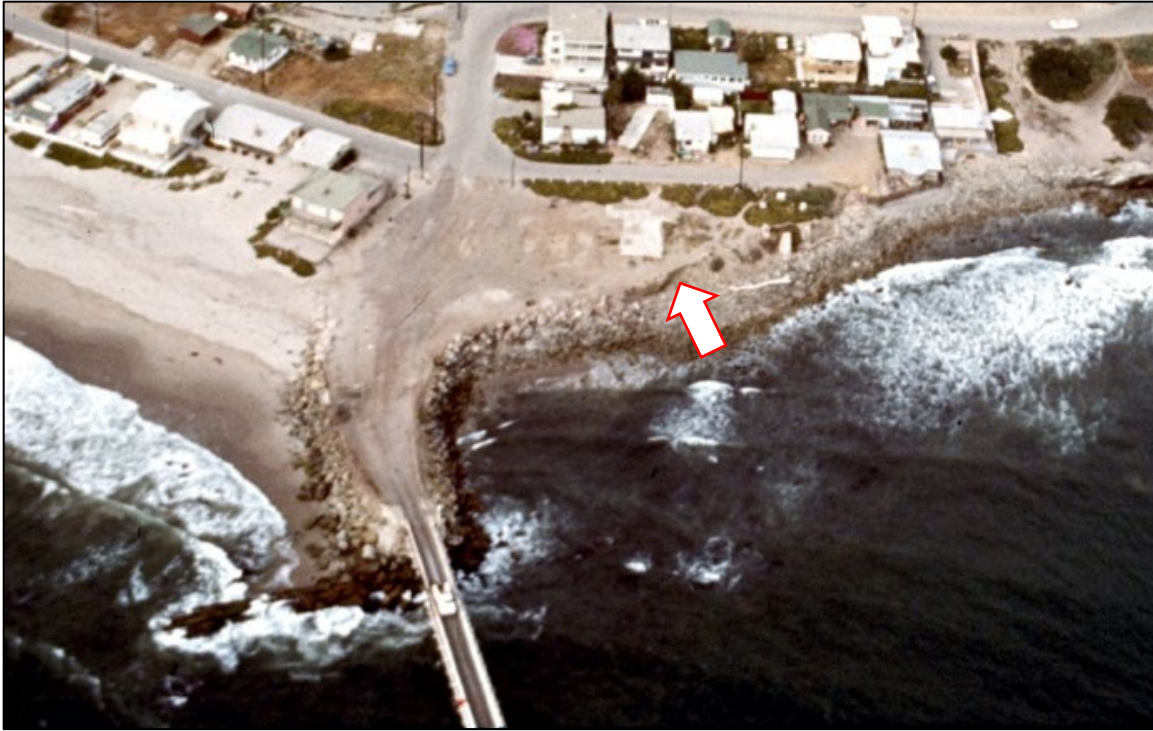
The 1972 oblique aerial photo illustrates a difference or contrast between the rock (riprap) adjacent to the abutment and what appear to be smaller cobbles scattered across the shoreline to the east (Figure 9). The cobbles have been overtopped and erosion has produced a scarp in the shoreline on the eastern side of the SCC parcel (Figure 9). It appears that the upper flat portion of the site is being used as a staging or storage area at this time. The 1987 aerial photo shows little additional shoreline change in this area (Figure 10).

Figure 9. SCC site in 1972. The downcoast or eastern side of the parcel shows a rocky beach but no riprap and a scarp that has been eroded into the low unarmored bluff (arrow) (California Coastal Records Project - Kenneth and Gabrielle Adelman).

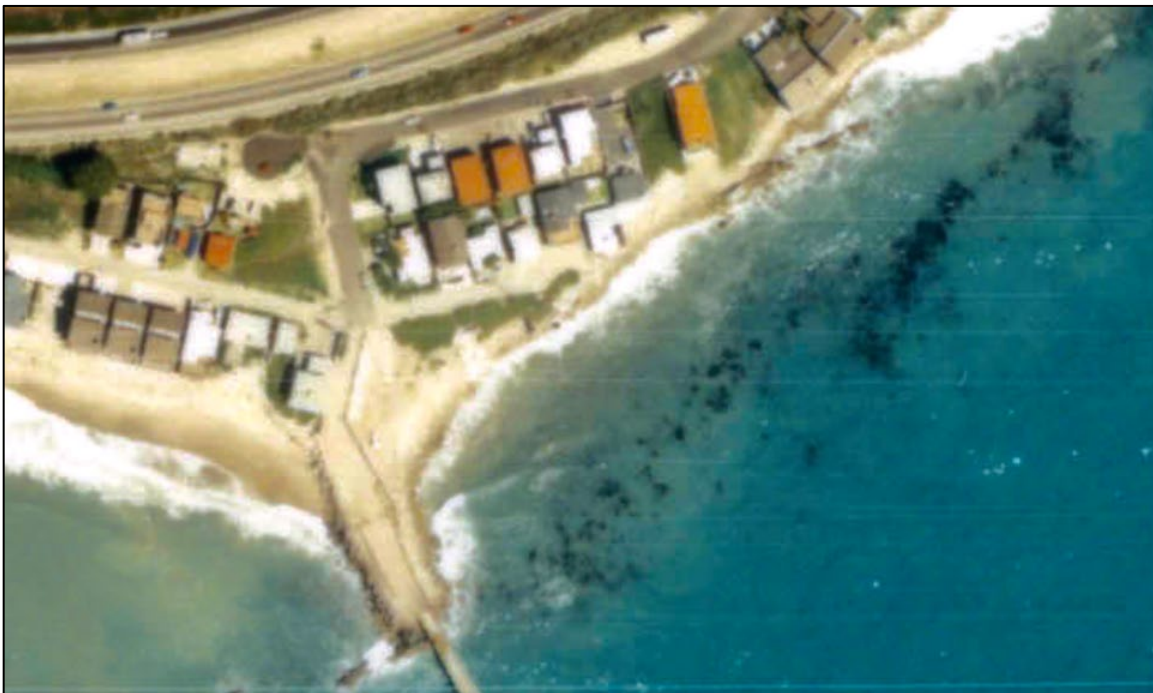
Figure 10. 1987 image of SCC parcel, with the shoreline immediately east of the abutment now having developed a relatively smooth concave or arcuate shape.

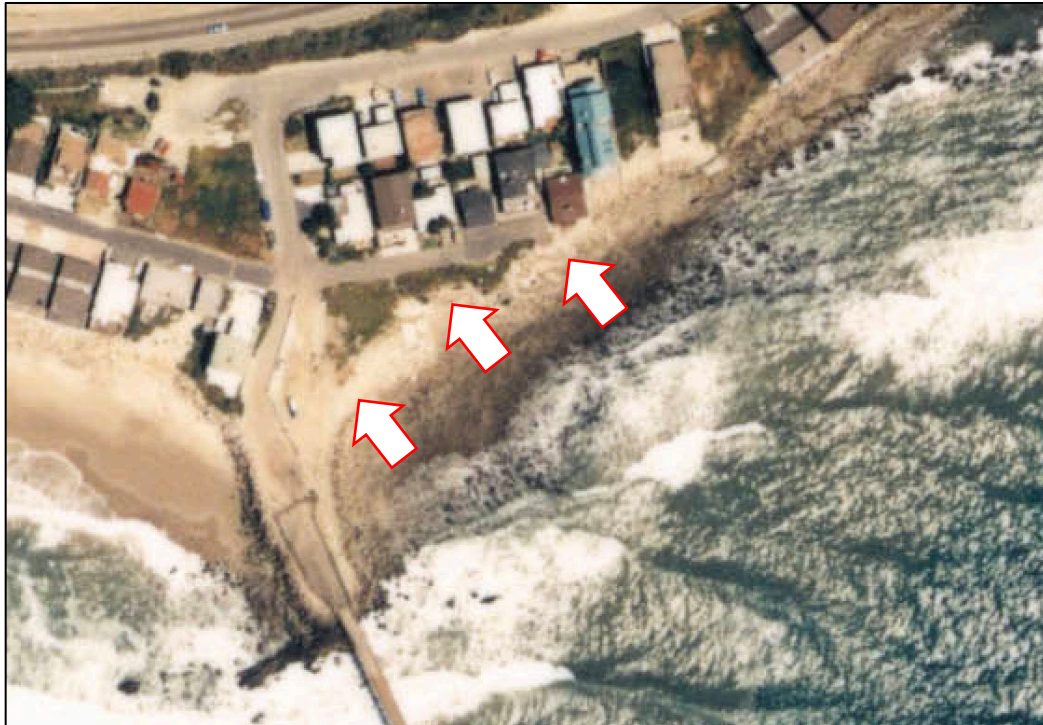
While riprap was placed completely around the concrete abutment and in an arc downcoast, by the time of the 1993 vertical photograph, some of the riprap appears to have spread or collapsed onto the beach and bluff edge has been eroded back, narrowing the flatter upper portion of the parcel (Figure 11).

Figure 11. 1993 photograph. Recent wave action appears to have overtopped and moved the riprap seaward and eroded the coastal bluff landward at arrows.

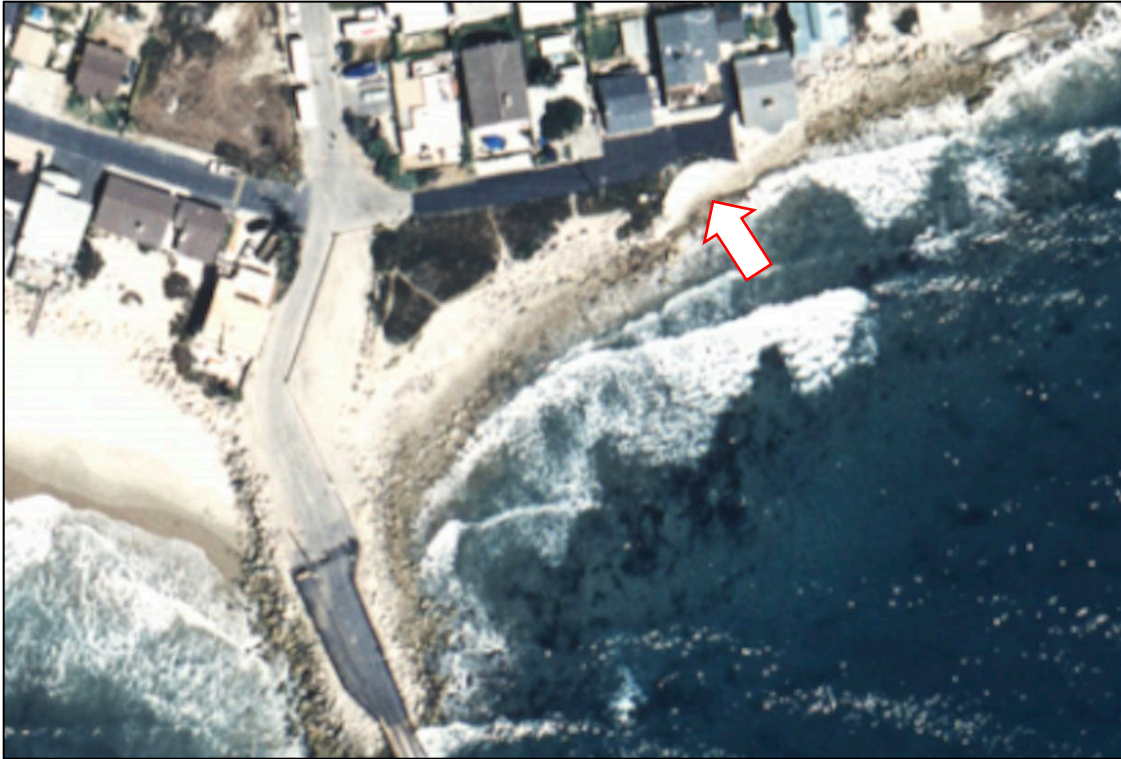
Eight years later in the 2001 aerial image, the riprap and rock along the shoreline has developed an arcuate profile and no additional erosion had taken place. A curved face concrete seawall has also now been built on the far eastern end of the SCC parcel to protect the house directly inland (Figure 12).

Figure 12. 2001 photograph showing eroded shoreline and curved-face concrete seawall at eastern edge of parcel (arrow).

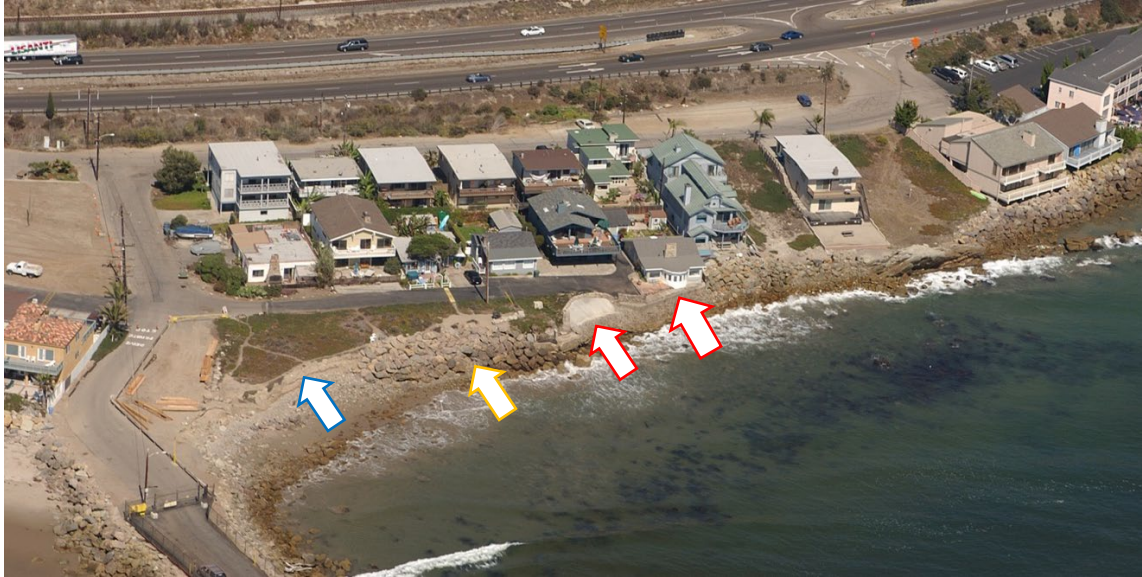
Figure 13. 2002 photograph showing two concrete seawalls at downcoast end of SCC parcel (red arrows) and riprap now added upcoast of the seawalls (orange arrow). The low bluff is now fronted with a scarp along its entire western section (blue arrow) (California Coastal Records Project – Kenneth and Gabrielle Adelman).

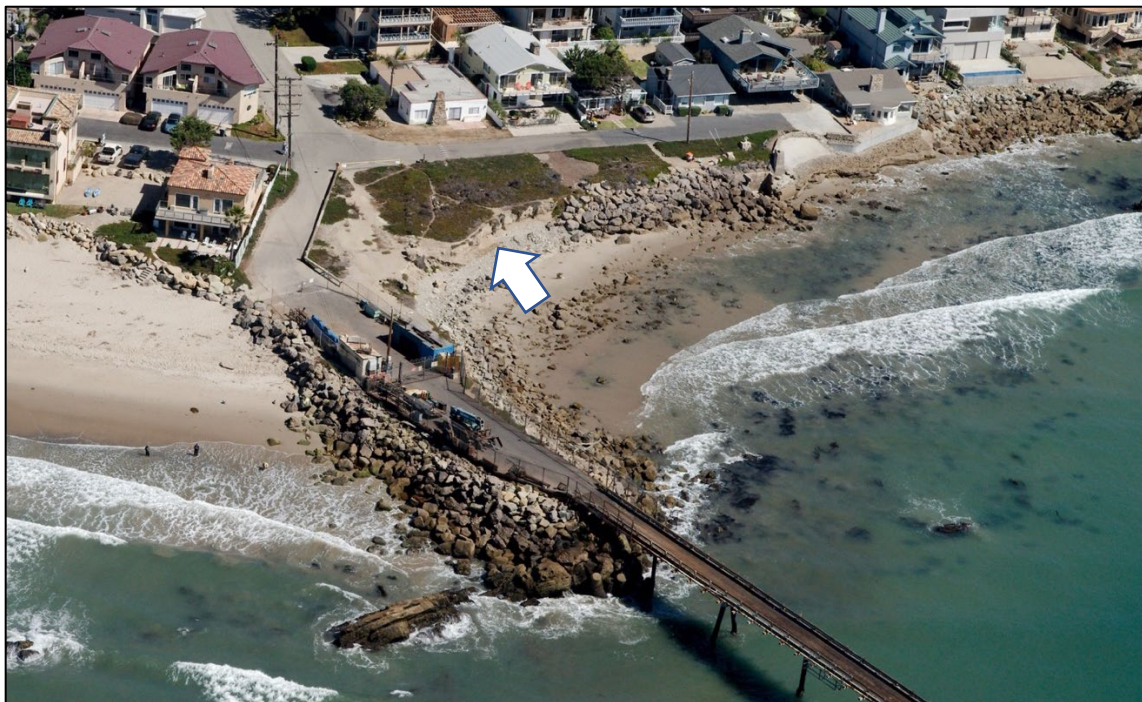
The most recent aerial photograph from the California Coastal Records Project (2013) shows some settling of the riprap along the abutment and seaward migration of the downcoast riprap. There doesn't appear to have been any additional retreat of the unprotected bluff immediately downcoast (Figure 14). It is likely due a combination of the 1) scattered rock along this unprotected rocky shoreline that disperses some of wave energy, and also 2) the wave shadow or protection offered by the causeway abutment to waves, such that any high energy waves from the dominant southwest sector undergo refraction and therefore lose energy before reaching the shoreline.

Figure 14. 2013 image of SCC parcel. The main section of eroded bluff backs the shoreline that is not armored (arrow). Original riprap adjacent to abutment has partially collapsed onto the beach (California Coastal Records Project – Kenneth and Gabrielle Adelman).

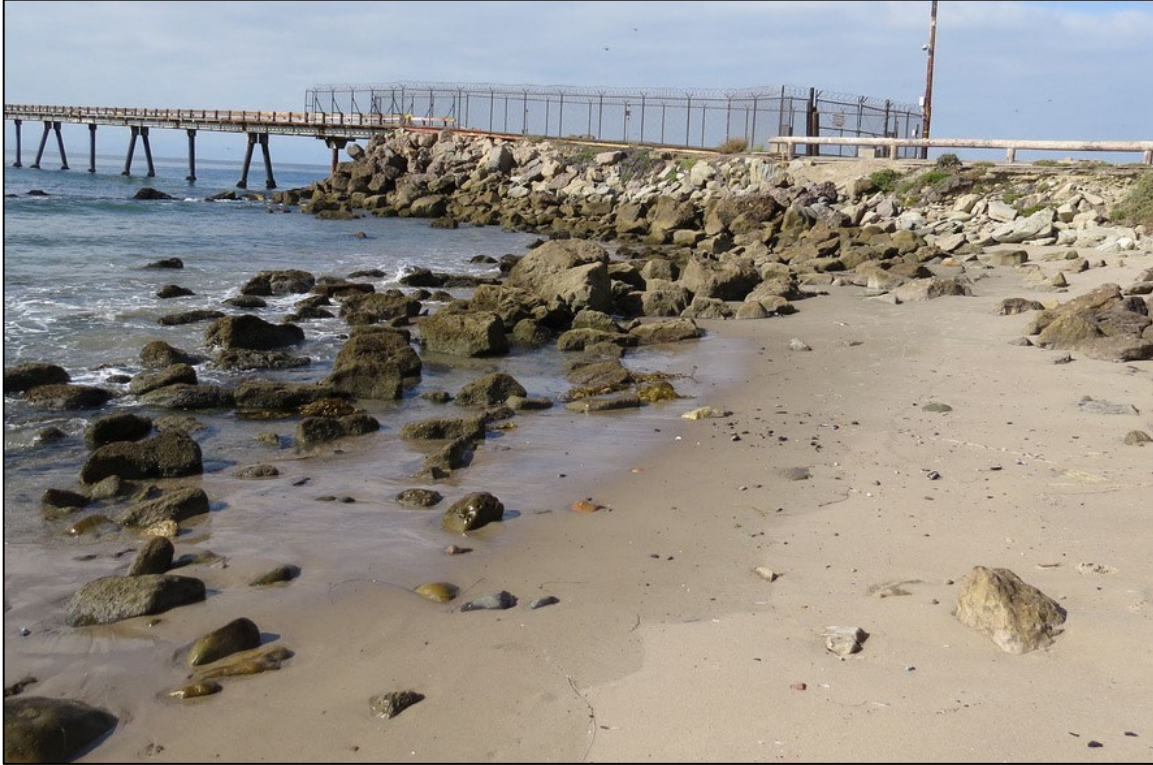
A field investigation on October 2, 2022, indicated that the Study Area contains a sandy beach with discontinuous boulders along the shoreline that have moved downcoast and seaward from the original 1959 causeway revetment (Figure 15). These boulders are of the same rock type as those flanking the abutment, so are what are referred to as "fugitives", or rocks which have moved from their original placement locations. These provide evidence for the forces that waves can exert, even on large riprap, at this location.

Figure 15. October 2, 2022, view towards the abutment and causeway showing riprap that has migrated east or downcoast since original emplacement in 1959.

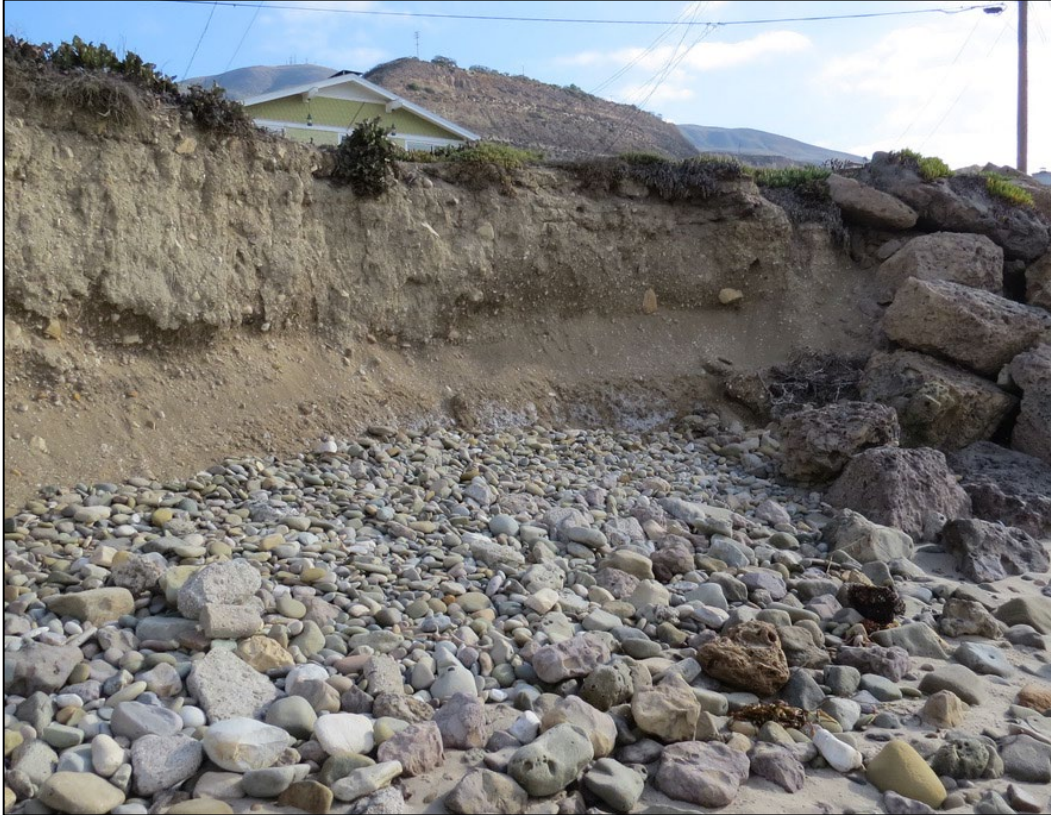
The near vertical eroding bluff backing the shoreline is about eight feet high and consists of a mixture of poorly sorted material which is believed to be the alluvial fan material brought to the shoreline from the inland drainage over thousands of years. This material is only loosely consolidated so has eroded easily when impacted by large storm waves at very high tides. The bluff is fronted by a low cobble berm that provides some protection from wave attack (Figure 16).

Figure 16. Eroding bluff immediately downcoast from abutment that is fronted by a cobble berm but no riprap.

Alternative 9C would include all of the components included in Plan 9A and would add riprap to armor the roughly 130 feet of shoreline that is presently unprotected. The additional riprap would extend from the existing intact riprap adjacent to the abutment to the riprap protecting the downcoast homes and Breakers Way (Figure 29). About 135 feet of the western or upcoast portion of the shoreline was originally protected by riprap when the abutment was constructed in 1959 (see Figure 9). Over the subsequent 62 years, however, the rock has been broken down and displaced by wave action so that it no longer provides significant protection to the upper portion of the parcel (see Figure 15). Wave erosion has left an approximately eight foot high near vertical bluff (see Figure 16).

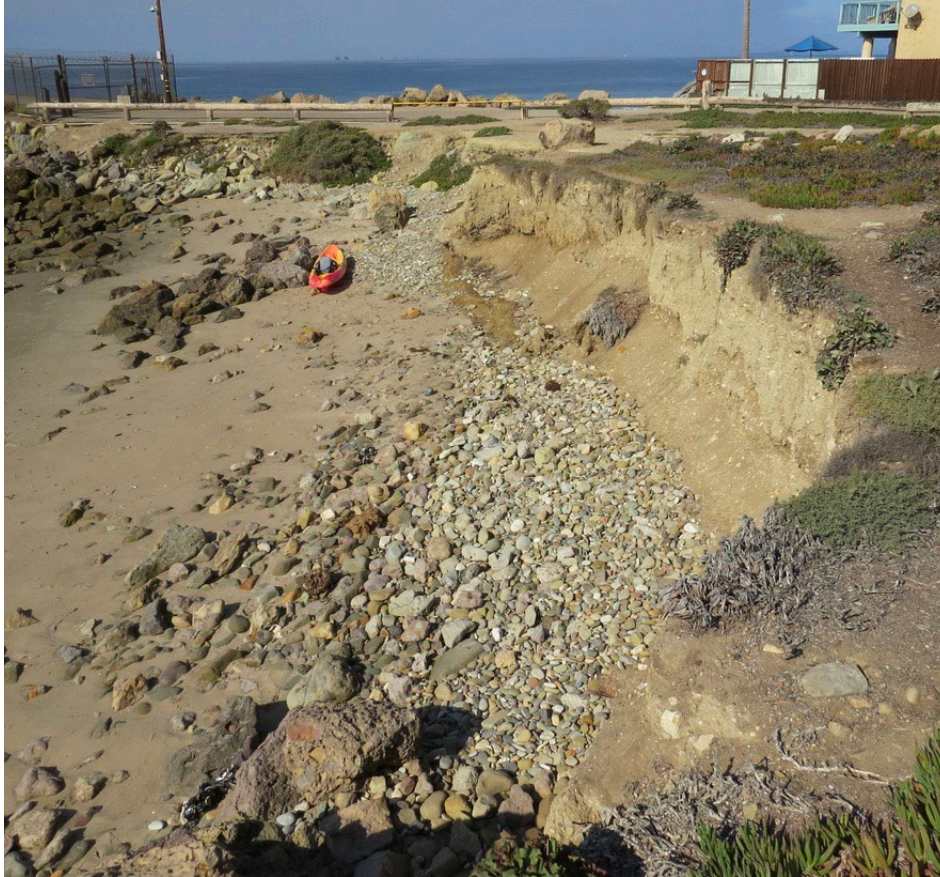
Figure 18. View of the flat upper portion of the SCC parcel and the bluff fronted by a cobble berm (October 2, 2022).

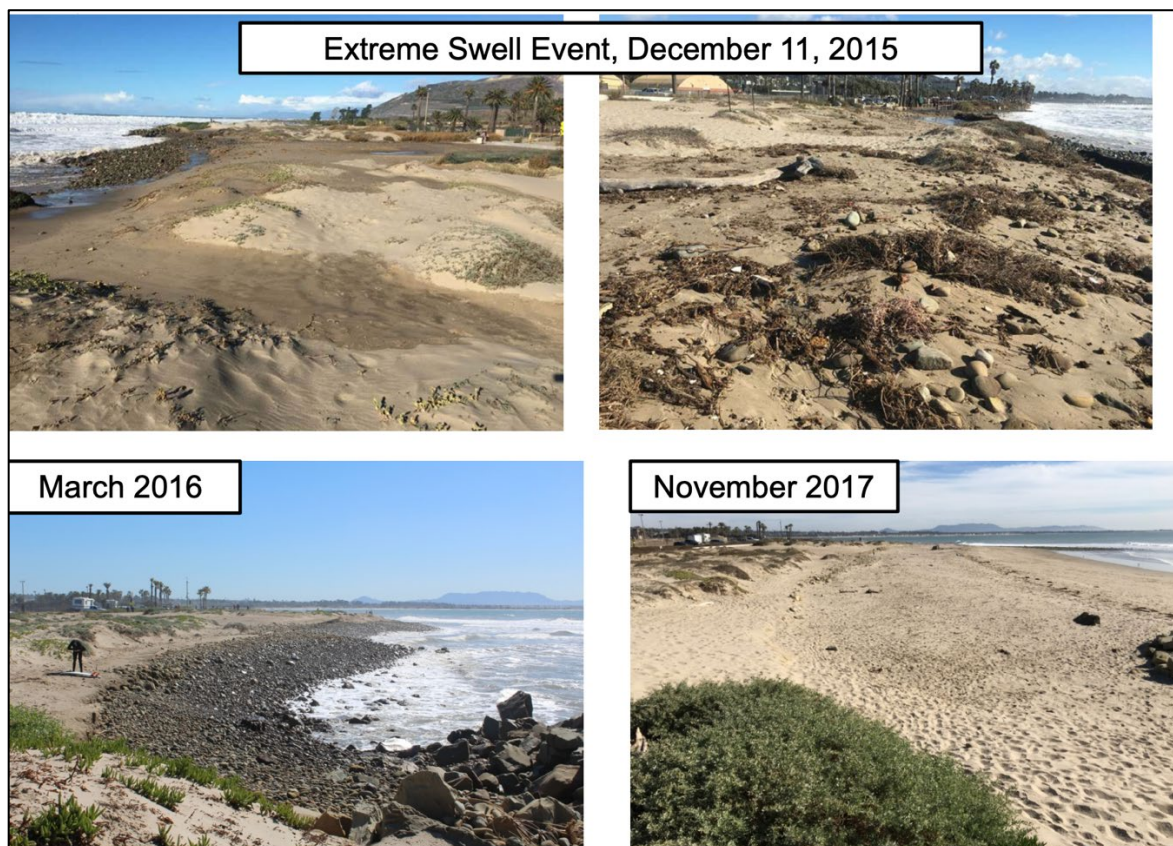
Figure 25. Cobble berm at Surfer's Point following 2015-16 storm wave attack and then recovery.

While significant wave attack occurred in the winter of 2015-2016, removing the sand cover and exposing the cobbles, a year later the beach had rebuilt and the cobble berm was nearly completely covered again (Figure 25).

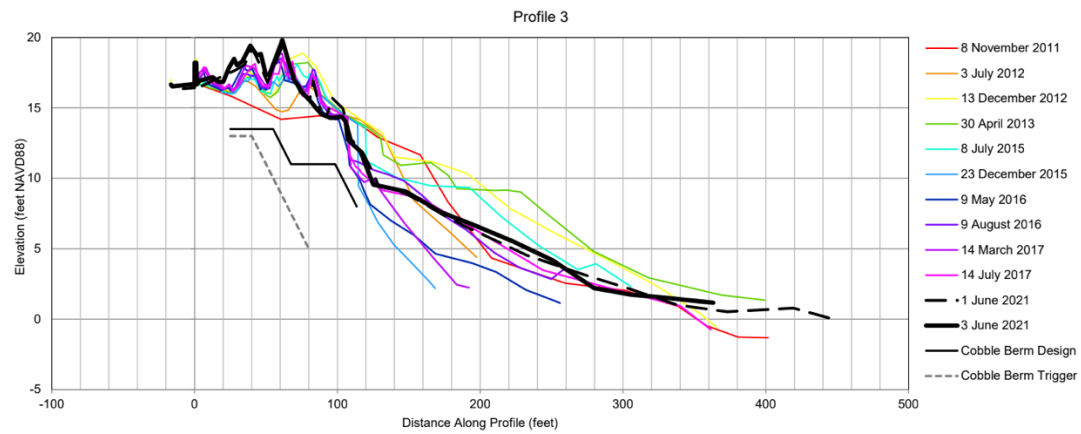
Profile 3 – City of Ventura and ESA Surveys

Figure 27. Profile 3 across dunes and shoreline at Surfer's Point built over the 10-year period from 2011 to 2021 showing stability and little change on the upper portion of the profile where cobbles were placed and dunes were constructed.

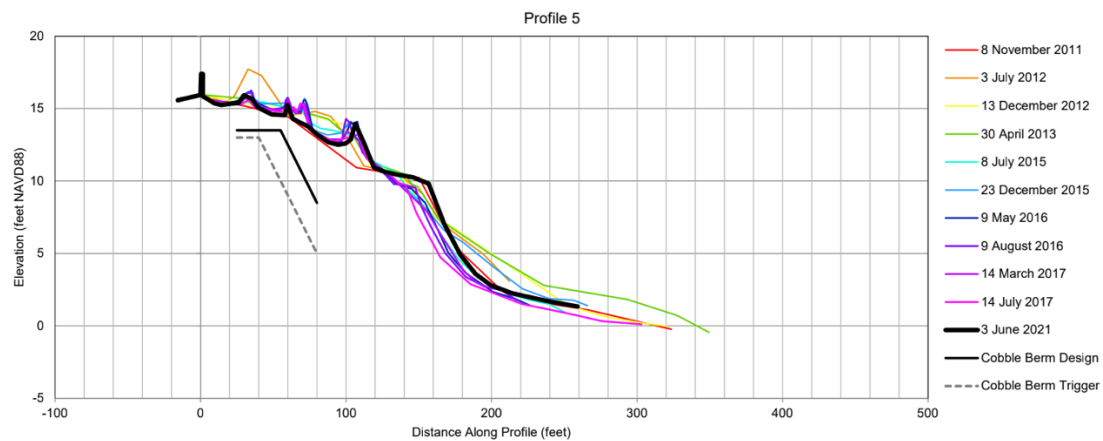
Profile 5 – City of Ventura and ESA Surveys

Figure 28. Profile 5 across the eastern end of the project, showing virtually no change on the upper portion of the profile over ten years of surveys. The sand on the beach does come and go seasonally.

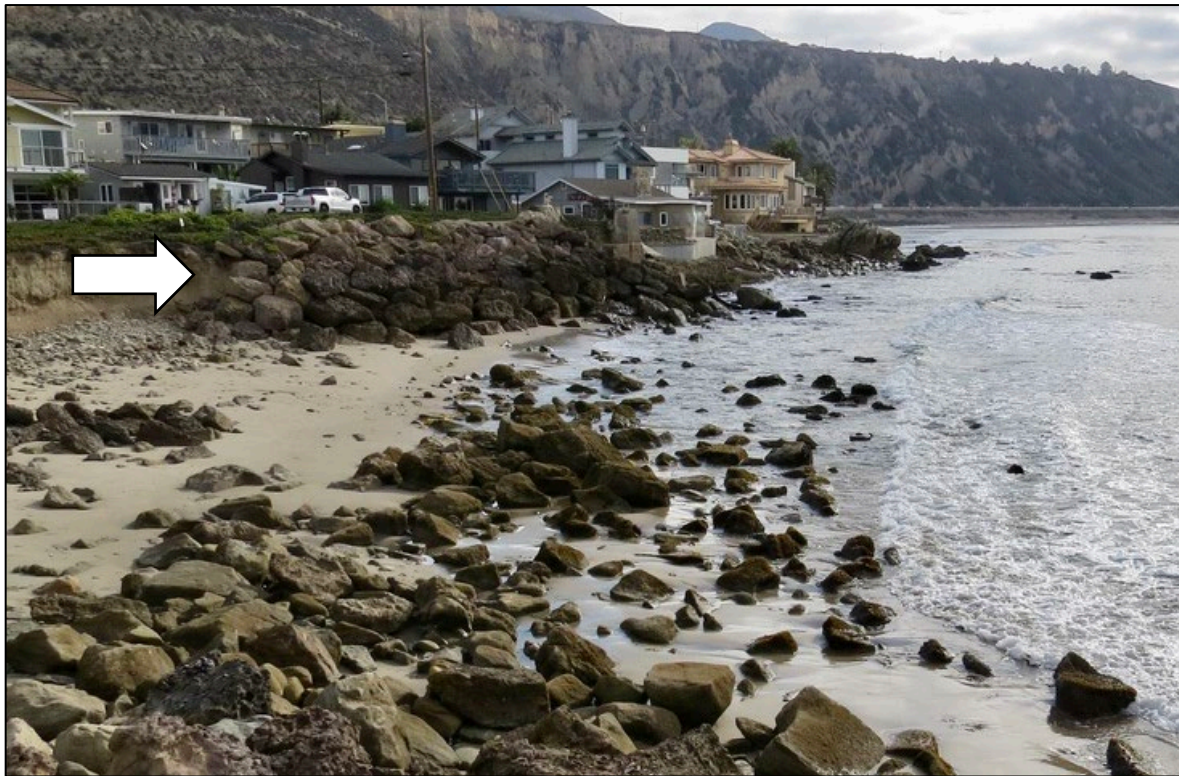
The existing riprap around the causeway abutment has performed well over the 62 years since its original placement, as has the rock protecting Breakers Way and the downcoast homes (Figure 30), which has been in place for at least 20 years. Additionally, the rip rap armoring the downcoast hotel has been in place since at least as far back as 1972 or 50 years. The rock revetment protecting Highway 101, both upcoast and downcoast of Punta Gorda have also performed well for over 50 years.

Figure 30. Riprap (arrow) protecting Breakers Way and downcoast homes and remnants of original 1959 riprap scattered along the shoreline.
