Platform Holly & PRC 421 Abandonment & Decommissioning Update

Community Town Hall

November 7, 2019

California State Lands Commission

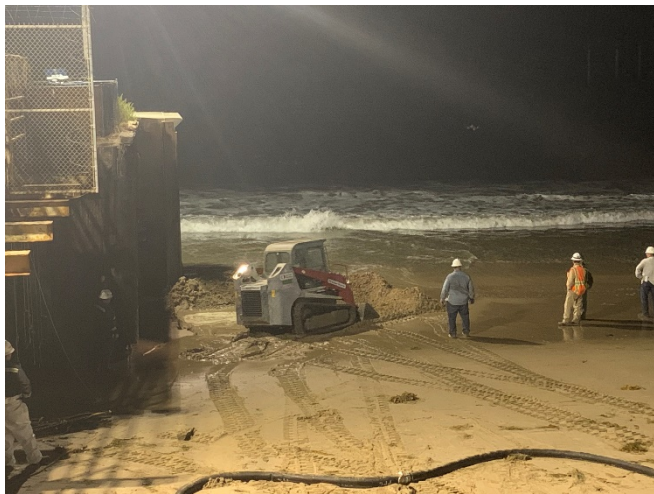
Excavating the Sand
Next to the caisson

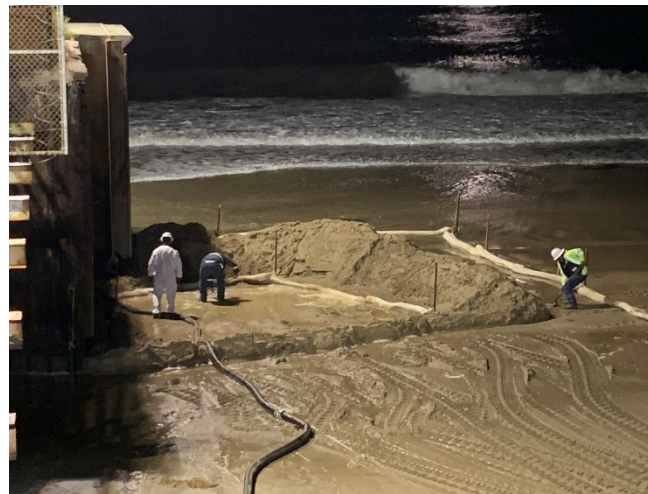
Building the
berm around
the site of the
oil expression
on the beach

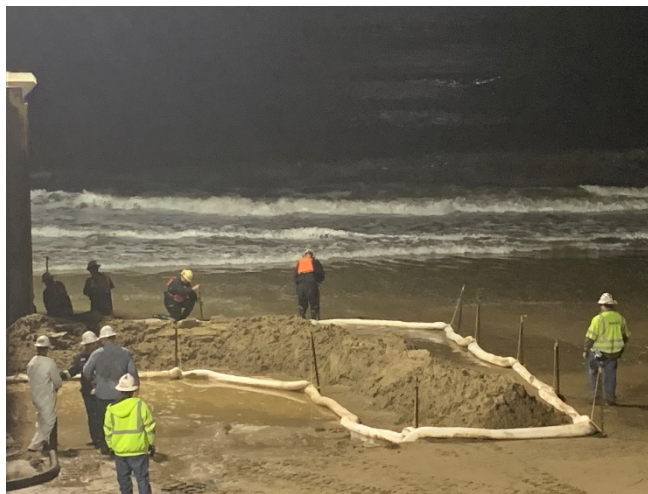
The berm surrounded
by oil absorbent boom

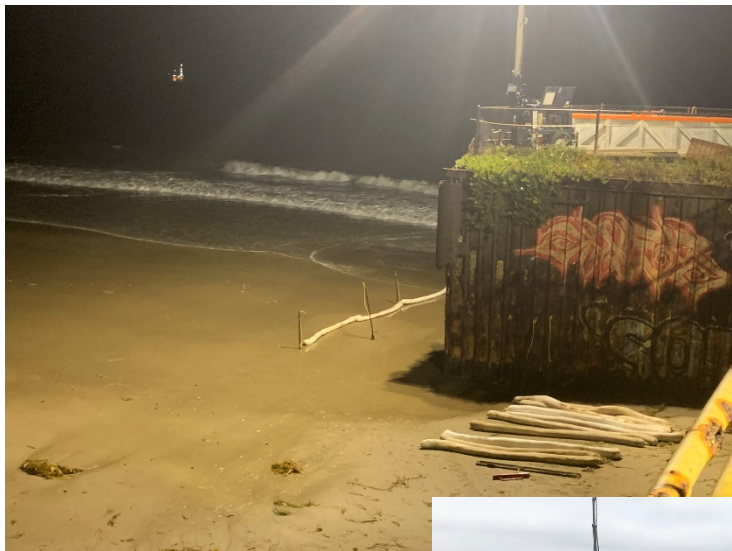
Placement of boom
Around caisson

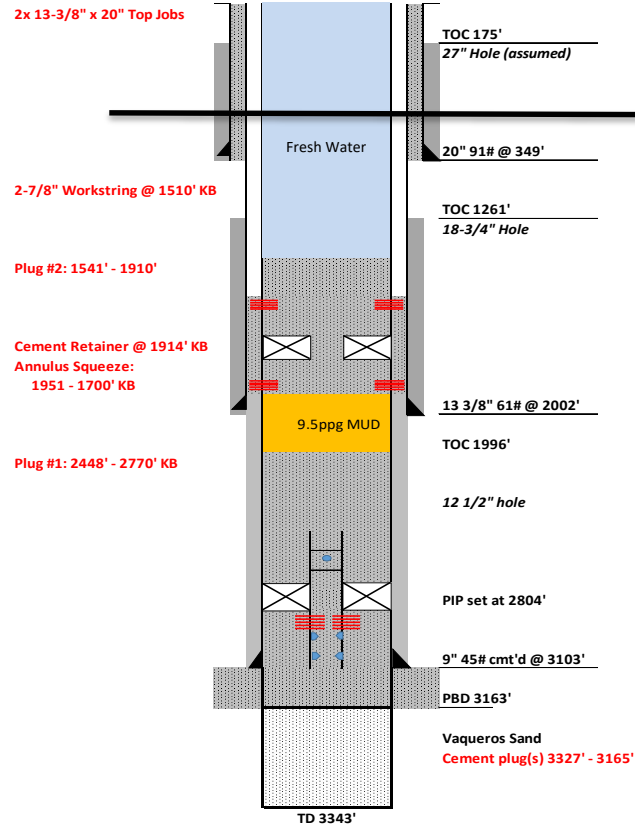
The Wellbore

- The original expression of oil occurred after a minor pressuring of the annular space between the steel casing strings
- Casing likely in contact with natural fractures
- A conduit to the beach was uncovered during the excavation at low tide

- We determined that 3-100' cement plugs in the 9" by 13 3/8" casing annular space would seal off any flow paths for the old oil.
- After each set of perforations a predetermined amount of cement was placed inside the casing above the highest perf and allowed to "settle" (push out through the holes from the weight of the cement) into the annular space. This was to minimize pressure on the hole.

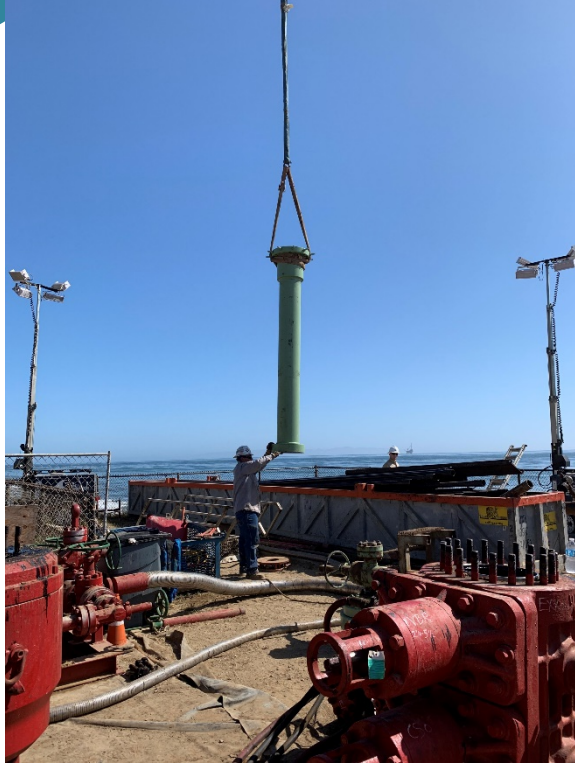
New “Riser”

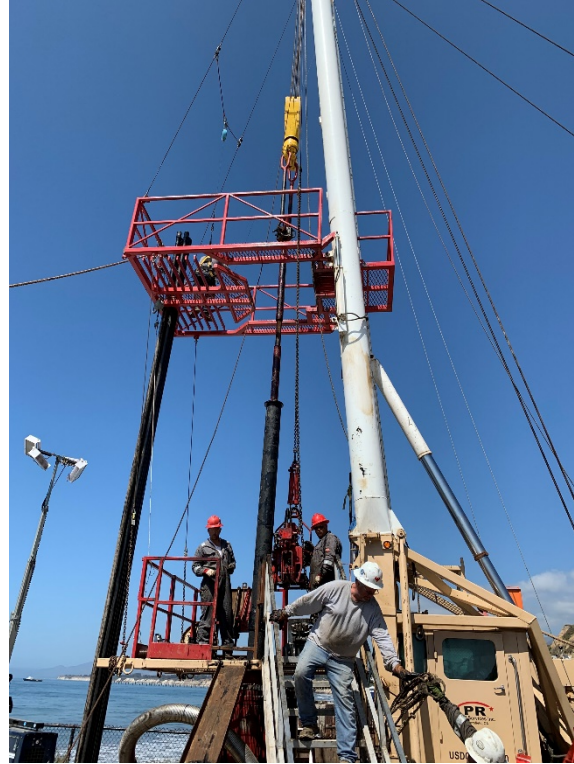
Pulling the Casing

9” casing wrapped in plastic for transport to waste facility
