December 2, 2021 Project No. 2101-0252

- Attention: Mr. Eric Gillies Assistant Chief - Environmental Planning and Management
- Subject: Report of Findings Asbestos and Lead-Based Paint Survey, PRC 421 Decommissioning Project, Pier Access Road, Goleta, Santa Barbara County, California

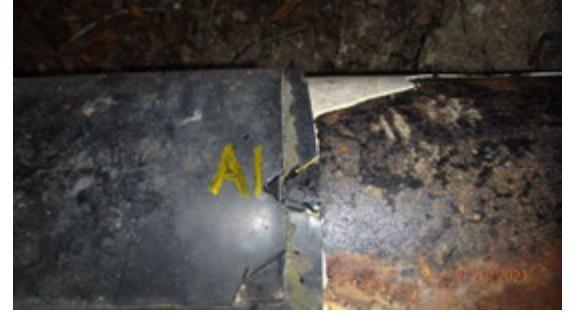
112321-ELLWOOD-A1 Black Pipe Wrap and Mastic (No Asbestos Detected)

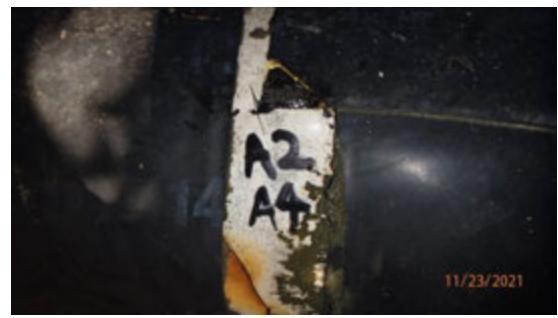
112321-ELLWOOD-A2 White Pipe Wrap and Mastic (No Asbestos Detected)

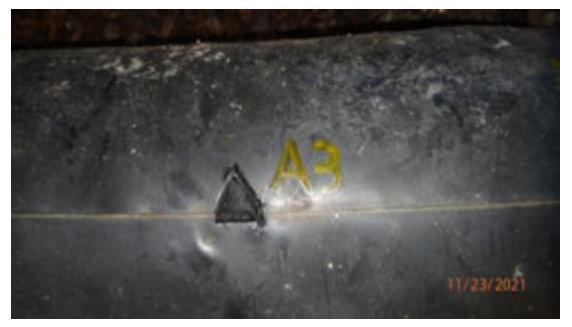
112321-ELLWOOD-A3 Black Pipe Wrap and Mastic (No Asbestos Detected)

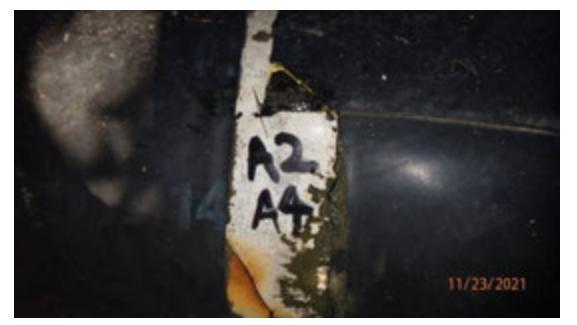
112321-ELLWOOD-A4 White Pipe Wrap and Mastic (No Asbestos Detected)

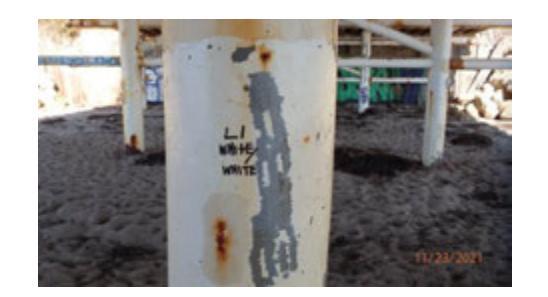
Sample ID	Location of Sample	Color	Condition	Lead in Paint (PPM)	Estimated Quantity (ft²)
112321- ELLWOOD- L1	The paint sample was collected from the support structure associated with Pier 421-1.	White / White	Some Flaking	<60	600
112321- ELLWOOD- L2	The paint sample was collected from the support structure associated with Pier 421-2.	White / White	Some Flaking	<60	600

112321-ELLWOOD-L1 Pier 421-1 White Paint (<60 PPM Total Lead)

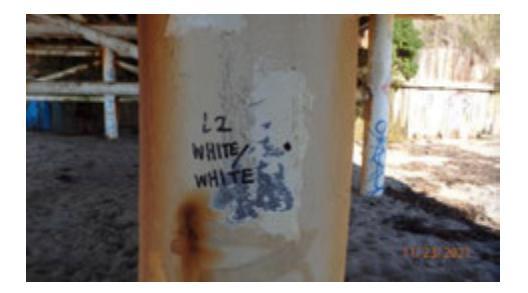
112321-ELLWOOD-L2 Pier 421-2 White Paint (<60 PPM Total Lead)
