TECHNICAL MEMORANDUM

Subject: Summary Report-OBS ROV Revised Cable Route Survey

JN 1102-0621

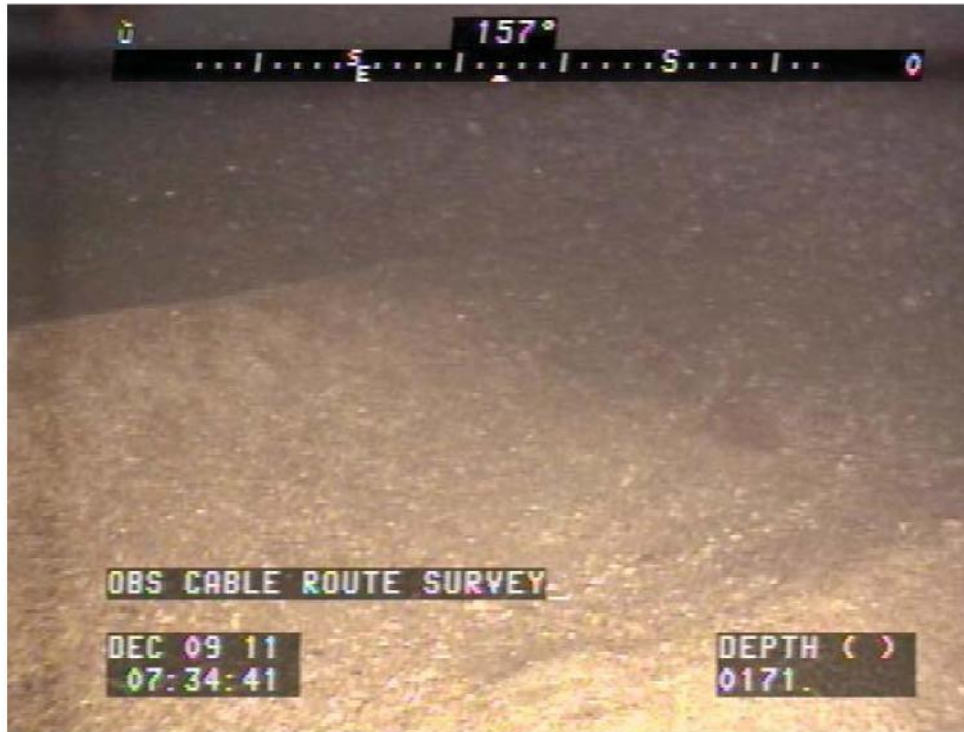
The seafloor habitat between Stations 8 and 6 was 95 percent sedimentary, consisting of areas of coarse sand and shell hash where sand waves (Photos 1 and 6) (from 0.2 to 1 m [0.5 to 3 ft] high) are interspersed among relatively flat areas of finer sediments (Photos 2 and 10). As is shown in Figure 3, rock features were observed 9 to 31 m (30 to 100 ft) from the proposed alignment and consisted of low to high (up to 3 m [10 ft]) relief reefs and scattered rock. Those features were located at Station 7 and at a site 457 m (1,500 ft) east of Station 6 (Location 14, Photos 3 through 5, and 7 through 9). Rock features that were observed along this segment of the realignment consisted of a sediment-covered, low relief (0.3 to 0.6 m [1 to 2 ft]) broken rock reef in 58 m (190 ft) of water, 305 m (1,000 ft) east of Station 6 (Location 15). The water depth along this segment ranged from 53 to 62 m (173 to 203 ft).

Photo 1. Sand Waves at OBS-4 Location, Inshore End of Proposed Revised Cable Route

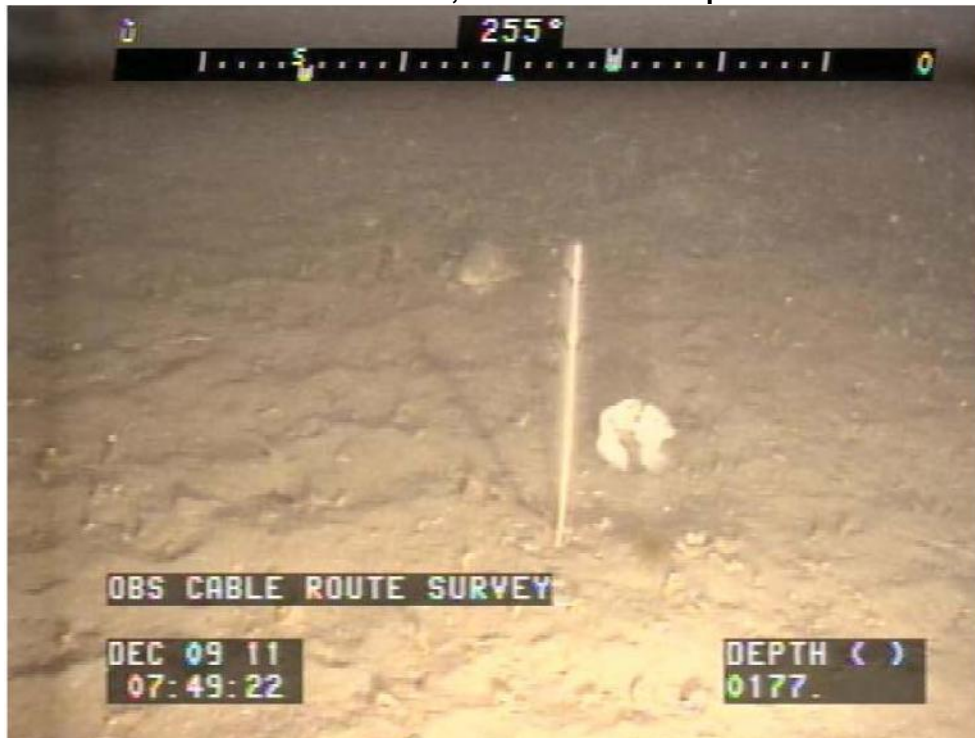
Photo 2. Flat Sedimentary Seafloor with Sea Pen (*Stylatula elongata*) Along Proposed Revised Cable Route Between Stations 8 and 6

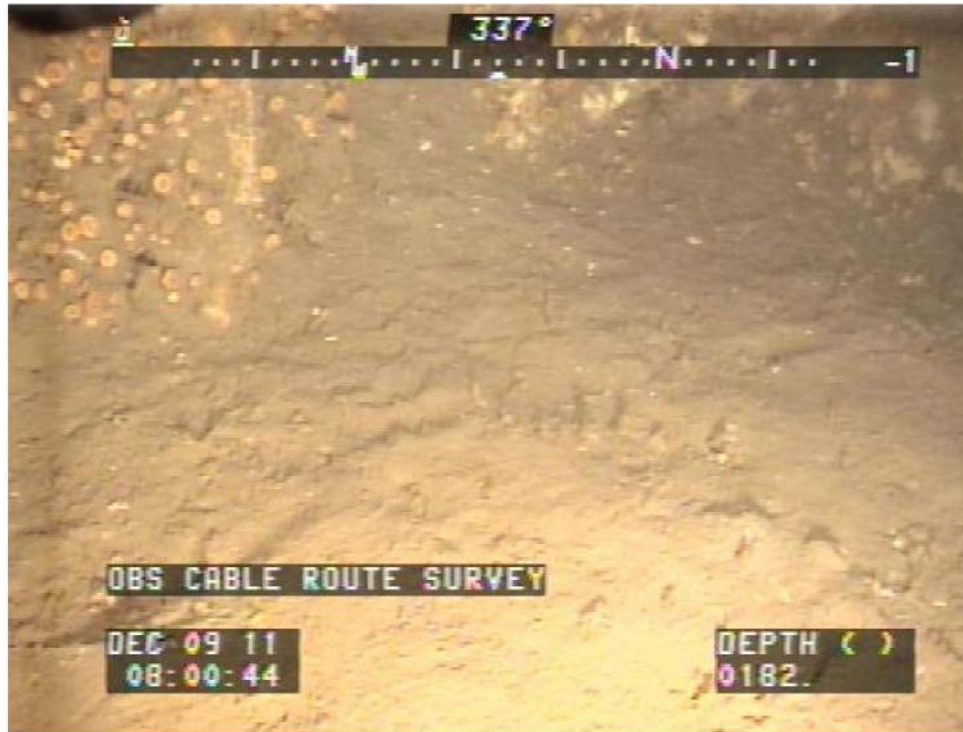
Photo 3. Rock Feature #7 (Location 7 in Figure 3), 100 ft North of Cable Alignment with Solitary Coral (cf *Coenocyathus bowersi*) and Strawberry Anemones (*Corynactis californica*)

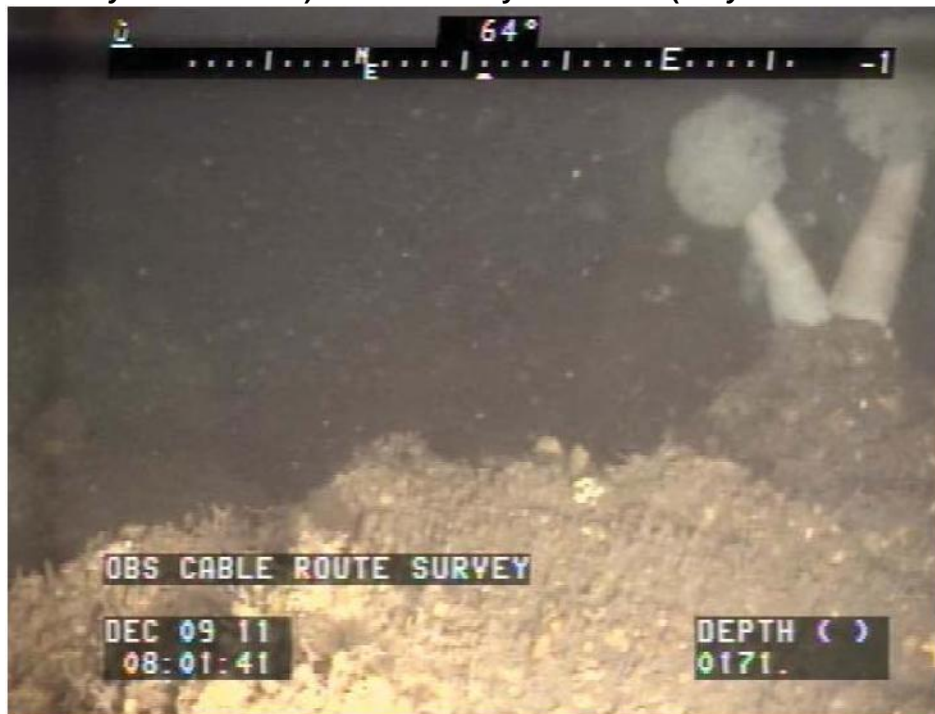
Photo 4. Top of Rock Feature #7 (Location 8 in Figure 3) with Powder Puff Anemones (*Metridium giganteum*), Encrusting Ectoprocts, and Solitary Corals

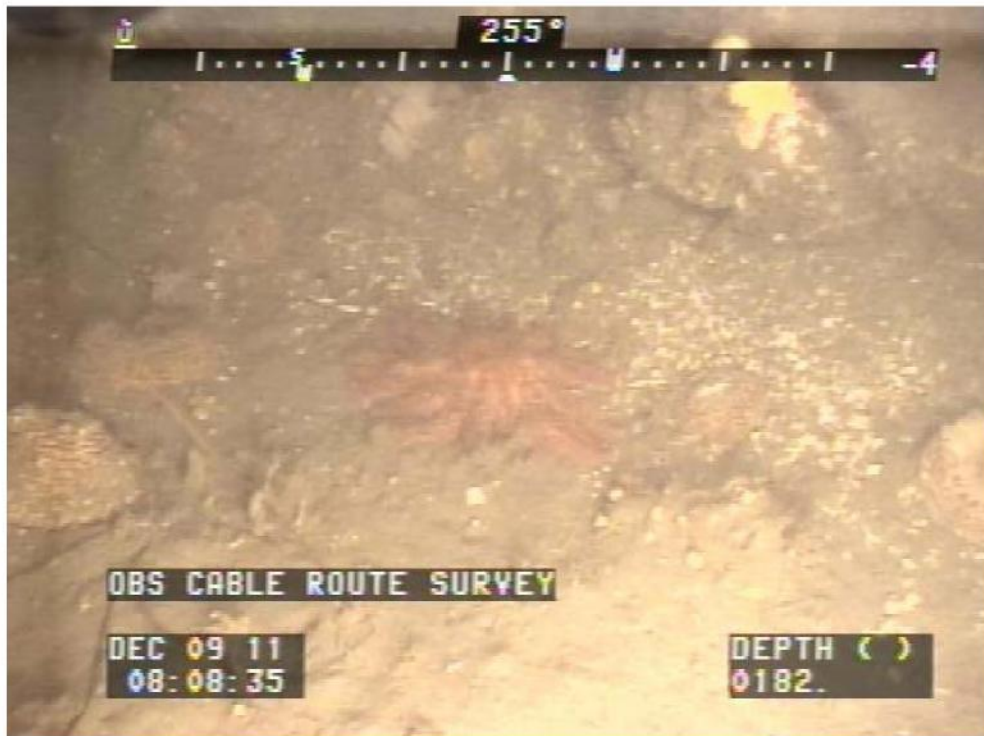
Photo 5. Base of Rock Feature Along Proposed Revised Cable Route Between Stations 8 and 6 with a Sunstar (cf *Solaster* sp), Unidentified Anemones, and Solitary Corals

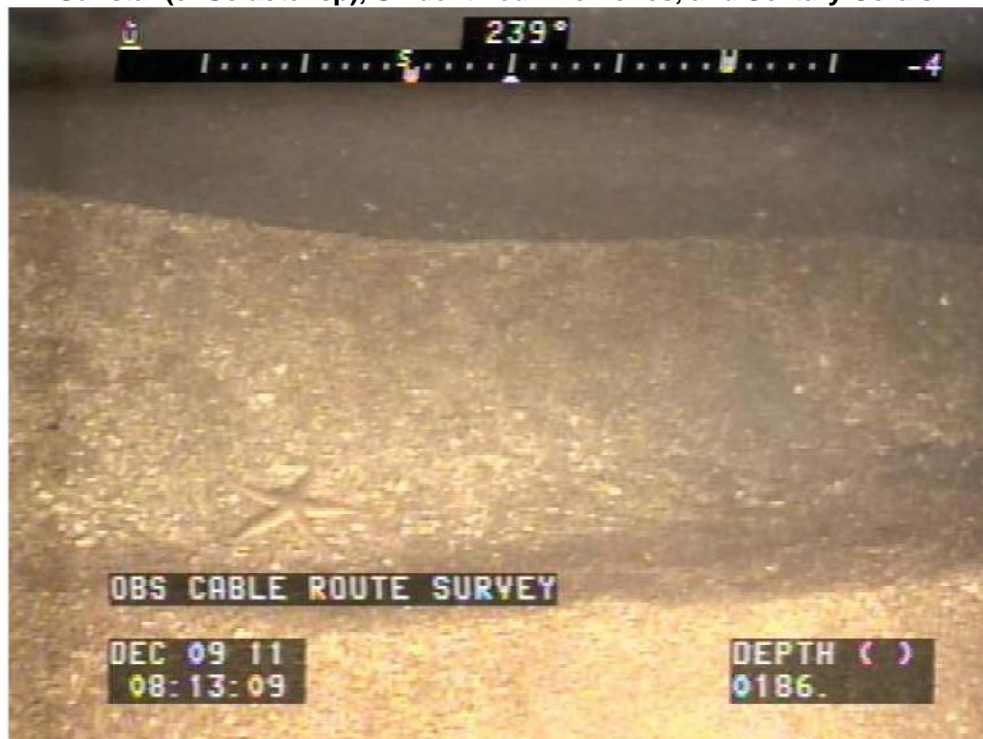
Photo 6. Sand Wave Habitat Near Station 6 with Sandstar (*Astropecten* sp)

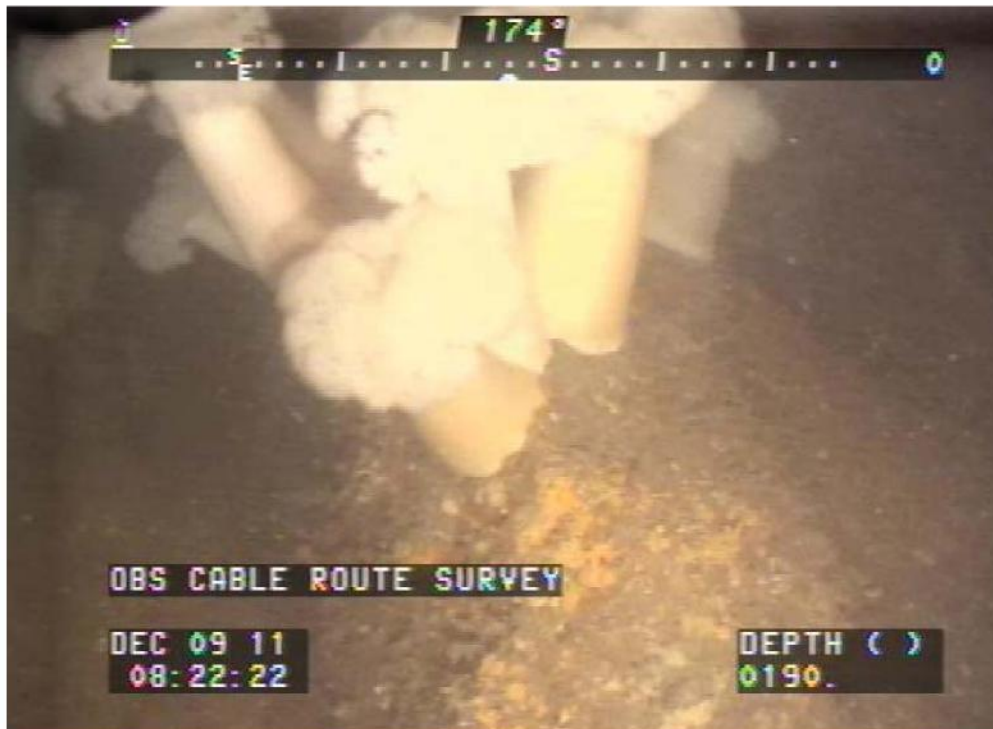
Photo 7. North Edge of Rock Feature Between Stations 8 and 6 with Powder Puff Anemones and Unidentified Encrusting Sponge

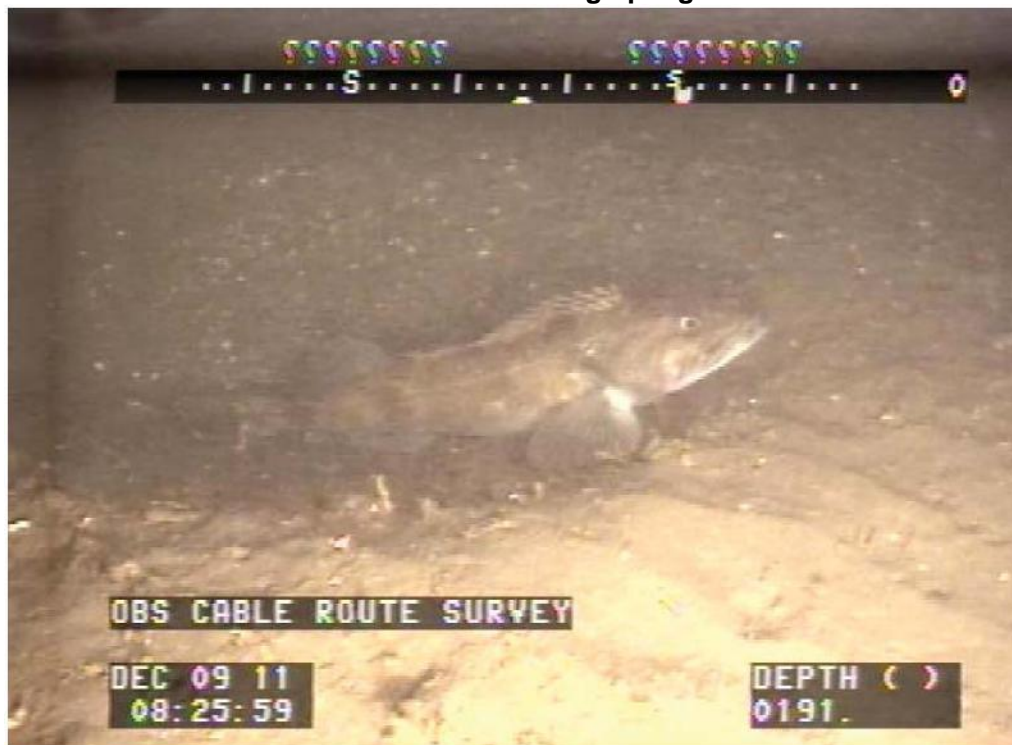
Photo 8. Subadult Lingcod (*Ophiodon elongatus*) on Sedimentary Seafloor Between Stations 8 and 6

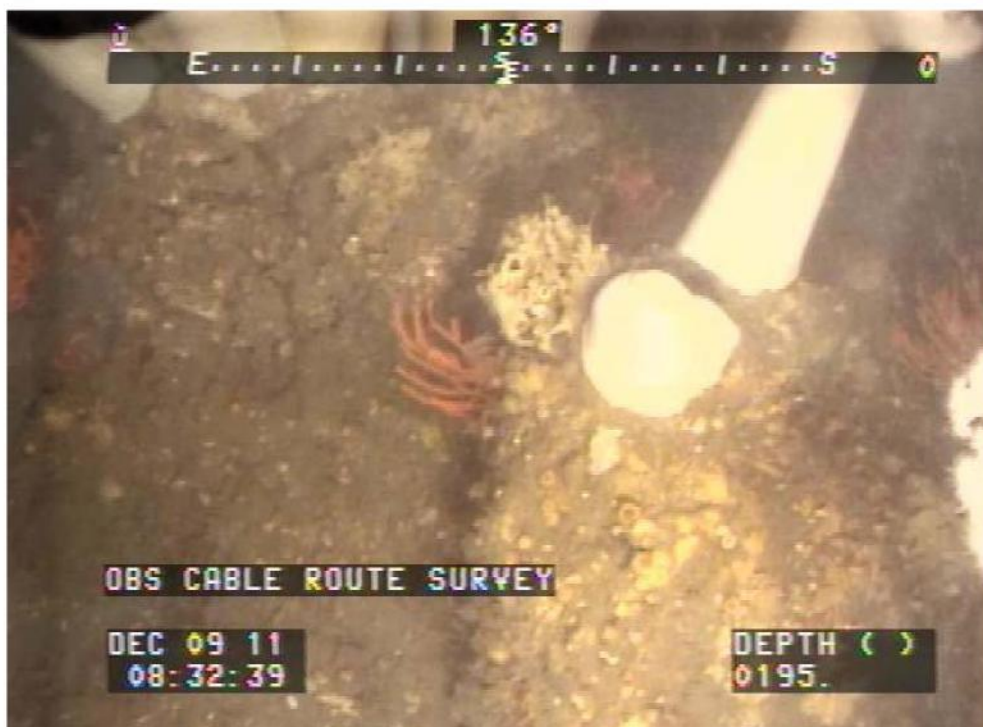
Photo 9. Rock Feature East of Station 6 with Powder Puff Anemones, Unidentified Ectoprocts, Solitary Corals, and Gorgonian Coral (cf *Eugorgia* sp)

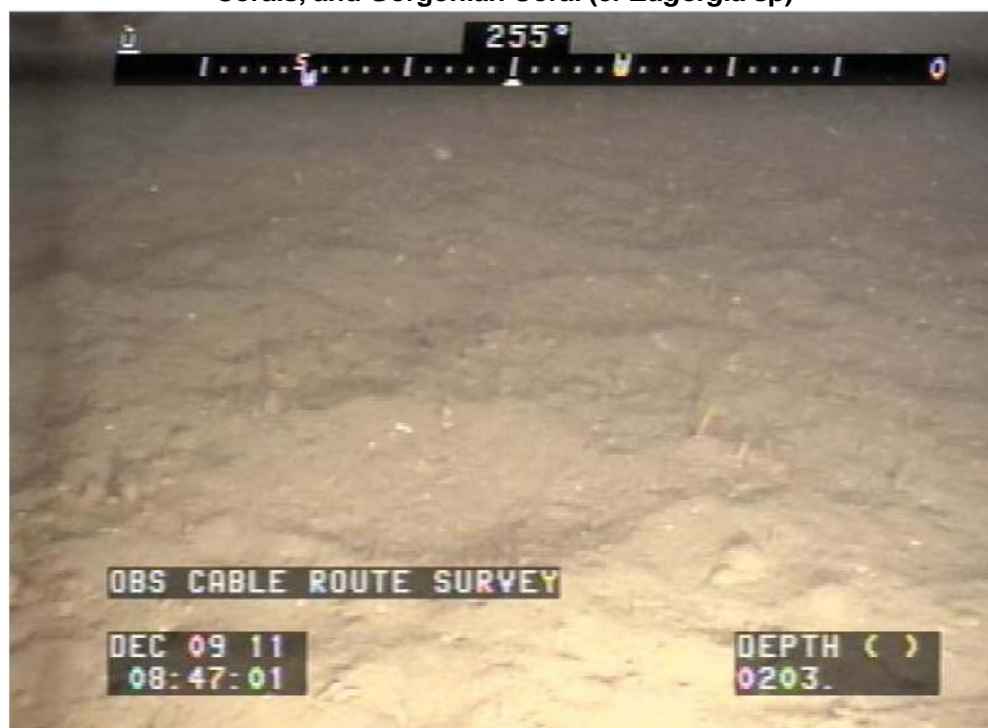
Photo 10. Sedimentary Seafloor Habitat at Station 6

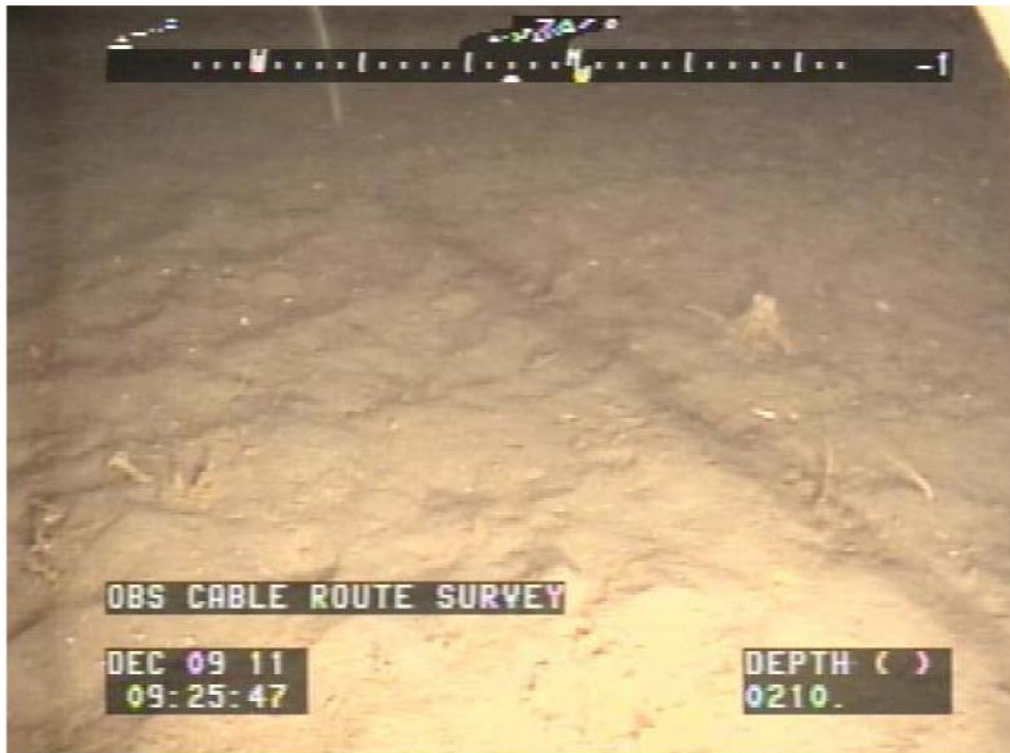
Biota observed within this segment was similar to that observed between Stations 8 and 6 (see above and Photo 11), but there were a few minor differences. Unidentified brittle stars were locally abundant in the flat, fine-sediment areas in this segment and, except for the feature southeast of Station 4 (Location 26), rock habitat here supported fewer powder puff anemones than the features between Stations 8 and 6. Adult and sub-adult rockfish, including yellowtail, rosy, copper, and blue (*S. rosaceus*, *S. caurinus*, and *S. mystinus*, respectively), were observed in the water above and around these features. Lingcod were also present around the base of outcrops and on the lower relief features within this segment.

Photo 11. Sedimentary Seafloor Habitat at Station 5

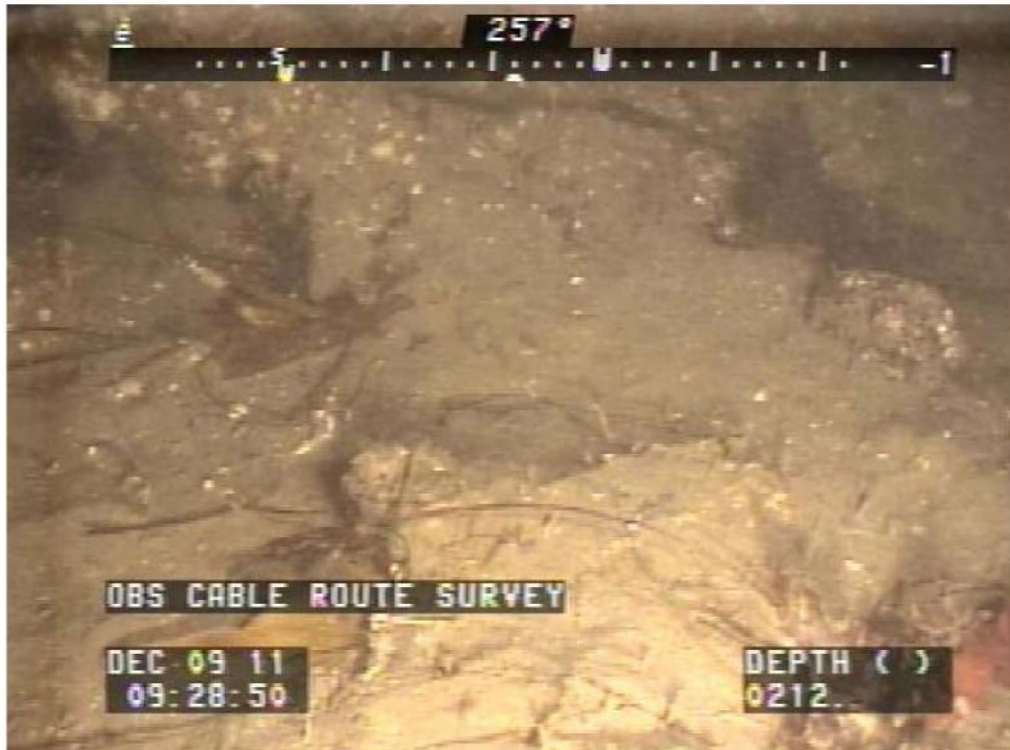
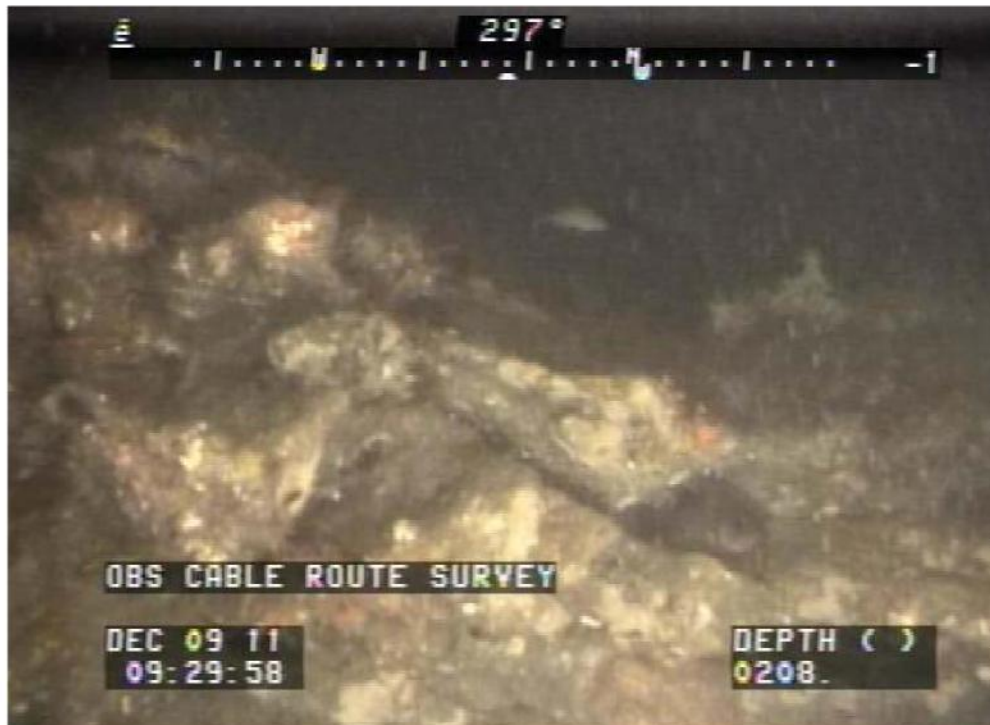
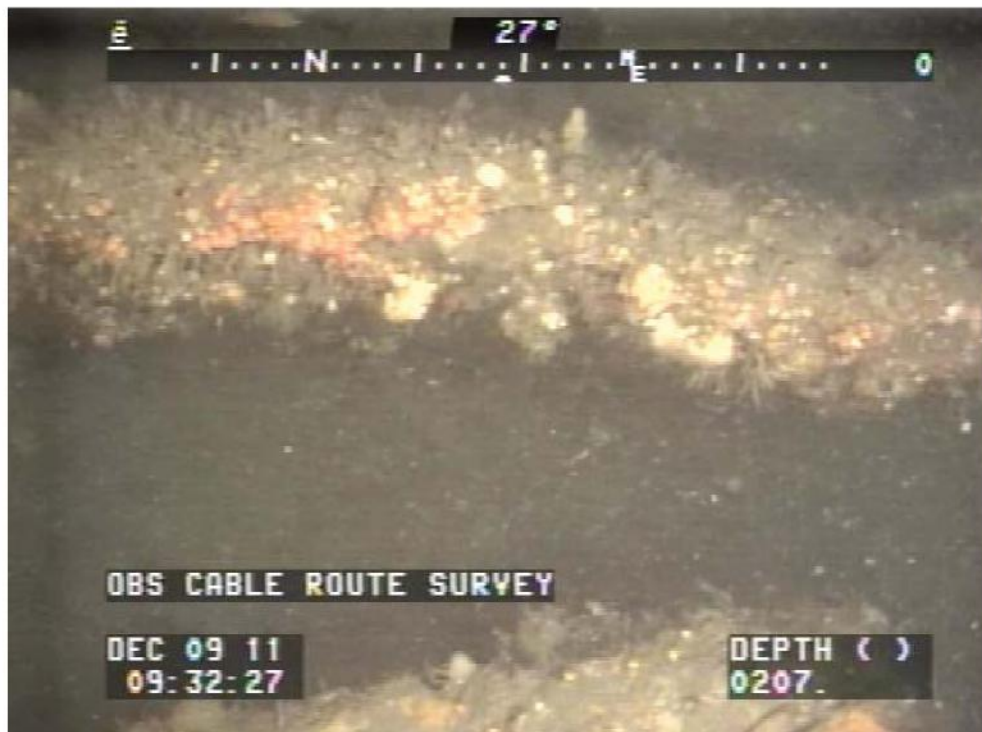
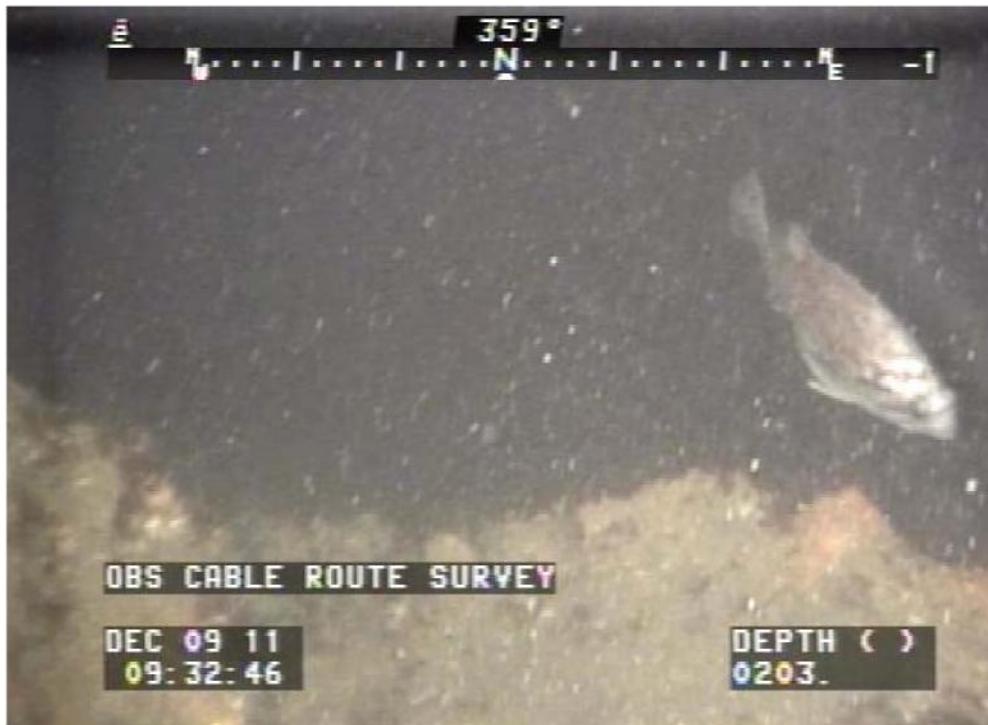
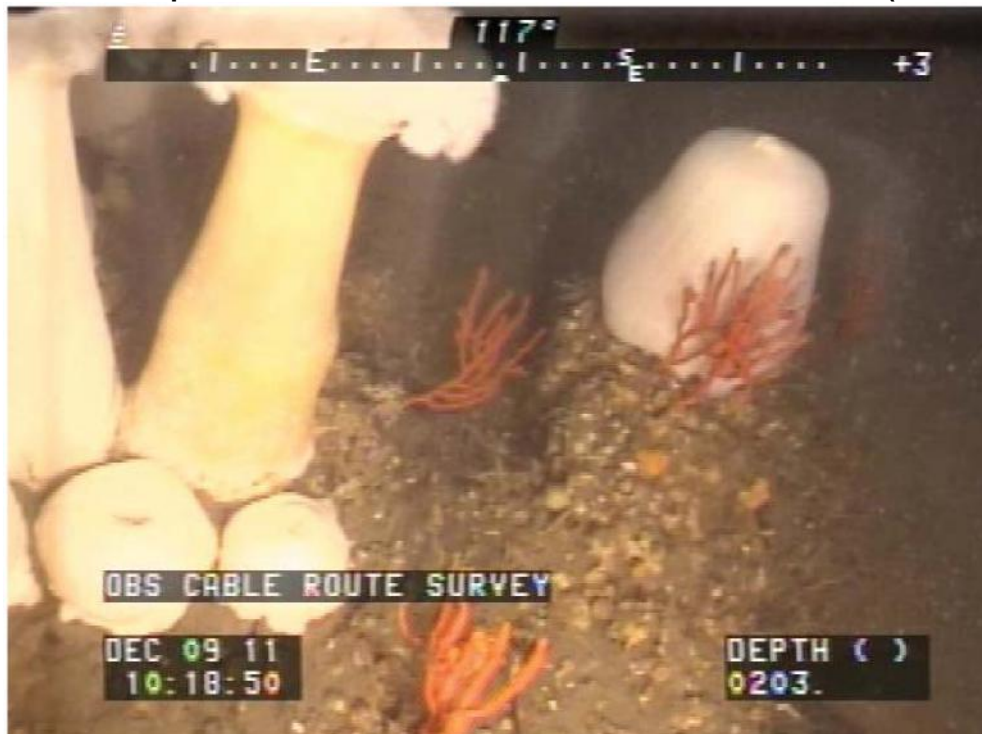
ridges, 76 m (250 ft) northwest of Station 5 (Locations 18 to 20 in Figure 3); lower relief features were observed 152 and 229 m (500 and 750 ft) northwest of Station 5 (Locations 21 and 22). The feature located 15 m (50 ft) southeast of Station 4 (Location 26) consisted of low-relief ledges, boulders, and broken rock pieces (Photos 12 through 16). Water depths between Stations 5 and 4 ranged from 62 to 65 m (203 to 212 ft).

Photo 12. South Edge of Rock Feature North of Station 5 with Drift Algae

Photo 13. Top of Rock Feature North of Station 5 with Unidentified

Photo 14. Typical Ledge at Rock Feature North of Station 5 with Unidentified Encrusting Sponges, Solitary Coral, and Strawberry Anemones

Photo 15. Top of Rock Feature North of Station 5 with Blue Rockfish (*Sebastes mystinus*)

Photo 16. Rock Feature East of Station 4 with Powder Puff Anemone and Unidentified Gorgonian and Solitary Corals

Based on the CDFG request to limit the amount of cable within the SMR and due to the presence of rock substrate within that portion of the SMCA of the MPA between Stations 5 and 4 (see Figure 2), it is not possible to completely avoid crossing rock. However, video recorded during this ROV survey suggests that sediment or lower-relief rock is present east of the proposed alignment between Stations 5 and 4 (Figure 4). Therefore, to avoid the rocky habitat at Locations 23, 24, and 25, it is recommended that the cable route from 200 m (656 ft) northwest of Station 5 to 75 m (246 ft) southeast of Station 4 be moved 50 m (164 ft) east of the proposed realigned cable (see dashed green line in Figure 4). The proposed alignment south of the dashed line does not need to be moved as it will avoid the high-relief features observed at Locations 20 and 21. With the implementation of this mitigation, approximately the same amount of rock habitat will be crossed. However implementation of this mitigation will: 1) eliminate or substantially reduce the amount of high-relief structures crossed, 2) provide for the cable to remain outside the SMR, and 3) reduce potential damage to the cable from freespanning and increased tension. No other revisions to the currently-proposed alignment are recommended.

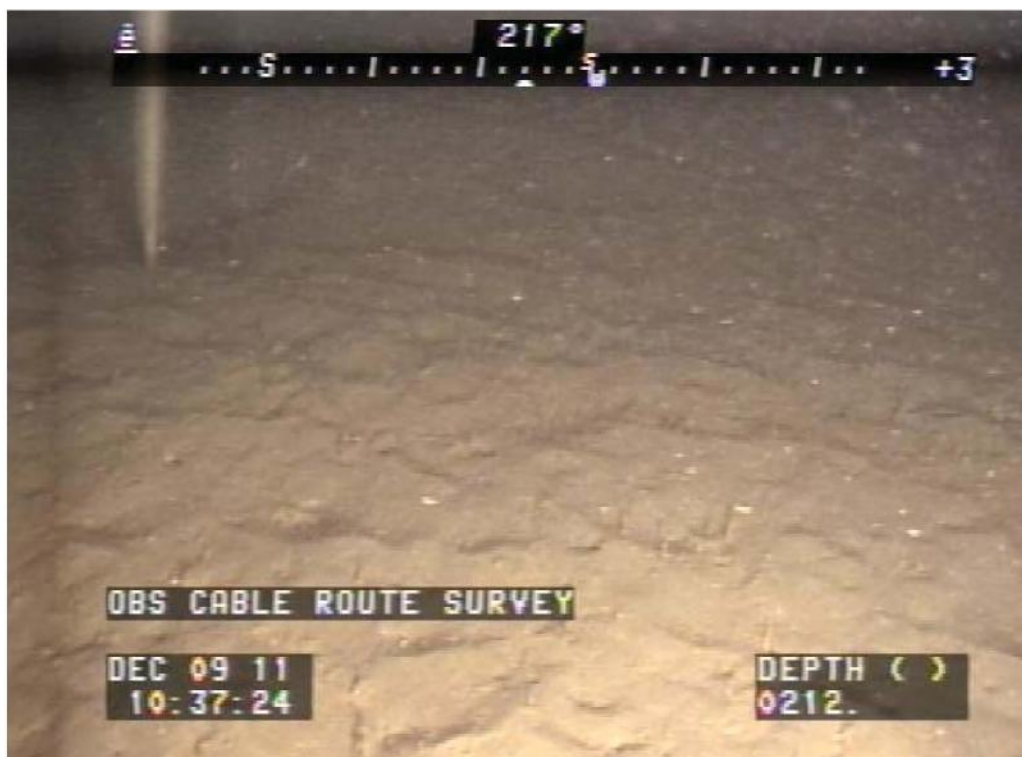
The seafloor habitat at the proposed revised Temp-4 location was flat, fine sediments (Photo 17). No rock features were detected within 15 m (50 ft) of the center point using the ROV's scanning sonar. Common biota within this area included seapens and seastars.

Photo 17. Sedimentary Seafloor at Revised Location for OBS Temporary #4

Temp-4 Locations: The seafloor habitat at the original and proposed revised locations for Temp-4 is sedimentary and no significant impacts are expected from the placement of that unit in that location. The relocation does reduce the amount of habitat affected within the SMR.
