November 19, 2020
Project No. 0802-1353

MEMORANDUM

Subject: Santa Barbara Channel Coastal Hazards Removal Program – Progress of Work Activities and Documentation of Environmental Compliance: 2020 Removal Season – Removal Activities on November 16, 2020: Site No. 5 (Ellwood East).

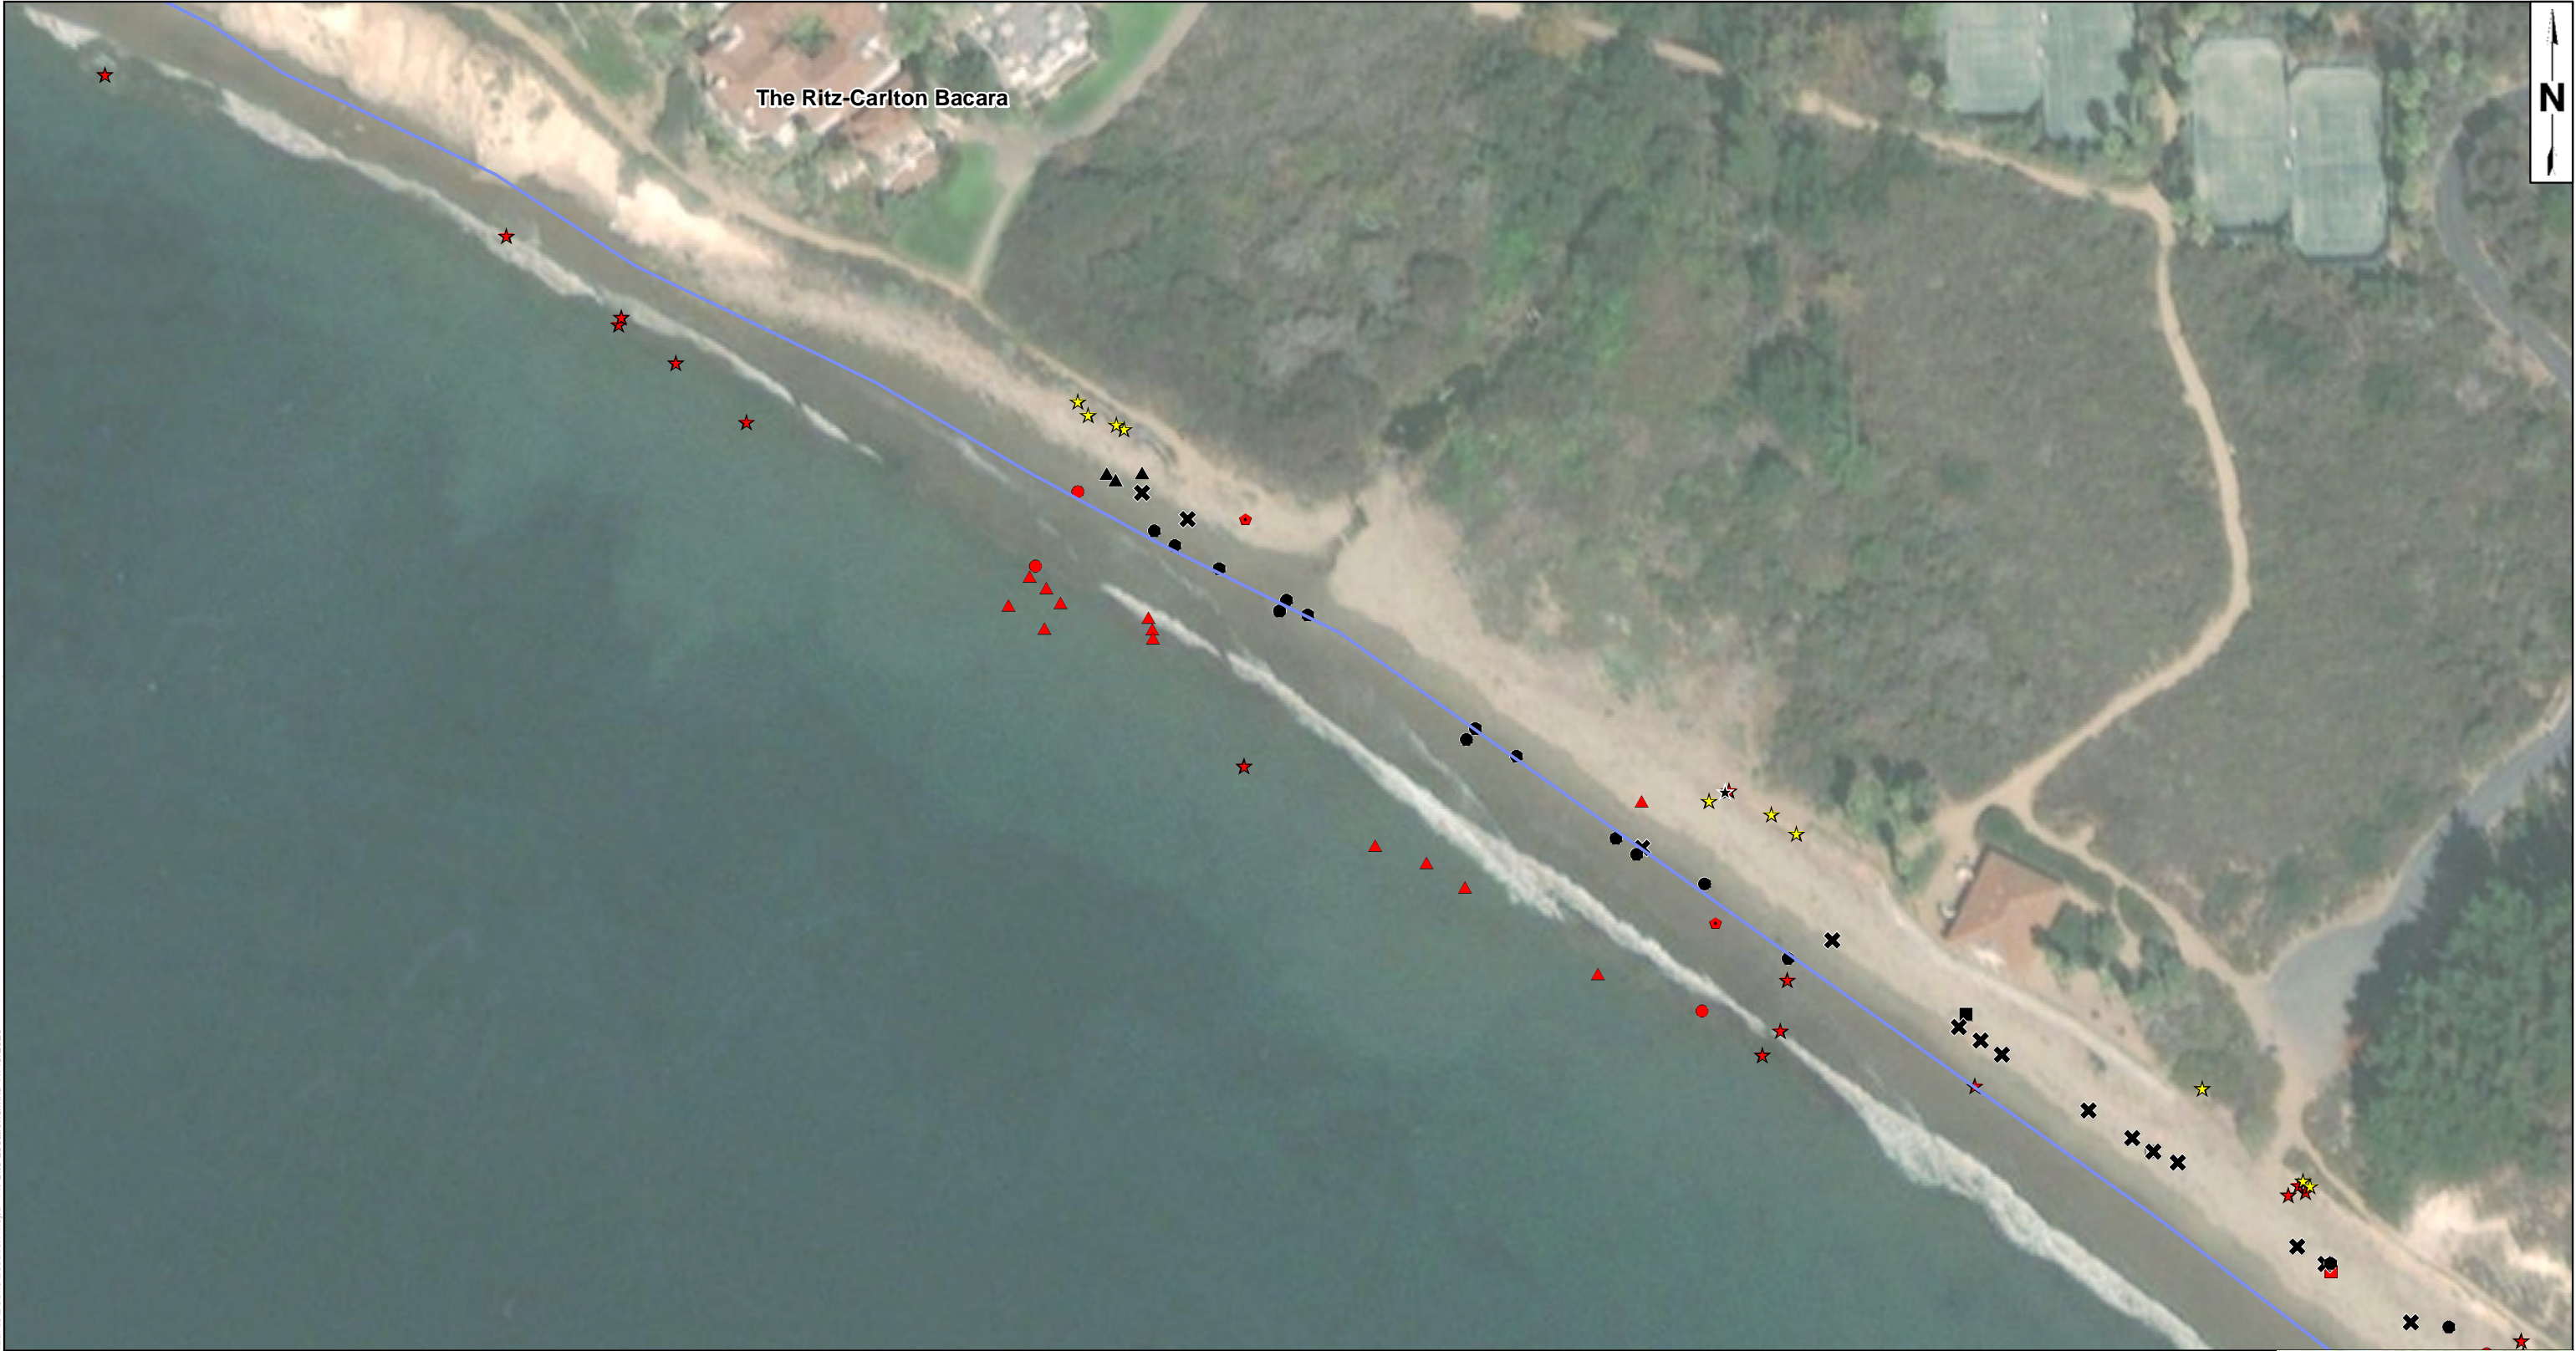
**FIGURE
7**

**HAZARDS INVENTORY
SITE NO. 5
ELLWOOD EAST**

On November 16, 2020, Cushman removed 1, 6-inch H-pile and 14 pipeline segments (varying from 1-inch diameter to 10-inch diameter and varying in length from 1-foot to approximately 20 feet) at Site No. 5 during the one day of removal activities. See updated inventory map(s) included in Attachment 1 for detail.

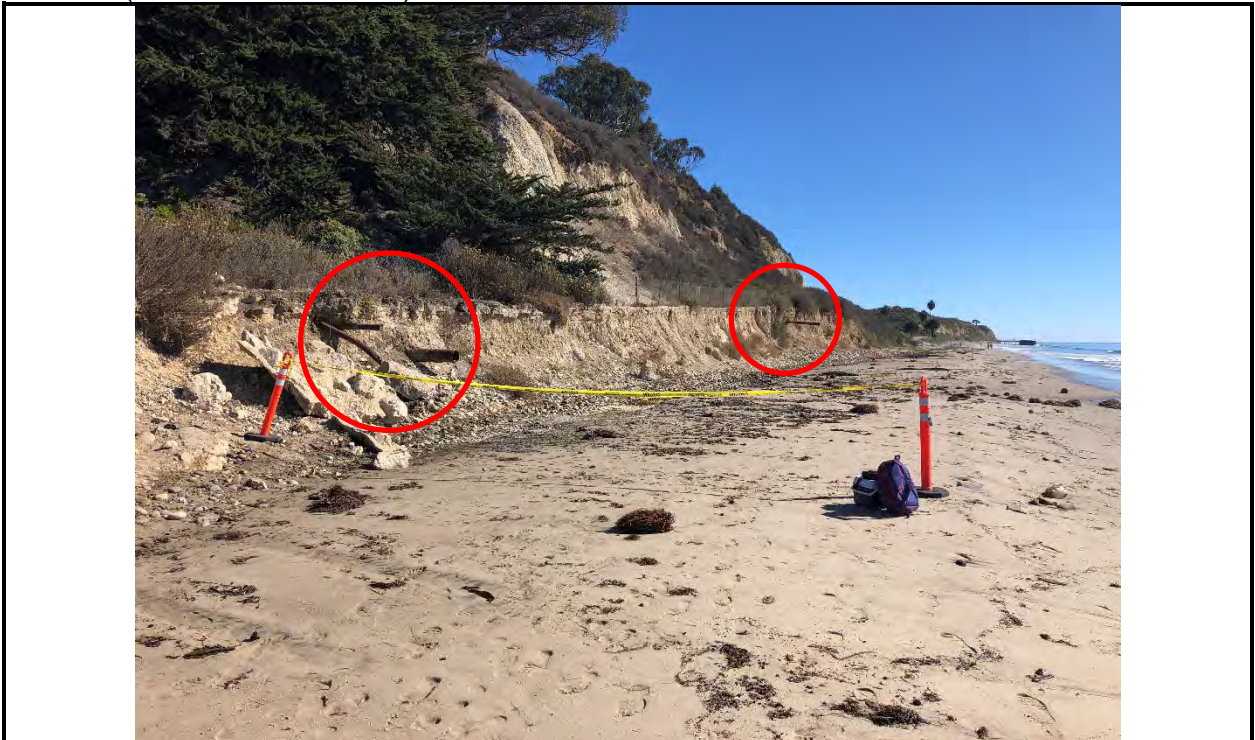
Photo 2. (11/16/20) View of the exposed hazardous pipelines (note red circles) immediately east of the beach access ramp.

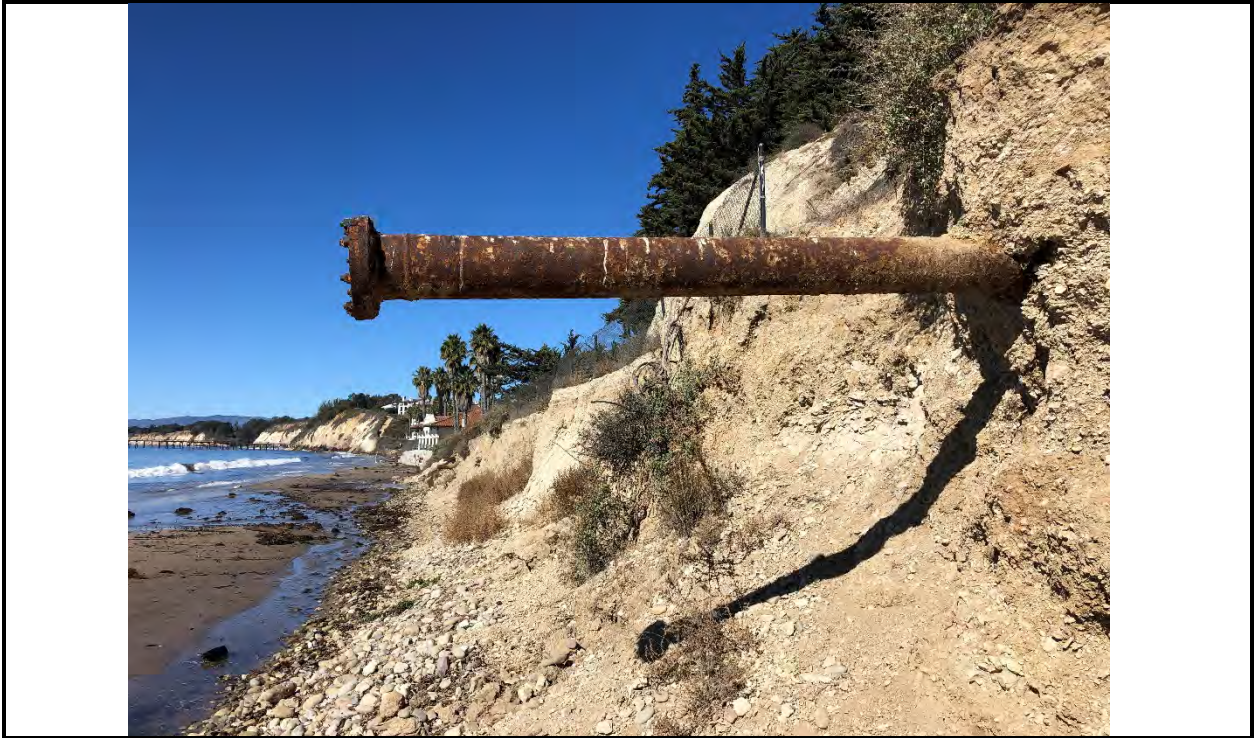
Photo 3. (11/16/20) View of the easternmost exposed pipeline hazard with capped flange. Remains in place as investigation and further assessment must take place prior to attempting removal (view to the northwest).

As noted within the current Project inventory maps (Attachment 1), additional H-piles, railroad irons, pipeline sections, wood piles, wood pier structure, and well casings remain at the Project site. Specifically, one remaining 12-inch pipeline protruding approximately 10-feet from the bluff face that was originally scoped for removal during this season was not addressed, as the pipeline is not open-ended and is capped with a flange; and will therefore require additional planning to address the appropriate removal procedure. Further hazard removal activities will be planned by CSLC and carried out during future efforts.

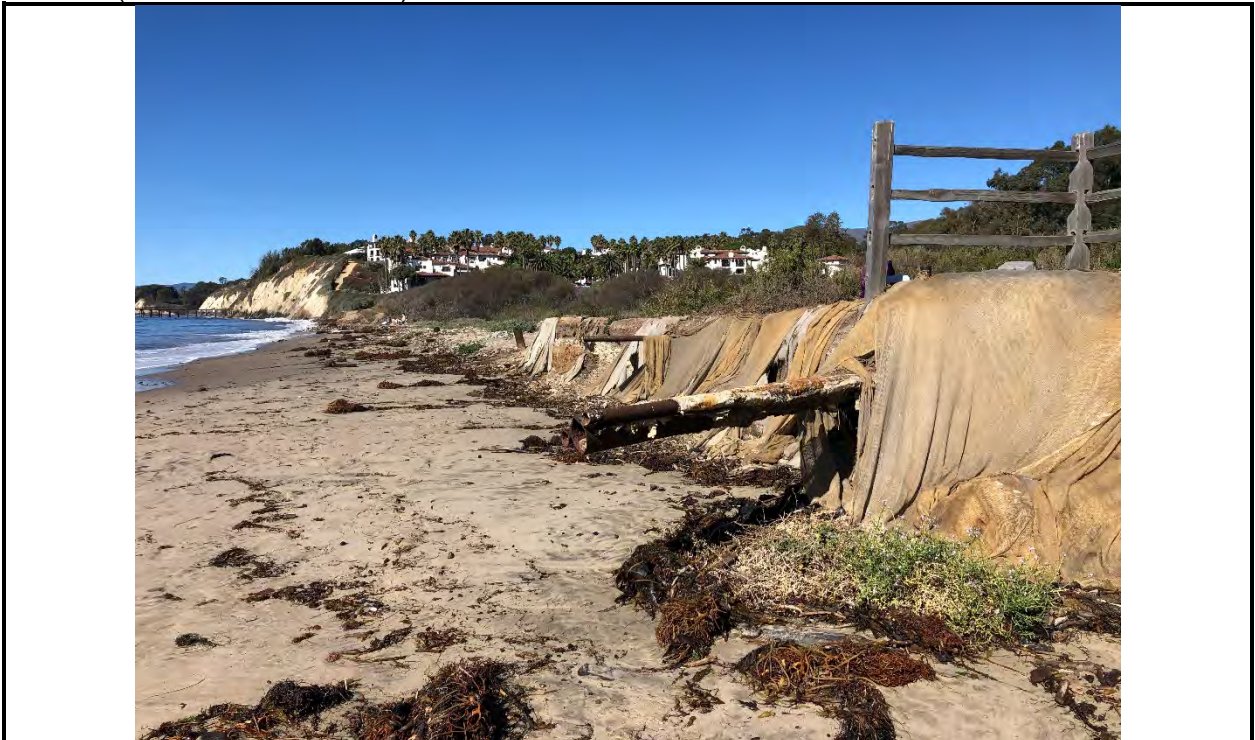
Photo 4. (11/16/20) View of exposed pipelines within the coastal terrace immediately west of the "Beach House" at Site No. 5, immediately east of Tecolote Creek (view to the northwest).

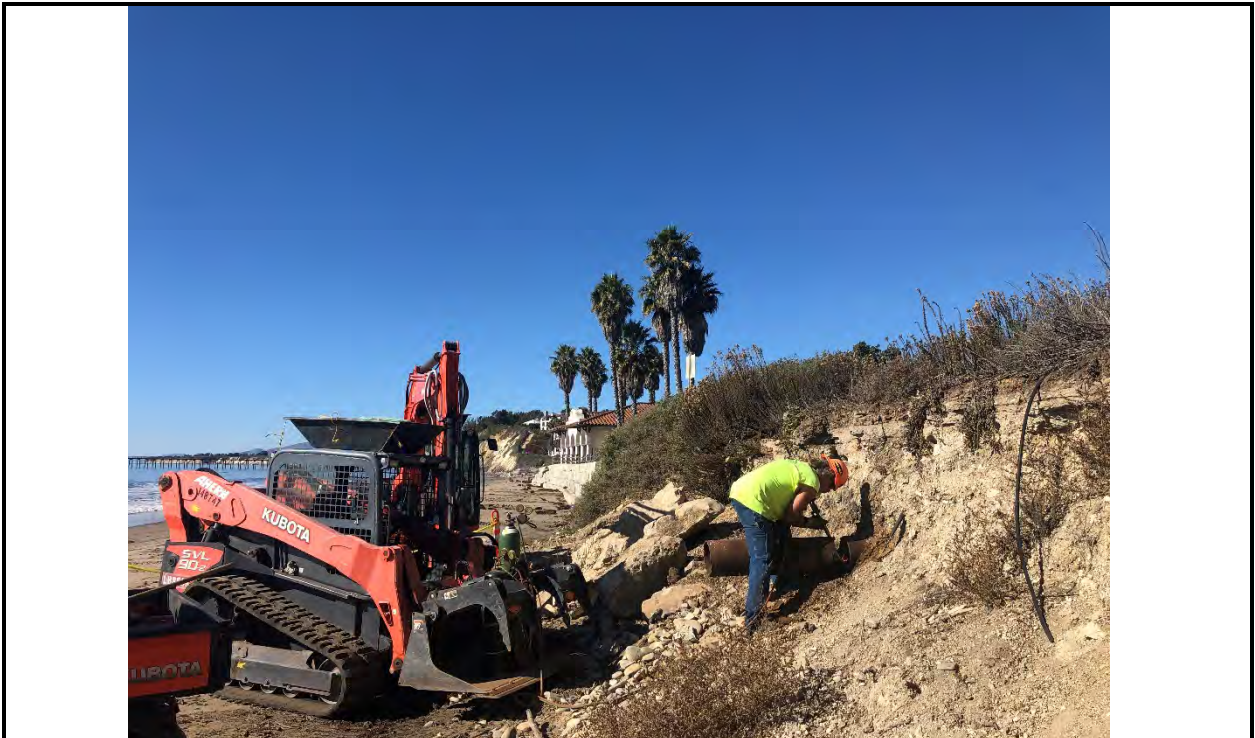
Photo 5. (11/16/20) View of equipment and Cushman personnel utilizing oxygen/acetylene torch to remove exposed segment of pipeline (view to the northwest).

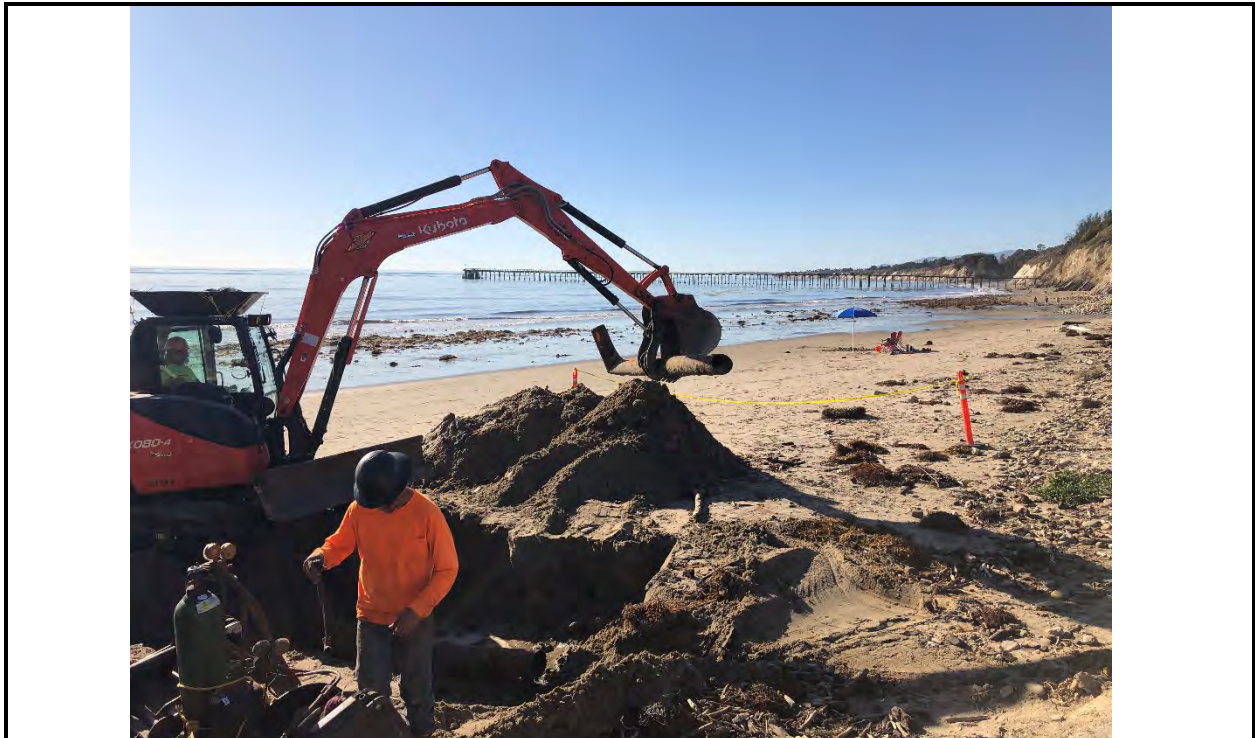
Photo 7. (11/16/20) View of the excavator removing approximately 15-foot length of 10-inch diameter pipeline immediately west of the “Beach House” (view to the west).

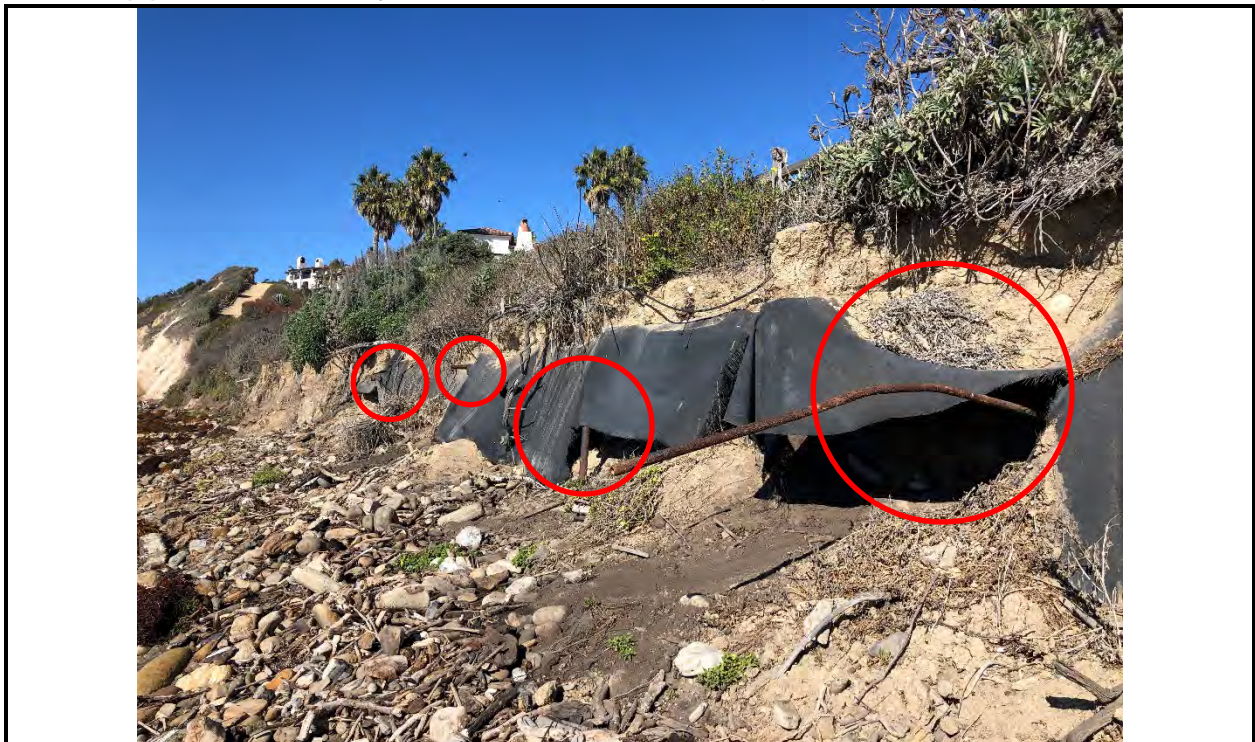
Photo 8. (11/16/20) View of the exposed pipelines (note red circles) within the coastal terrace immediately west of Tecolote Creek prior to removal (view to the north).
