PRELIMINARY FEDERAL AQUATIC RESOURCES DELINEATION REPORT

PACIFIC GAS & ELECTRIC THREEMILE SLOUGH PIPELINE CROSSINGS REMEDIATION AND DECOMMISSIONING PROJECT SACRAMENTO COUNTY, CALIFORNIA

Padre Project No. 2402-1171

NOVEMBER 2024

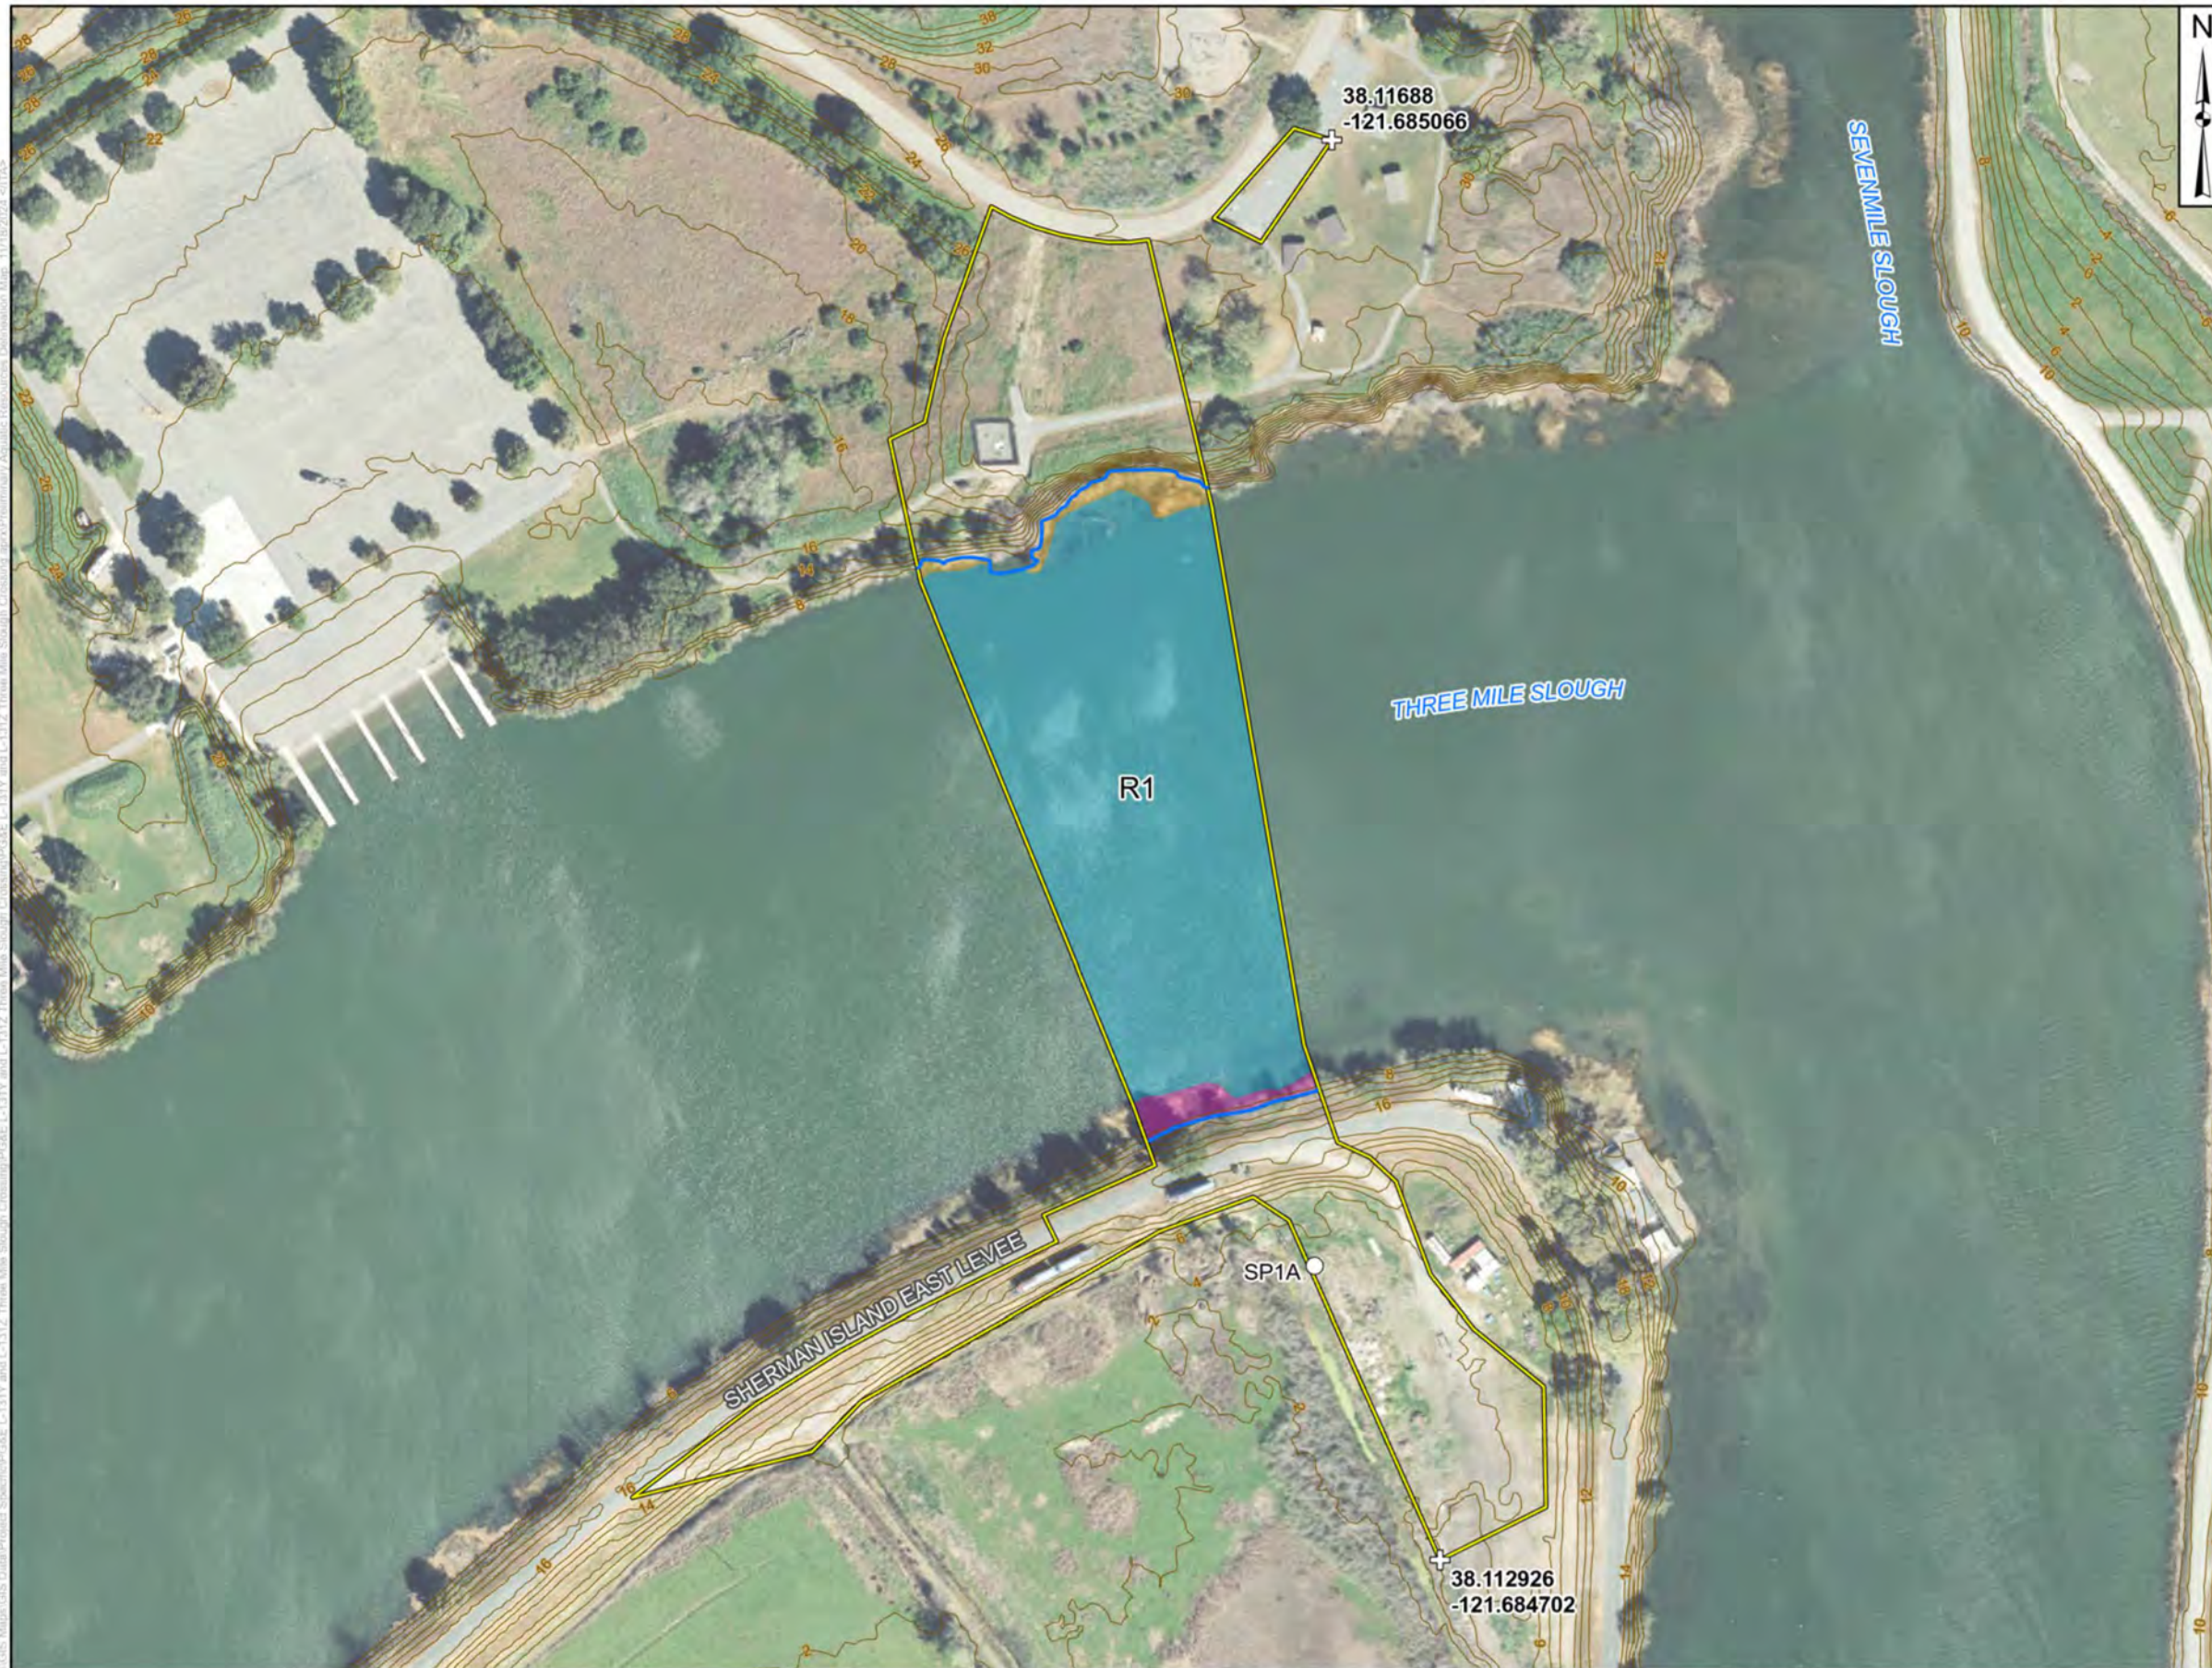
- ⊕ Control Point
 - Sample Plot Location
 - High Tide Line
 - ▭ Study Area (7.6ac)
- Cowardin Classification**
- Palustrine Forested Wetland (0.11ac)
 - Palustrine Scrub Shrub Wetland (0.13ac)
 - Tidal Riverine Water (3.27ac)

Preliminary Jurisdiction Delineation Acreage Calculations					
Feature	ID	Cowardin Classification	Waters of the U.S.		Acreage
			Other Waters	Wetlands	
Three Mile Slough	R1	Palustrine Scrub Shrub Wetland	Yes	No	0.13
		Palustrine Forested Wetland	Yes	No	0.11
		Tidal Riverine Water	Yes	No	3.27
Total:					3.51

Stream gage data analysis identified that the approximate location of the HTL was at 7 feet elevation (USGS, 2024). After plotting the GPS points recorded in the field for physical indicators of HTL, it was determined that the approximate location of the HTL was at 8 feet elevation. Although at slightly different elevations, the indicators observed in the field closely matched the expected HTL derived from stream gage data, and the HTL was therefore mapped at approximately the 8-foot elevation contour.

Palustrine forested wetlands have a dominance of woody plants that are greater than 20 feet tall (trees). In the western United States, this wetland type is common on the fringes of river systems where higher soil moisture is present but frequent and violent flooding does not occur. The south bank of Threemile Slough is jurisdictional as a water of the U.S. below the HTL and it is classified as a palustrine forested wetland due to its physical properties. Within the study area, this wetland type was part of the California sycamore and coast live oak riparian forest vegetation community and was located on the southern side of Threemile Slough. A total of 0.11 acres of palustrine forested wetlands occurs within the study area.

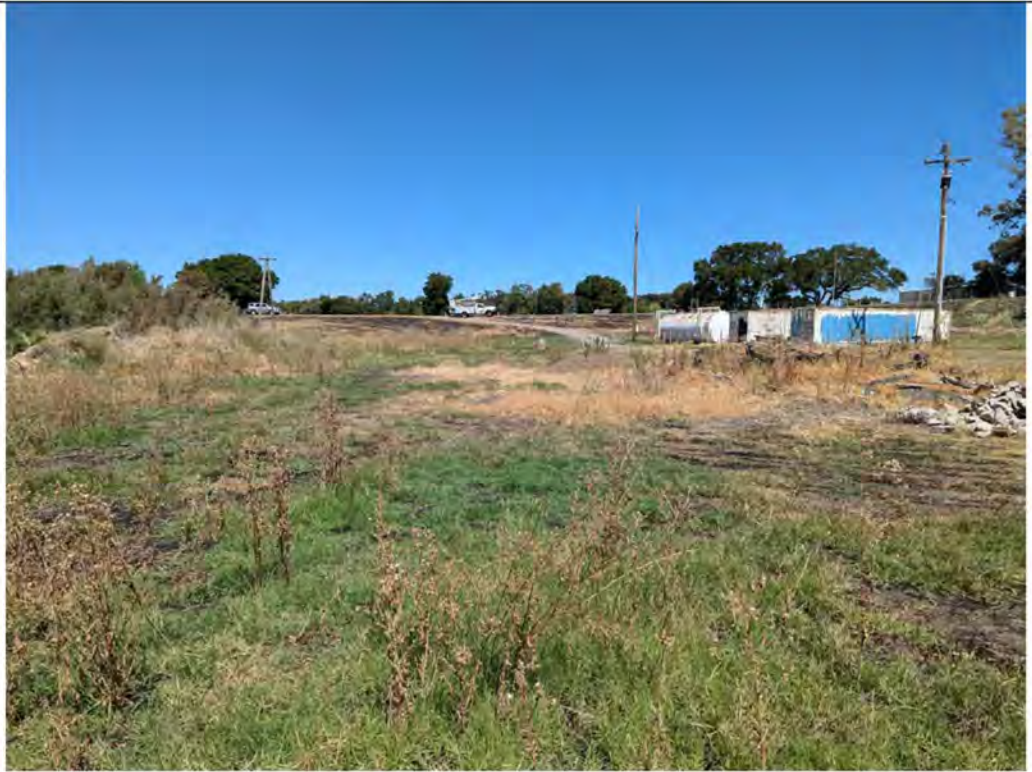
Photograph A. View of the disturbed land in the southern portion of the study area with visible remnants of burn piles and trash piles. View north (photograph taken 8/15/24).

Within the study area, disturbed land was present within the low-lying field to the south of Sherman Island East Levee Road. There were multiple types of human disturbance identified throughout this field including old storage facilities and equipment, remnants of burned vegetation and trash piles, and soil or debris dump piles. In addition, piles of dredge spoils and vegetation were present from recent dredging that occurred in an agricultural ditch approximately 15 feet west of the study area. Due to the variety of disturbance activities in this area, there was a variety of herbaceous vegetation observed in this community. The dominant vegetation observed in the disturbed area included Bermuda grass and beardless wild rye (*Elymus triticoides*). Where dredged material from the agricultural ditch was piled, there was a higher concentration of hydrophytic plants including common reed (*Phragmites australis*), narrow-leaved cattail (*Typha angustifolia*), willow weed (*Persicaria lapathifolia*), tall cyperus (*Cyperus eragrostis*), and cocklebur (*Xanthium strumarium*) presumably from the seedbank within the dredge spoils. Throughout the disturbed lands there were many disturbance-adapted weedy species like bristly ox-tongue (*Helminthotheca echioides*), bindweed (*Convolvulus arvensis*), bur clover (*Medicago polymorpha*), and Italian thistle (*Carduus pycnocephalus* ssp. *pycnocephalus*).

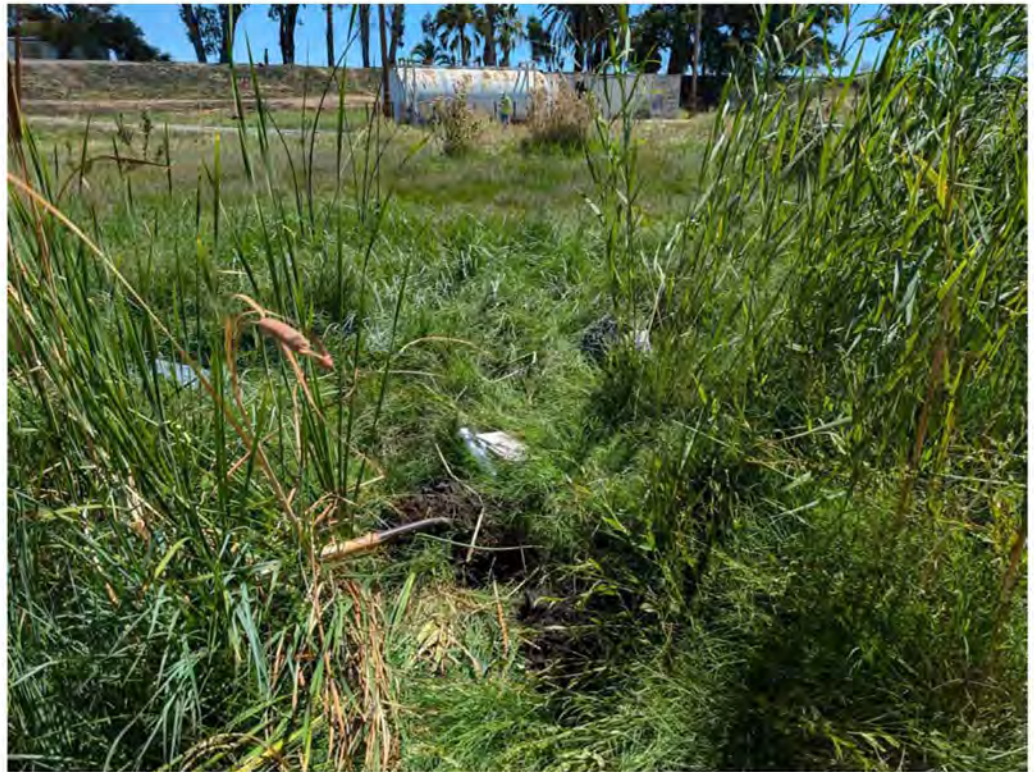
Photograph B. View of sample plot SP1A located in an area of deposited dredge spoils adjacent to a recently dredged drainage ditch. View northeast (photograph taken 8/15/24).

One sample plot was selected within the study area to identify the presence or absence of hydric soils. This sample plot, SP1A, was located in soil map unit 139 and the location was selected based on the presence of hydrophytic vegetation and location immediately adjacent to a dredged agricultural ditch located outside the study area. The soil texture observed at sample plot SP1A was silty clay. Soil colors observed in the matrix at the sample plot ranged from very dark brown (10YR 2/2) to black (10YR 2/1 and 2.5Y 2.5/1). Some redox concentrations were observed in the upper and lower layers of soil including a strong brown (7.5YR 5/8). Despite the dark matrix color and the presence of some redoximorphic features, this sample plot did not meet any of the hydric soil indicators. As discussed in section 5.2.1.3 above, the adjacent agricultural ditch (located outside the study area) had recently been dredged and the dredge spoils were deposited at this location. Dredge spoils appear to be routinely deposited in and around this area; therefore, this sample plot may exhibit some wetland characteristics due to the import of dredged material from the bottom of an agricultural ditch and not due to in-situ conditions.

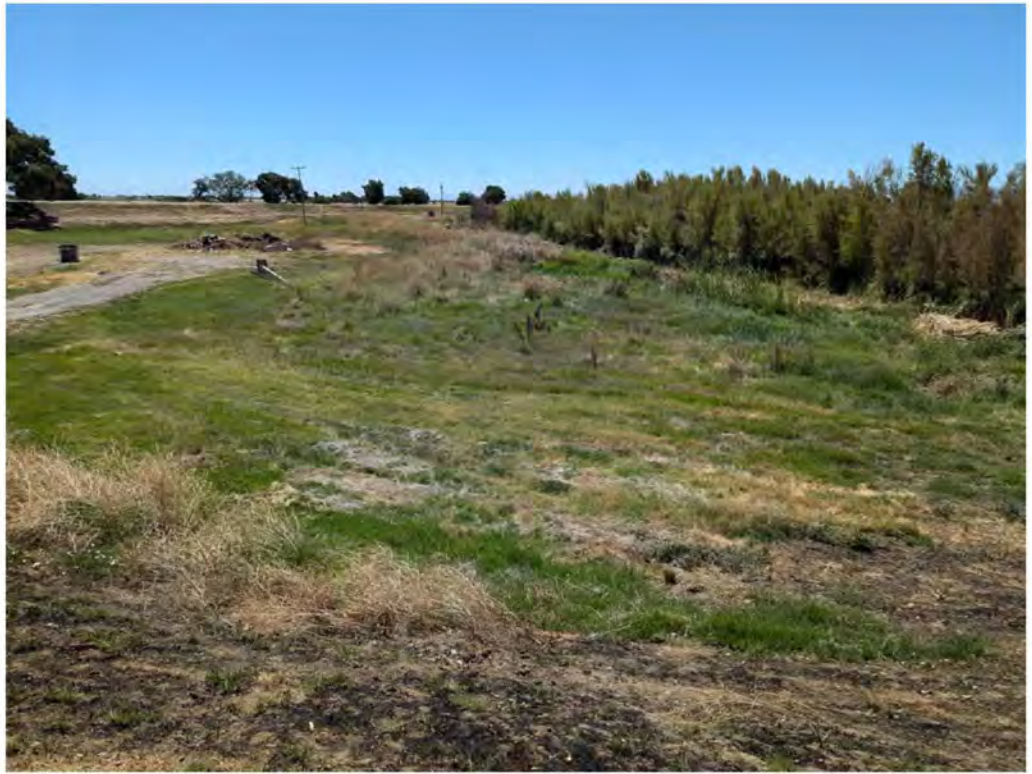
Photograph C. View of the disturbed land cover type. The agricultural ditch adjacent to the study area and the location of SP-1A is visible in the right of the photo. View south (photograph taken 8/15/24).

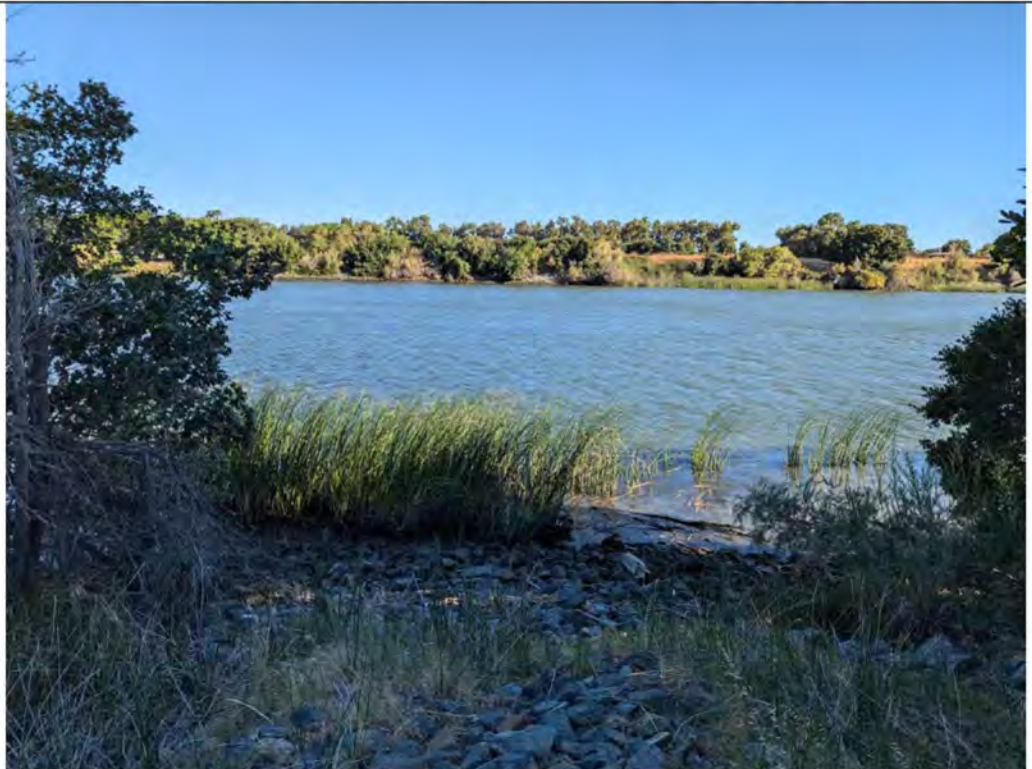
Photograph E. View of the south bank of Threemile Slough along the waterside slope of the Sherman Island levee showing drift deposit where the high tide line was mapped. View northeast (photograph taken 8/15/24).

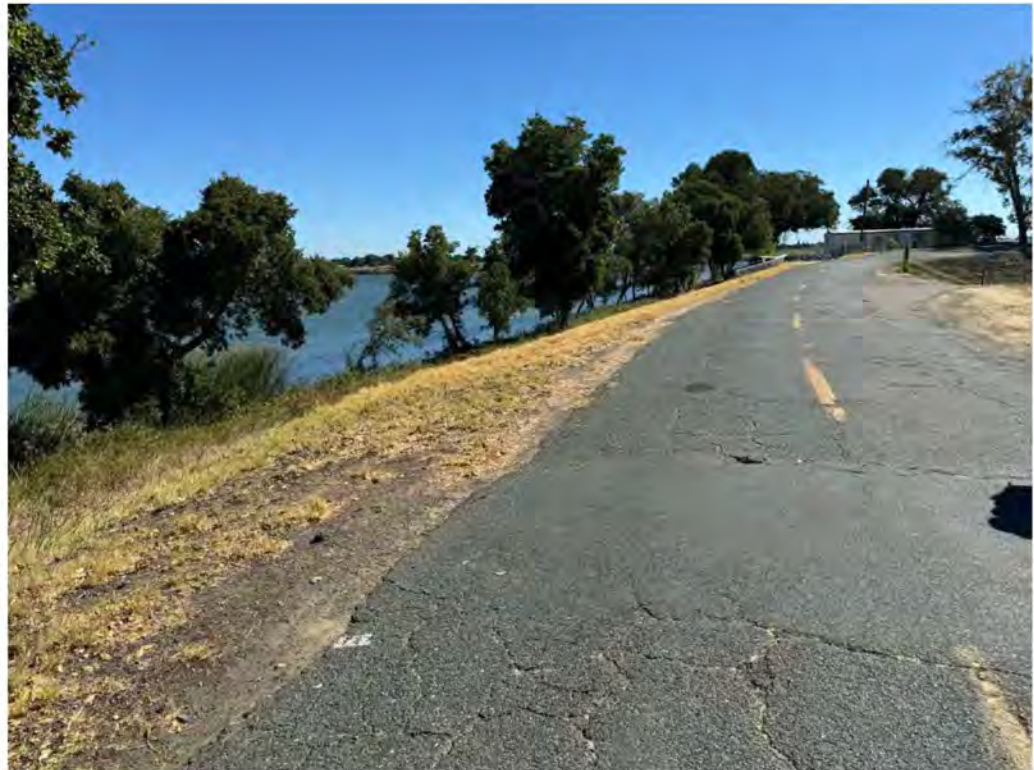
Photograph F. View of Sherman Island East Levee Road along the levee crown and the California sycamore and coast live oak riparian woodland community along the southern bank of Threemile Slough. View northeast (photograph taken 8/15/24).

Within the study area, a California sycamore and coast live oak riparian woodland was present in a narrow band along the south bank of Threemile Slough. The dominant species observed in the tree canopy was coast live oak. Narrow-leaved willow and California button willow (*Cephalanthus occidentalis*) were present in the shrub layer. Herbaceous species observed in this community were varied but included California rose (*Rosa californica*), Himalayan blackberry, delta tulle pea (*Lathyrus jepsonii* var. *jepsonii*), Bermuda grass (*Cynodon dactylis*), lamp rush (*Juncus effusus*), ragweed (*Ambrosia* sp.), and curly doc (*Rumex crispus*). This community was mapped both above and below the HTL due to portions of the canopy overhanging the slough and is classified as palustrine forested wetland.

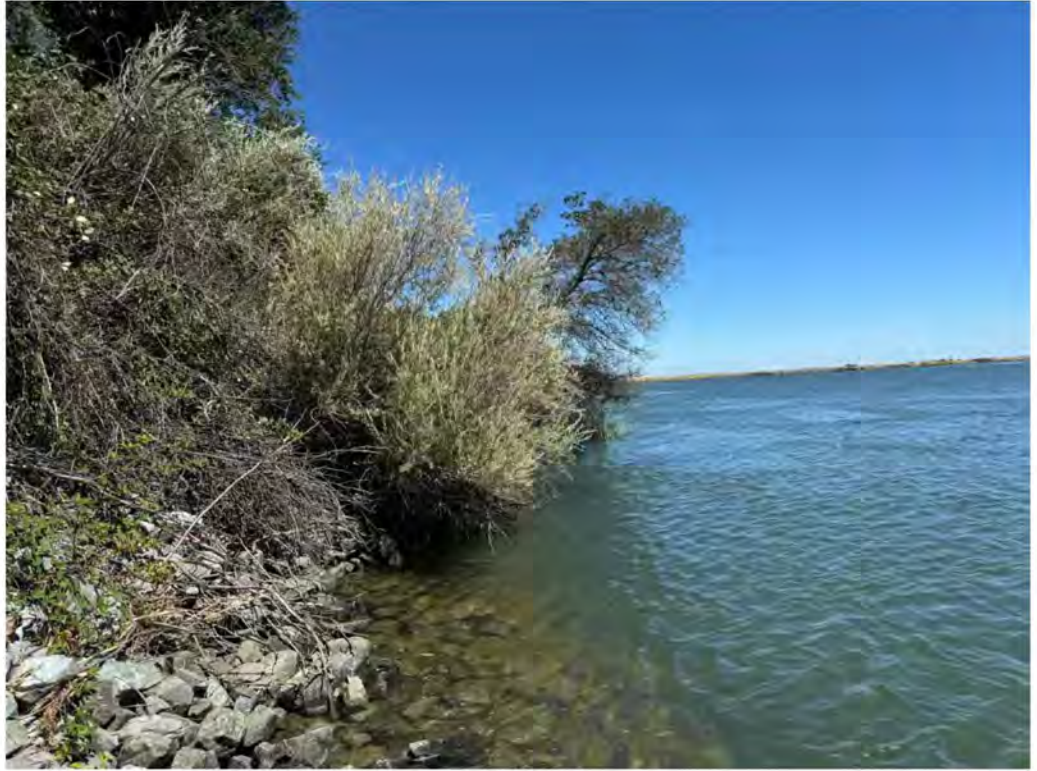
Photograph G. View of the sandbar willow thickets vegetation community located along the northern bank of Threemile Slough. View northeast (photograph taken 8/15/24).

Within the study area, sandbar willow thicket was present along the north bank of Threemile Slough. The dominant species was narrow-leaved willow, which was found in large dense patches along the steep north bank. Associate species observed included northern California black walnut, coast live oak, blue elderberry (*Sambucus mexicana*), Himalayan blackberry, and Gooding's black willow. This community was mapped both above and below the HTL due to portions of the canopy overhanging the slough and is classified as palustrine scrub-shrub wetland.

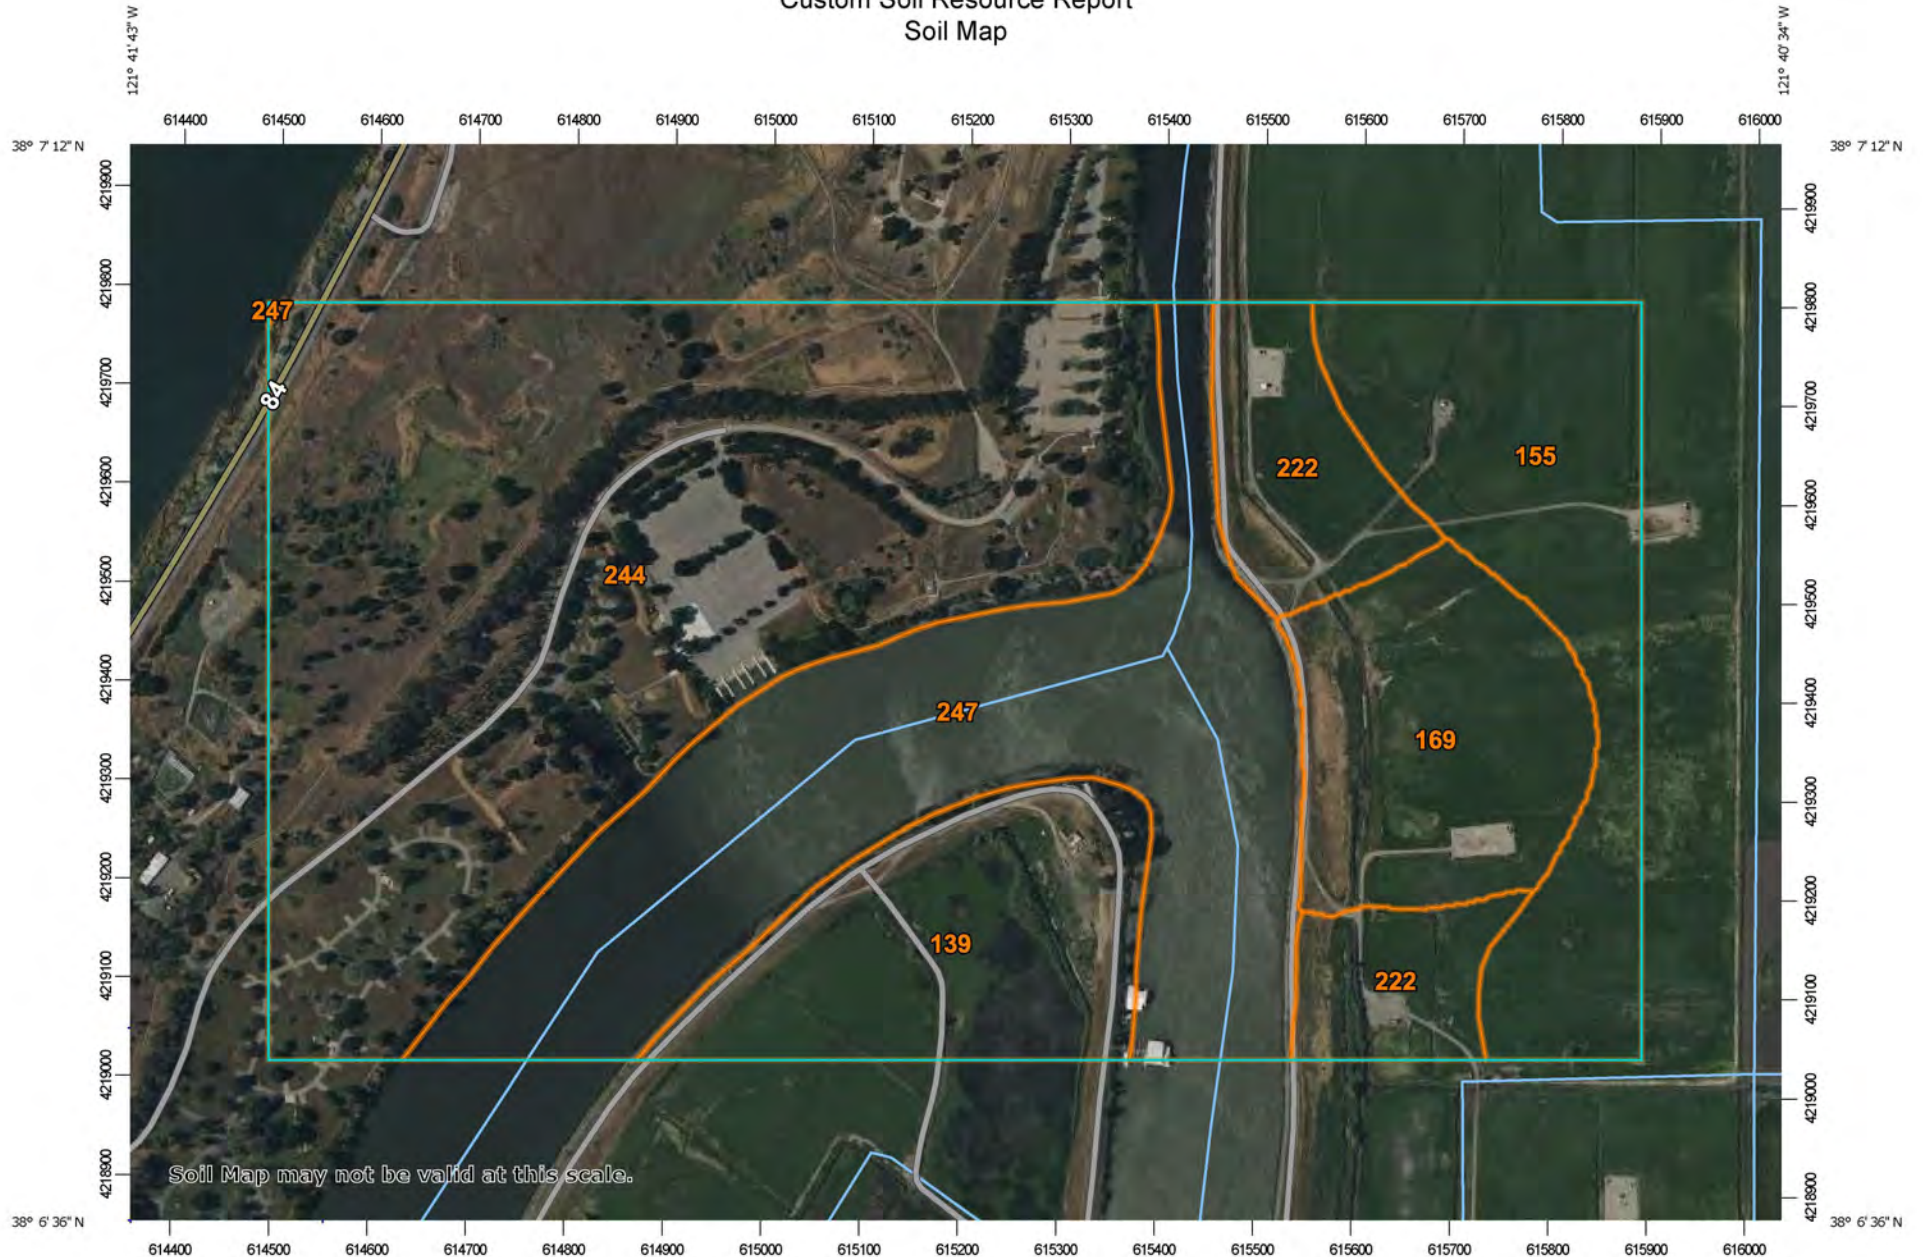
Custom Soil Resource Report Soil Map

Map Scale: 1:7,670 if printed on A landscape (11" x 8.5") sheet.
