December 2, 2021 Project No. 2101-0252

- Attention: Mr. Eric Gillies Assistant Chief - Environmental Planning and Management
- Subject: Report of Findings Asbestos and Lead-Based Paint Survey, PRC 421 Decommissioning Project, Pier Access Road, Goleta, Santa Barbara County, California

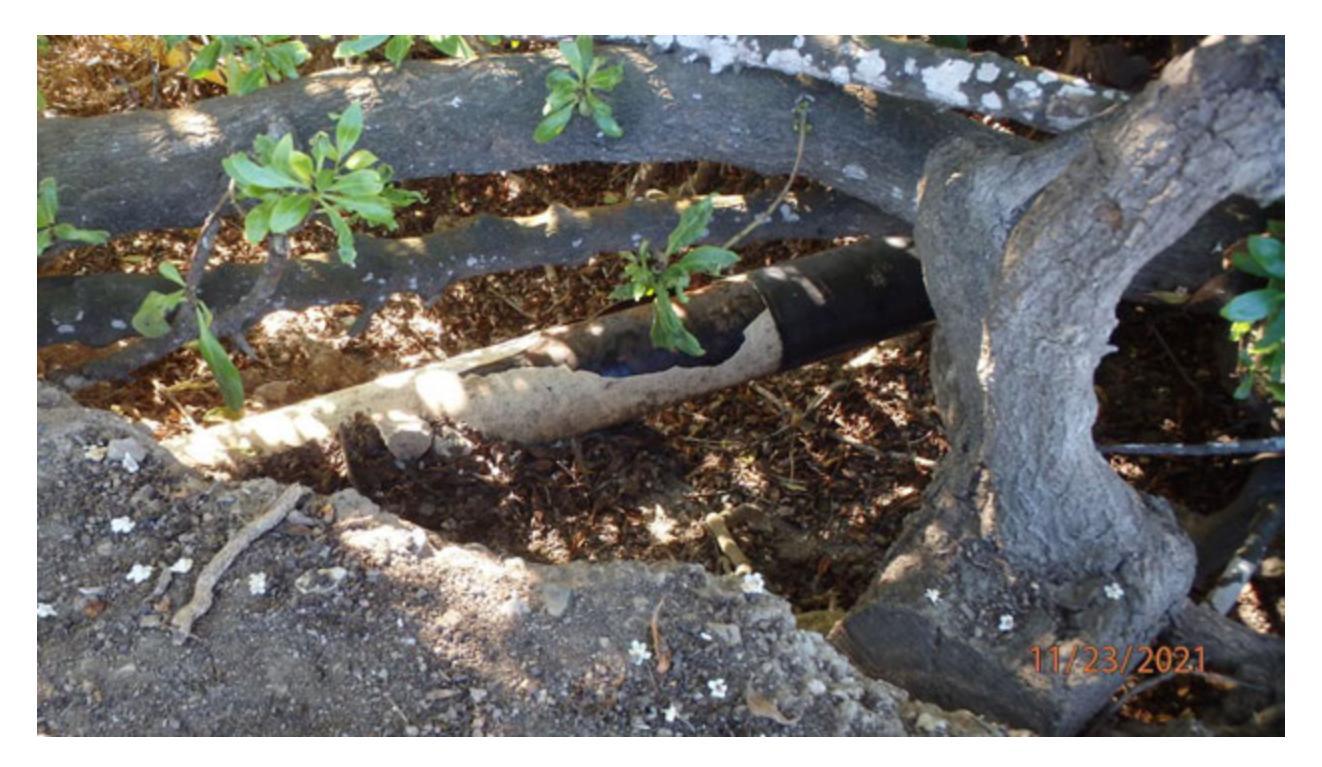
Asbestos Survey Partially Exposed 6-Inch Diameter Steel Pipeline along Pier Access Road PRC 421 Decommissioning Project, Goleta, Santa Barbara County, California

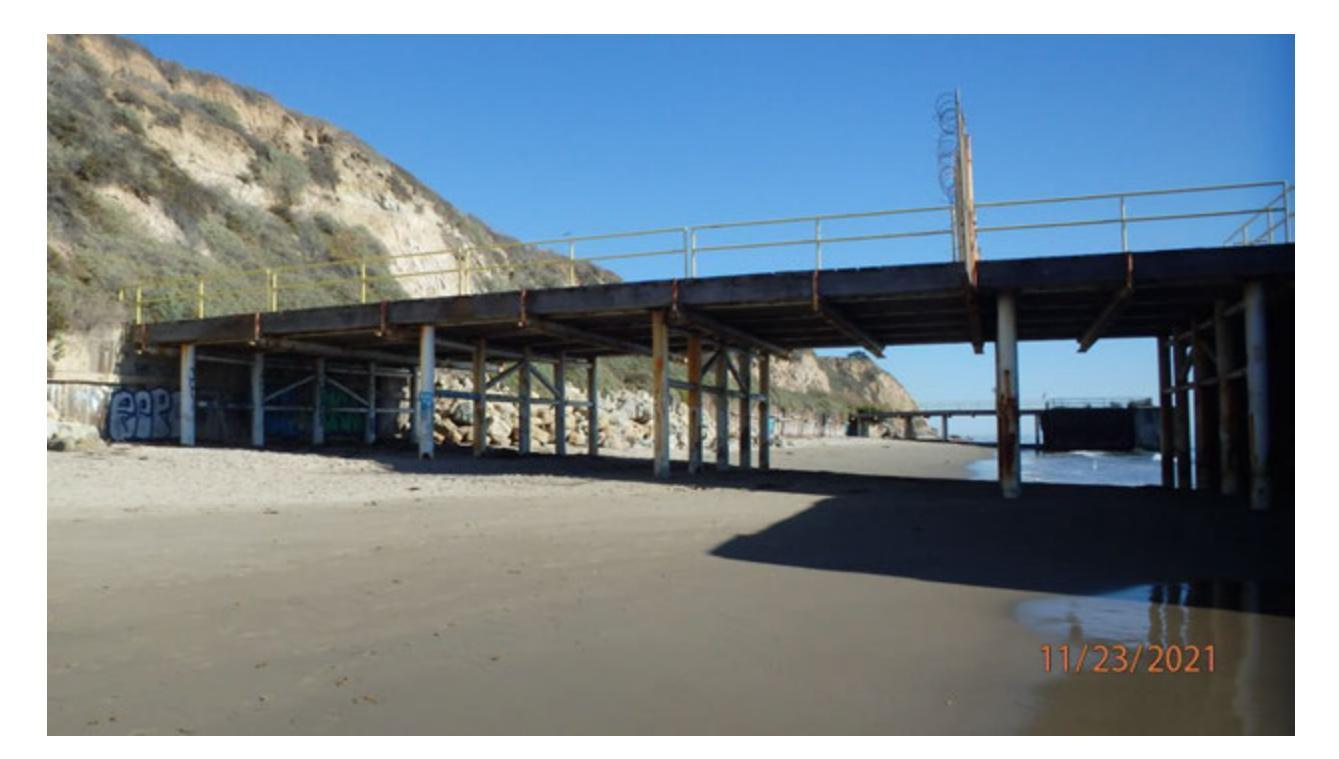
Lead-Based Paint Survey Piers 421-1 and 421-2 PRC 421 Decommissioning Project, Goleta, Santa Barbara County, California
