**RINCON PHASE 2 DECOMMISSIONING PROJECT –
EVALUATION OF EFFECTS AND EFFECTIVENESS OF THREE DIFFERENT TREATMENTS OF STATE
COASTAL CONSERVANCY PARCEL AT PUNTA GORDA,
VENTURA COUNTY COAST**

**GARY GRIGGS
CONSULTING COASTAL GEOLOGIST
321 ALTA AVENUE, SANTA CRUZ, CA. 95060
(831) 332-9318 – GRIGGS@UCSC.EDU**

INTRODUCTION – EVOLUTION AND PROTECTION OF THE STATE COASTAL CONSERVANCY PARCEL

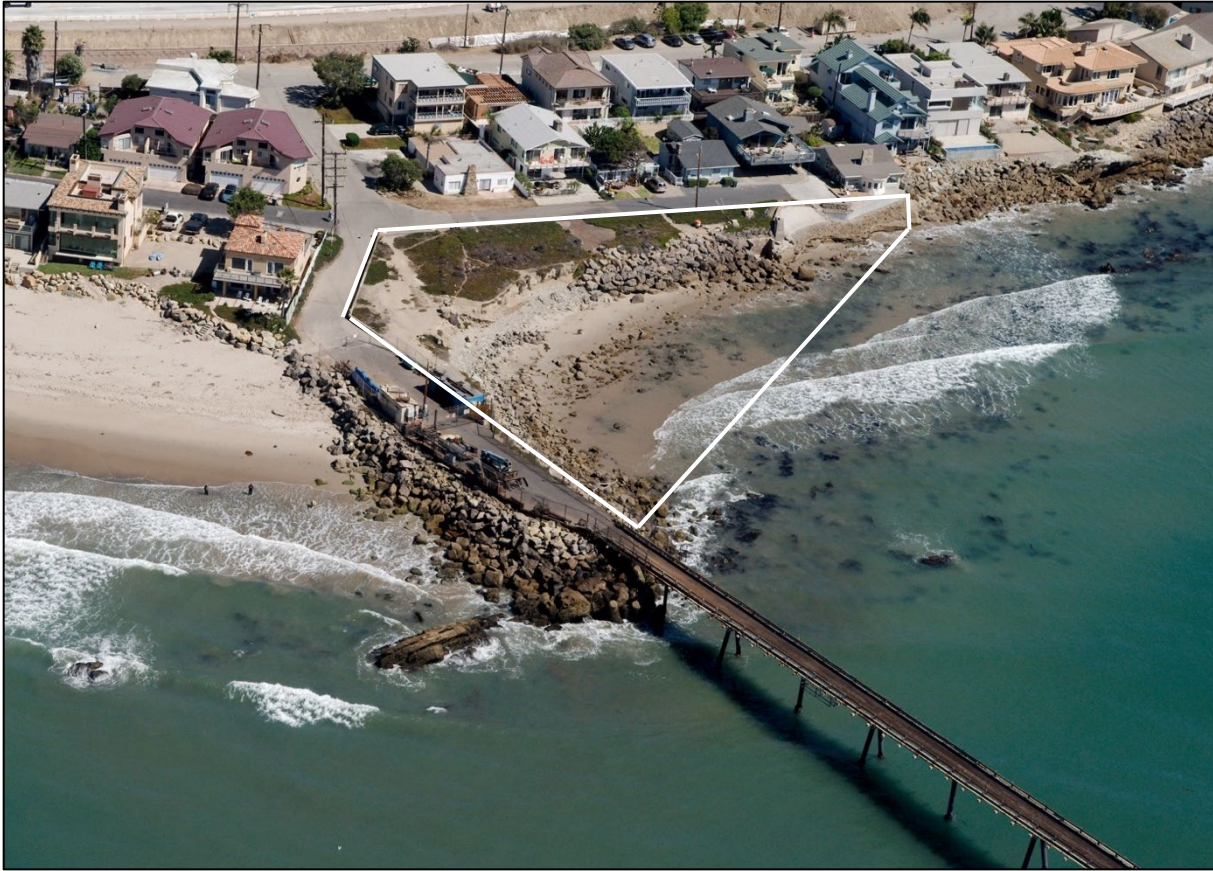
Figure 2. Aerial photograph of the abutment, causeway and the State Coastal Conservancy parcel. Approximate boundaries outlined in white (2013 photo from California Coastal Records Project – Kenneth and Gabrielle Adelman).

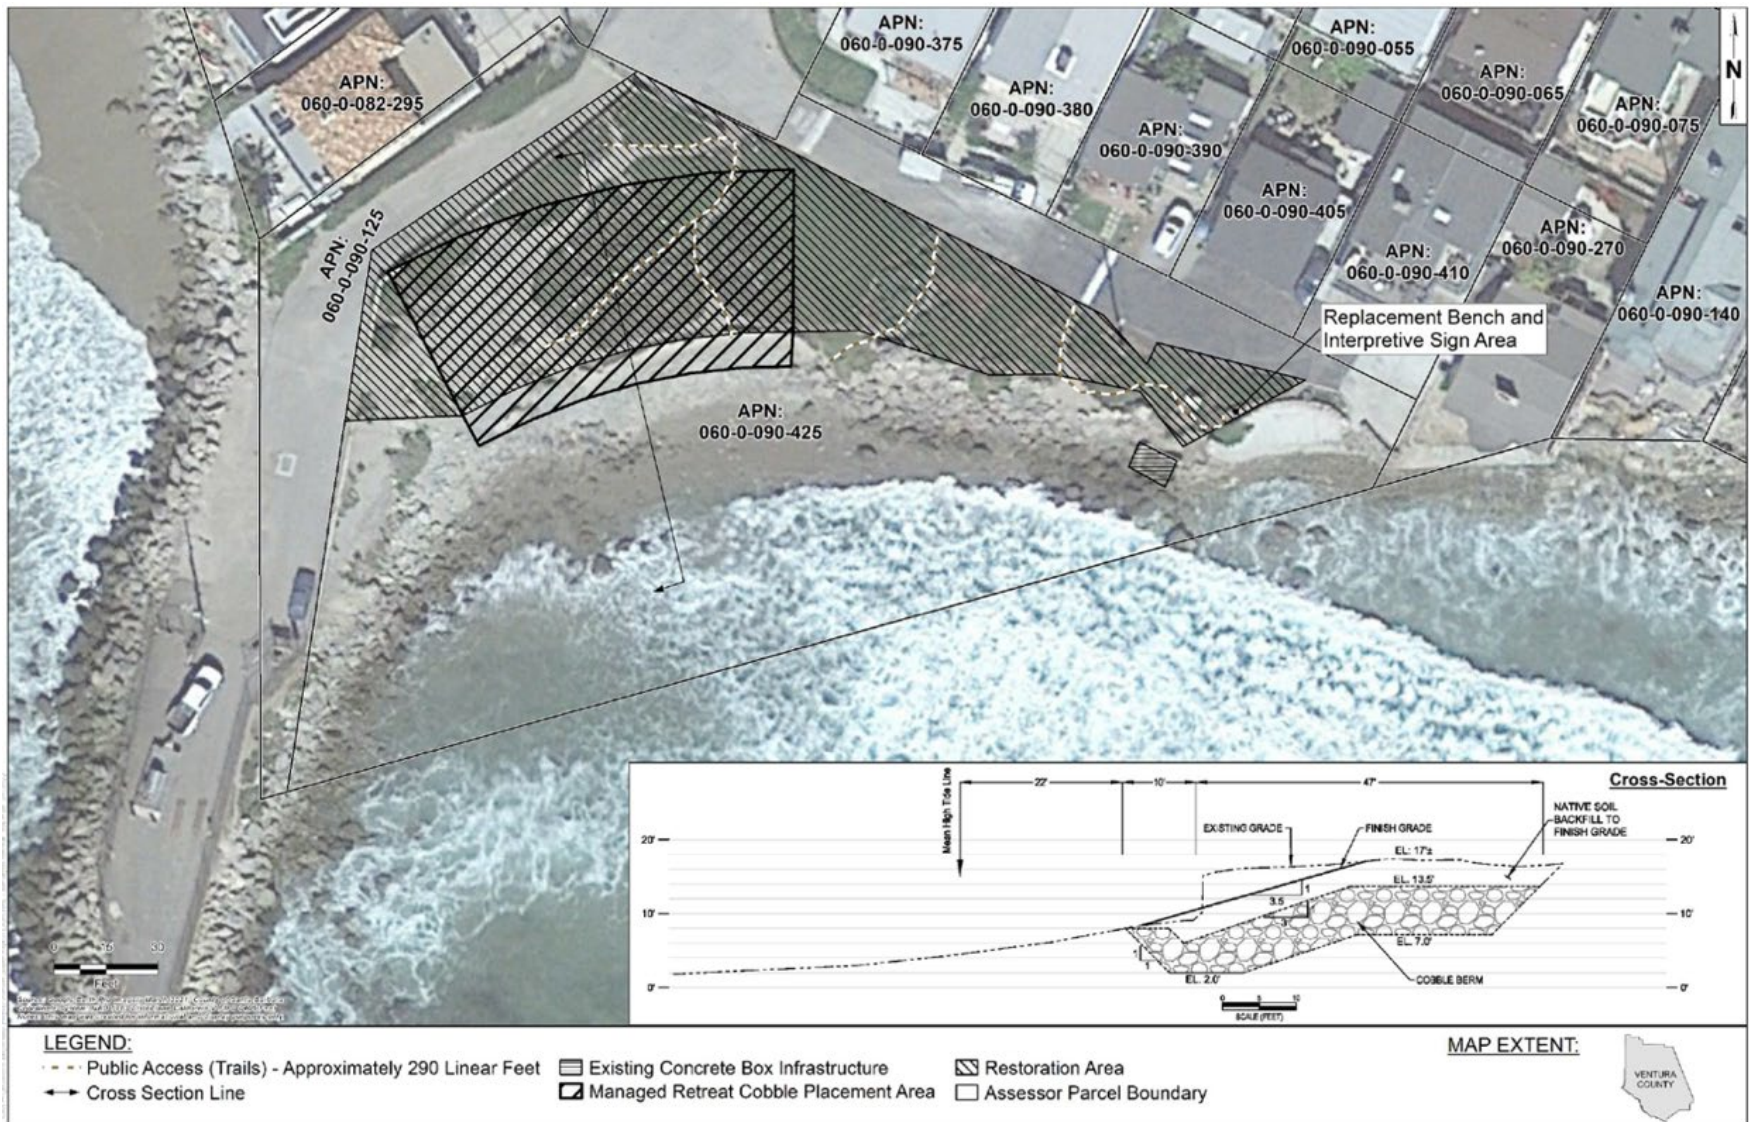
The cobble back berm would transition into a new cobble fill placed further down on the beach that would provide additional stability to the inland cobble fill. The profile of the cobbles was planned to mimic a “natural grade” from the inland vegetated portion of the parcel down to the beach and intertidal area (Figures 17 & 18). It is estimated that about 2,500 cubic yards of cobbles would be required to complete the cobble back berm and the back beach coverage of cobbles over an alongshore distance of “about 50 feet”. This is planned to fill in the existing gap between the revetments on either side (while 50 feet is the distance stated in the State Lands Commission report, the actual gap is closer to 100 feet). The cobbles would be imported to the site using dump trucks and placed with two excavators on the beach. Using dump trucks with a 10 yd³ capacity, would require about 250 truckloads of cobbles.

Figure 17. Plan and cross-section view of Alternative 9B (State Lands Commission).

Alternative 9B would include all of the components of Alternative 9A described above in addition to adding shoreline and bluff protection. The proposed plan would involve initially excavating the material on the upper unarmored portion of the parcel to a depth of about ten feet (Figure 16). The total soil volume removed has been calculated at approximately 3,800 yds³. Cobbles would then be imported to replace much of the material excavated and then covered with the excavated “native” soil. Any excess soil (potentially up to 2,500 yds³) would be trucked off-site to suitable area. The overall topographic profile would be altered from the nearly flat terrace existing at present which is fronted by a six-to-eight-foot-high, near-vertical bluff on the seaward side (Figure 17) to a narrower terrace and then a gradual slope to the beach at a 1:3.6 (V:H) slope, or about 16 degrees (Figure 17). The components of Alternative 9A would then be implemented, including native planting and seeding, pathway improvements and a stairway to the beach.

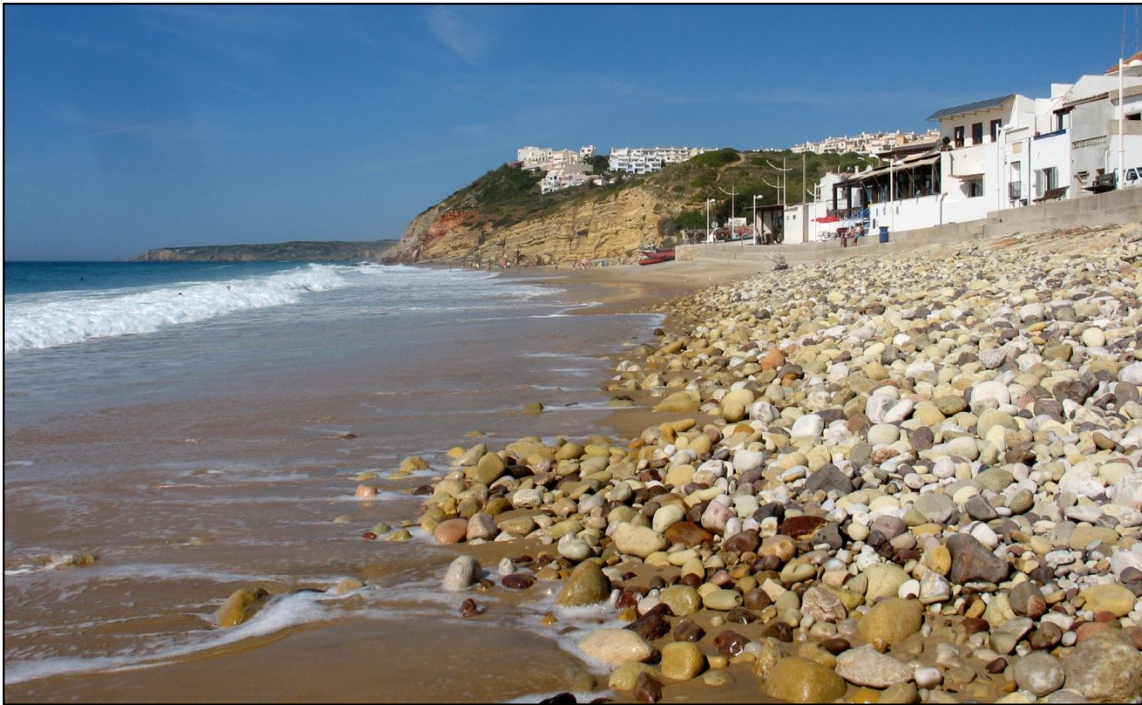
Natural cobble beaches and/or cobble berms often form on high energy coasts where sand is mobilized and moved offshore in the winter months (Figure 19). Cobbles may be seasonal or permanent features of the shoreline depending upon their availability and changes in seasonal wave energy. Severe winter scour on some sandy beaches may reveal a basal accumulation of cobbles as a type of natural armor. The presence of these protective cobbles, that are much more resistant to beach scour than sand, has given rise to a number of cases where these natural conditions have been mimicked as a type of more natural shore protection.

Figure 19. Natural cobble berm on the Algarve, Portugal.

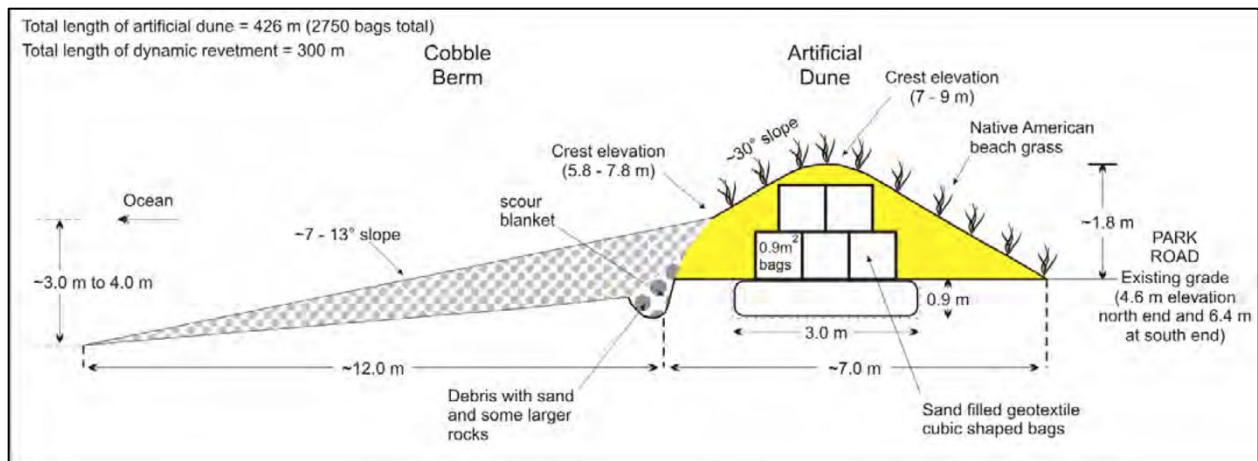
Komar and Allen (2009) describe the planning, construction and monitoring of a cobble berm at Cape Lookout State Park on the high energy northern Oregon coast. Cobble beaches and berms are common along the Oregon coast, in part because the coastal cliffs in places consist of hard volcanic rock that break down into cobble and boulder size material. They first studied the existing cobble beaches to see what size, slope and stability conditions occurred near the site. An eroding dune existed landward of the beach that was overtopped during extreme winter wave conditions. Instead of a cobble blanket beneath the dunes, they actually constructed a core of large, sand-filled geotextile bags, which were then covered with sand and revegetated (Figures 20 and 21).

Figure 20. Cross-section of proposed Cape Lookout State Park cobble berm and dune (from Komar and Allan, 2009).

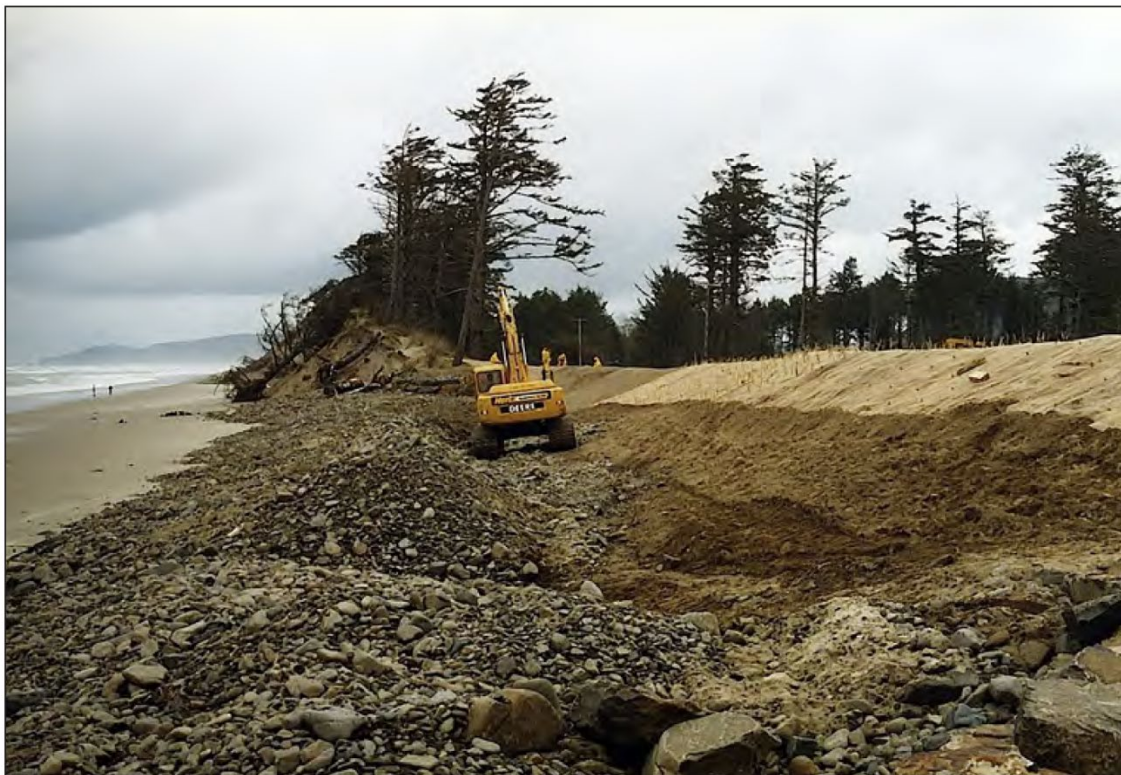
Figure 21. Cape Lookout State Park cobble berm under construction (from Komar and Allan, 2009)

Another major difference in the proposed Alternative 9B at Punta Gorda and the Oregon coast project was that there was a well-used sandy beach so that the constructed cobble berm was covered with sand. The Cape Lookout project was completed in 2000 and by 2008, it had lost about 6,500 yds³ of cobbles. In response, 3,500 yds³ of new rock was imported, but the cobble “mattress” was still deficient. The cobble berm was not built high enough initially nor completely according to the design. As a result, winter waves overtopped the berm and eroded the dunes, exposing the geotextile bags. The key lesson here is building what was designed, and

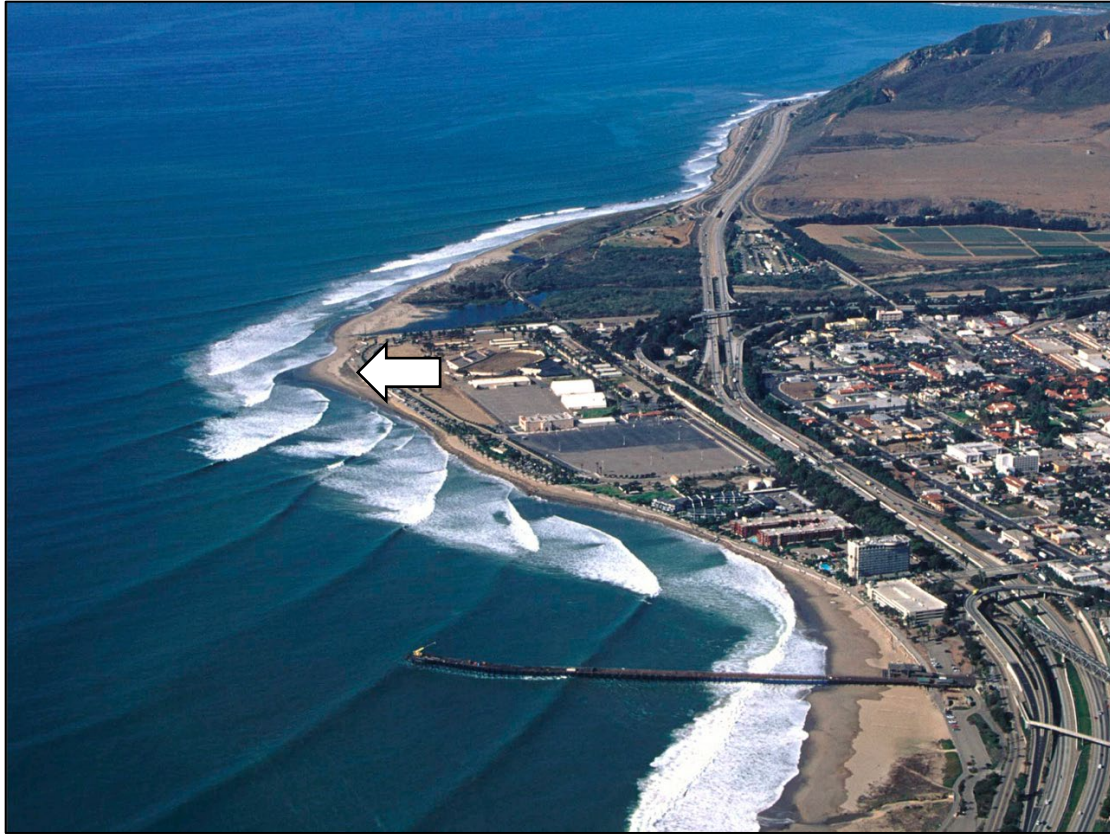
Figure 22. Ventura River delta and Surfer's Point (arrow) showing wave refraction around point.

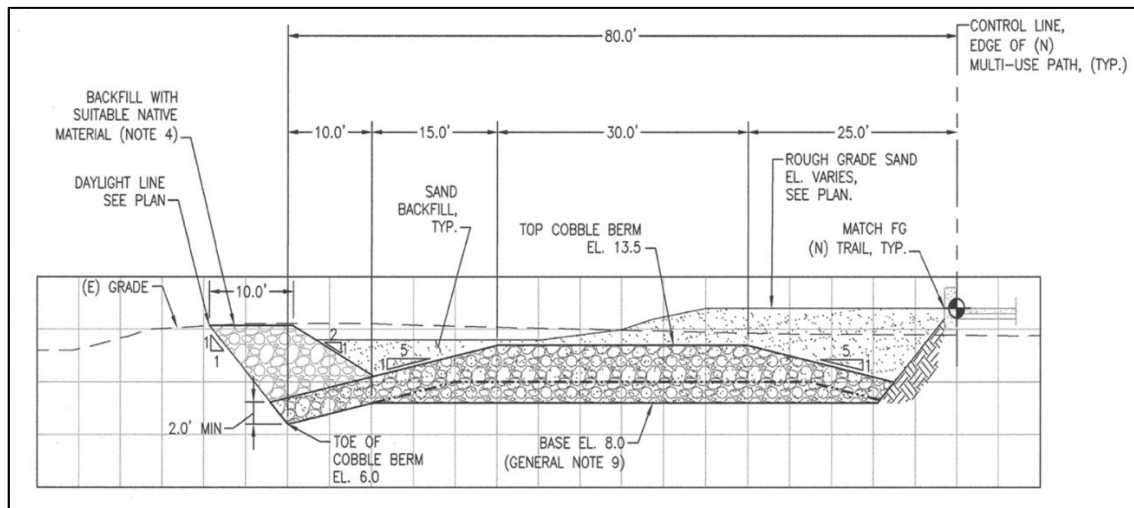
Figure 23. Cross-section of planned cobble berm at Surfer's Point.

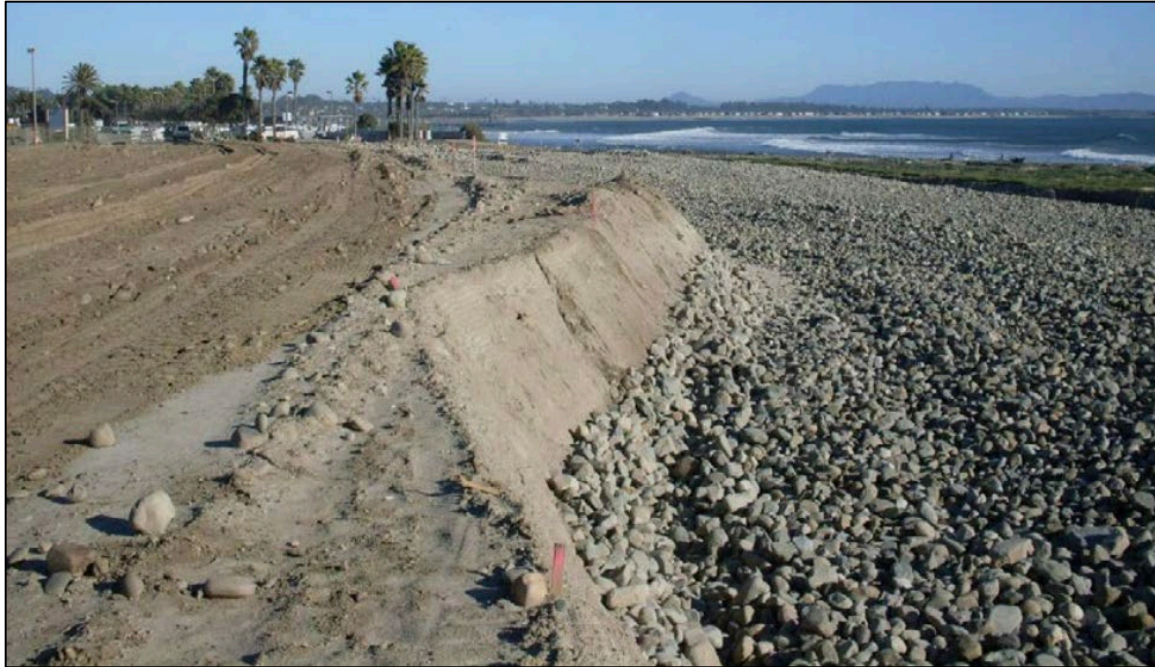
Figure 24 .Cobble berm under construction at Surfer's Point.

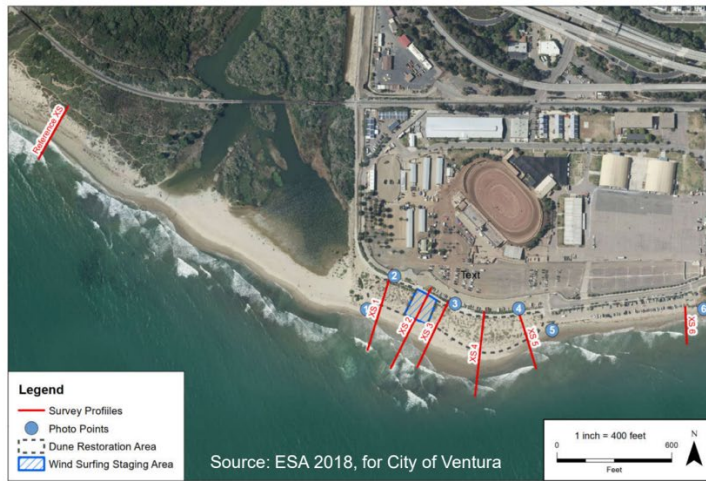
Map of Surveyed Transects

The Surfer’s Point cobble berm/blanket provides good evidence for the potential effectiveness of such an approach at Little Rincon where wave climate is very similar. Cross-shore surveys over a decade (2011-2021; Figure 26) indicate that while the beach sand on the foreshore comes and goes seasonally in response to changing wave condition, the back beach and dune areas underlain by cobbles have remained stable (Figures 27 & 28).

Figure 26. Survey profile locations across shoreline at Surfer's Point.

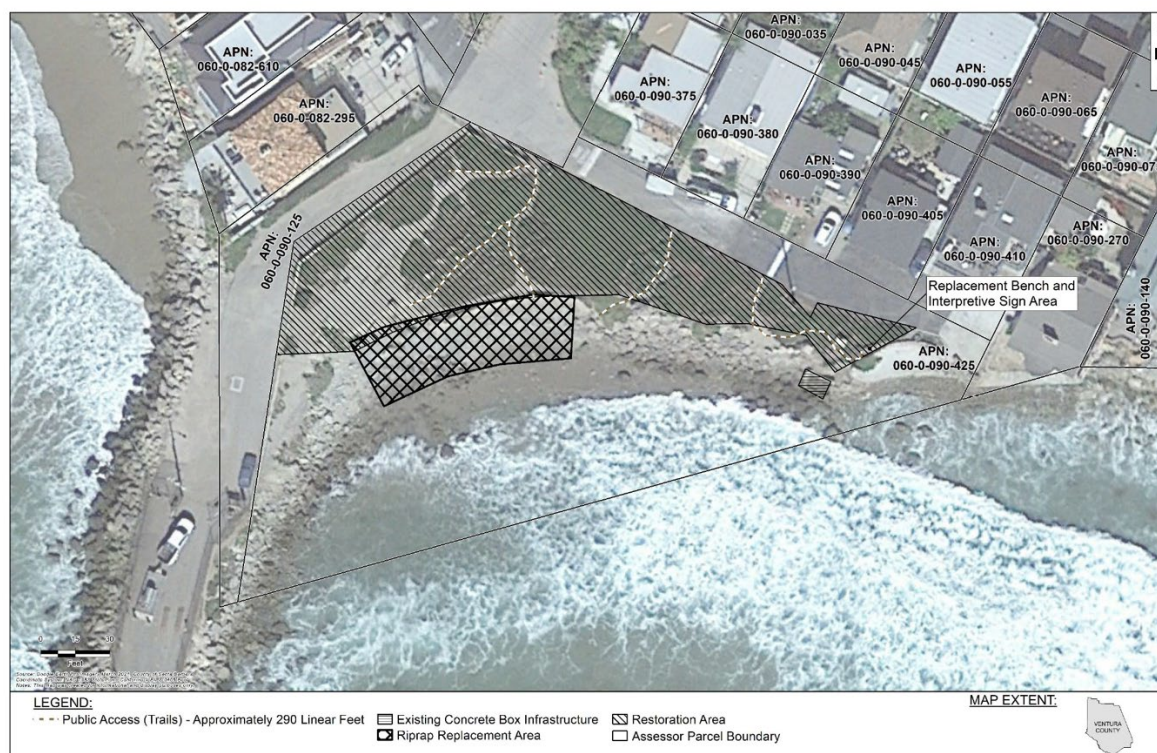
Figure 29. Details of placement of riprap for Alternative Plan 9c.

Alternative 9C would include all of the components included in Plan 9A and would add riprap to armor the roughly 130 feet of shoreline that is presently unprotected. The additional riprap would extend from the existing intact riprap adjacent to the abutment to the riprap protecting the downcoast homes and Breakers Way (Figure 29). About 135 feet of the western or upcoast portion of the shoreline was originally protected by riprap when the abutment was constructed in 1959 (see Figure 9). Over the subsequent 62 years, however, the rock has been broken down and displaced by wave action so that it no longer provides significant protection to the upper portion of the parcel (see Figure 15). Wave erosion has left an approximately eight foot high near vertical bluff (see Figure 16).

An estimated 360 yds³ of riprap (chosen to match the size of the riprap that currently exists onsite) would be needed to complete the shoreline armoring in this area. The riprap would be initially hauled from a quarry in Ventura County to the SCC area in covered dump trucks and staged within the upper portion of the site between the beach and Breakers Way.
