# **2023** PROGRESS REPORT

#### Coastal Hazards and Legacy Oil & Gas Well Removal and Remediation Program

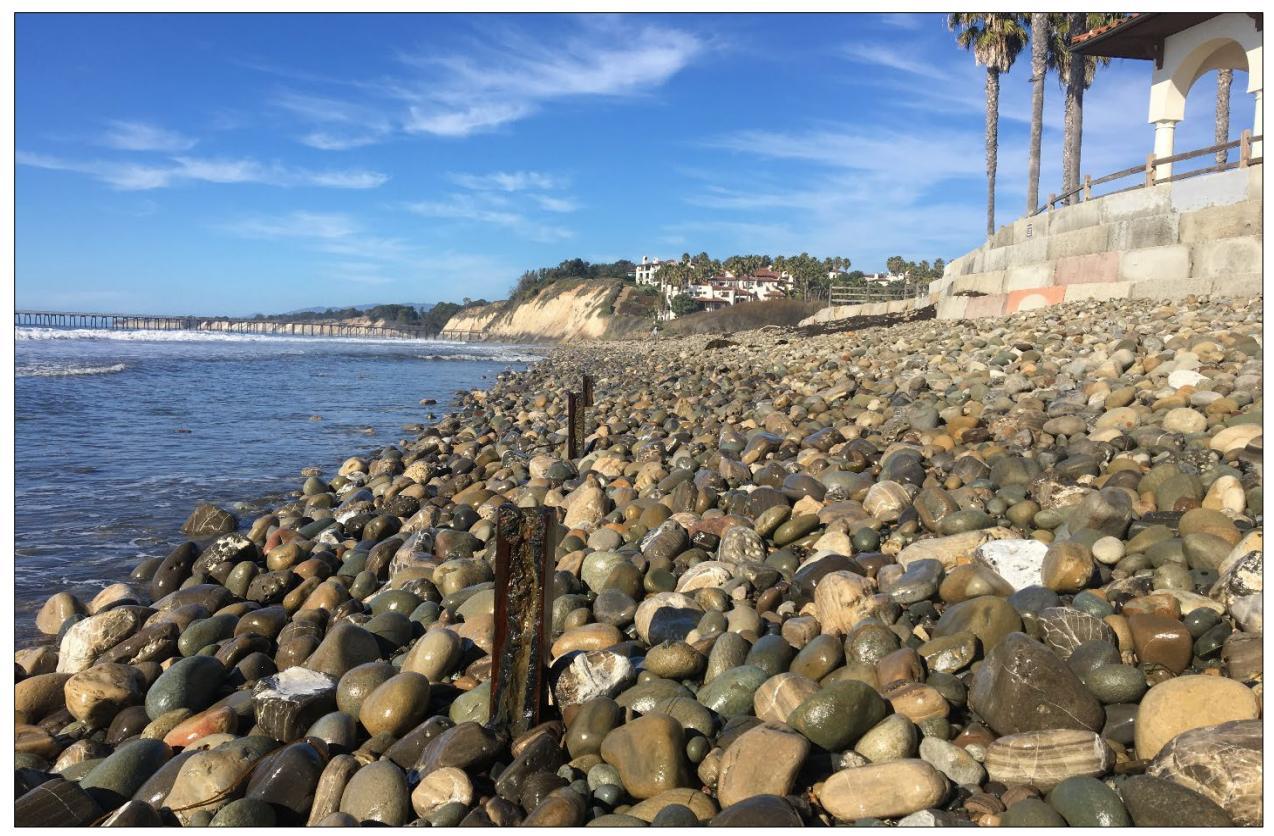
Figure 2. Exposed railroad irons near Goleta Beach (photo by Padre Associates).

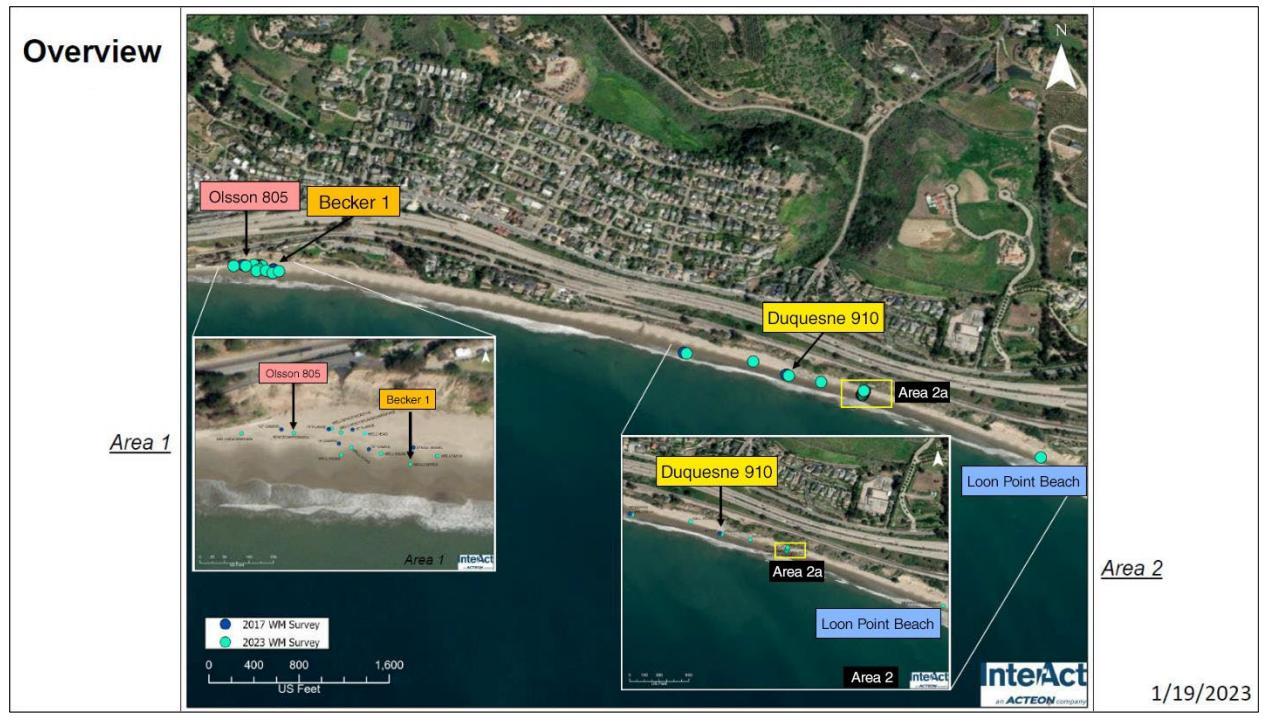
Figure 3. Overview map of Summerland Beach & Loon Point (photo by 2H).

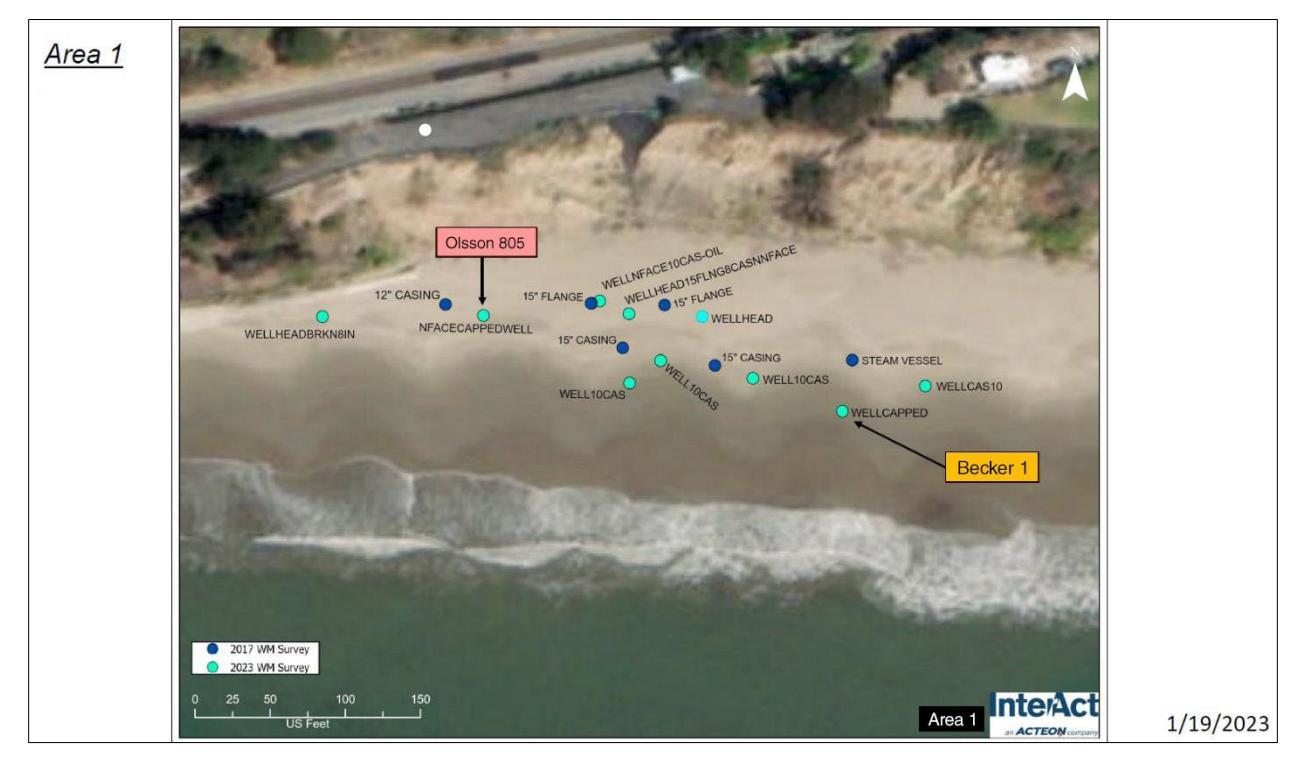
Area 1 includes 16 surveyed locations of remnants (well casings, capped wells, and pipelines) of legacy oil field activities. Survey data was collected in 2017 and 2023 and is indicated on the map below (Figure 4).

#### Figure 4. Area 1 location map (photo by 2H).

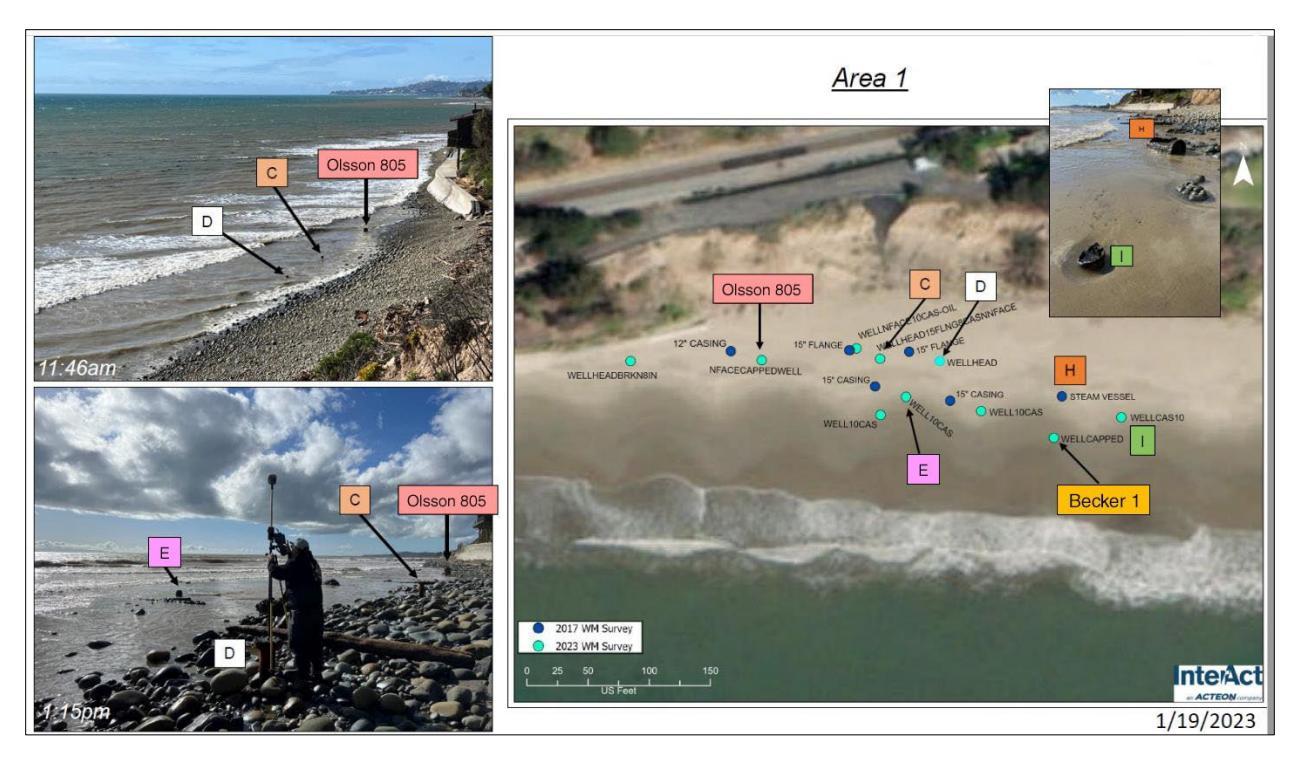
Multiple well casings were exposed at the time of the field site survey. Labels were given to the surveyed locations and assigned to associated field photos as indicated in Figure 5, Figure 6, and Figure 7 below. The wells were exposed and able to be photographed and surveyed due to local low tidal depths.

Figure 5. Area 1 photos and survey locations at low tide looking west (photo by 2H).

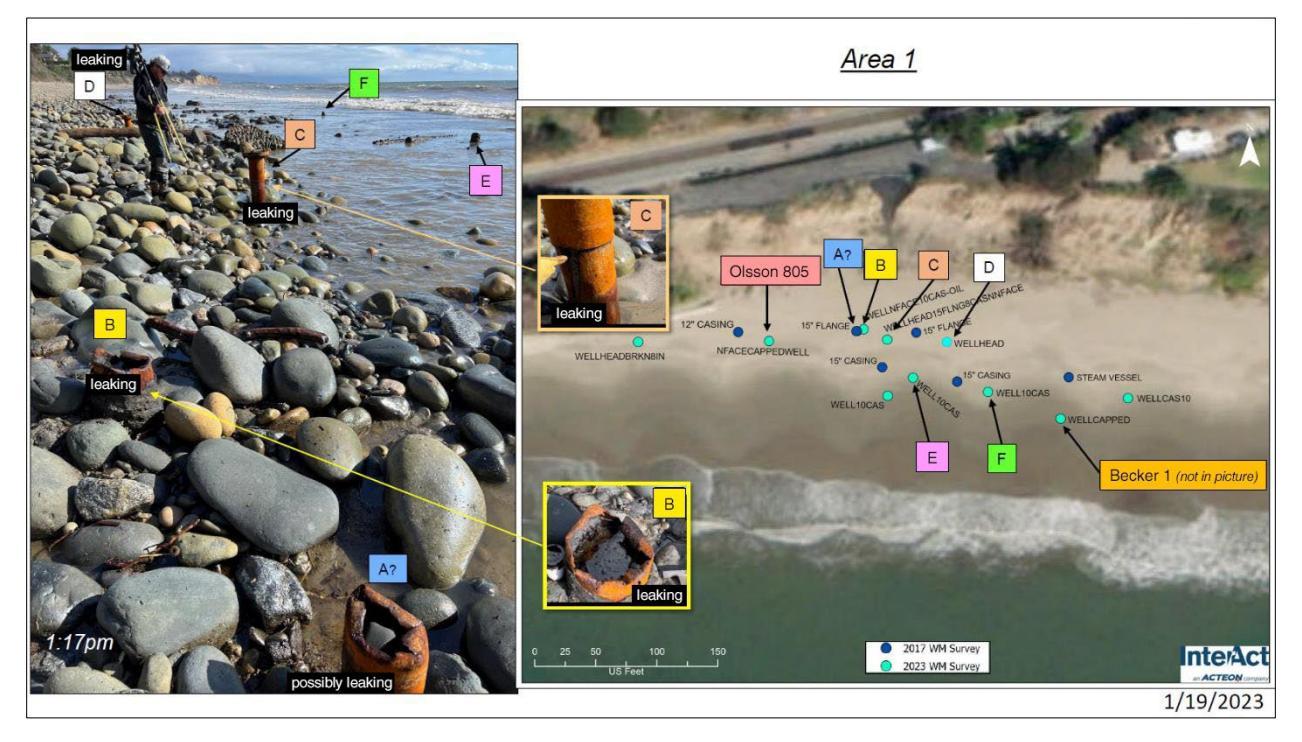
Figure 6. Area 1 photos and survey locations at low tide looking east (photo by 2H).

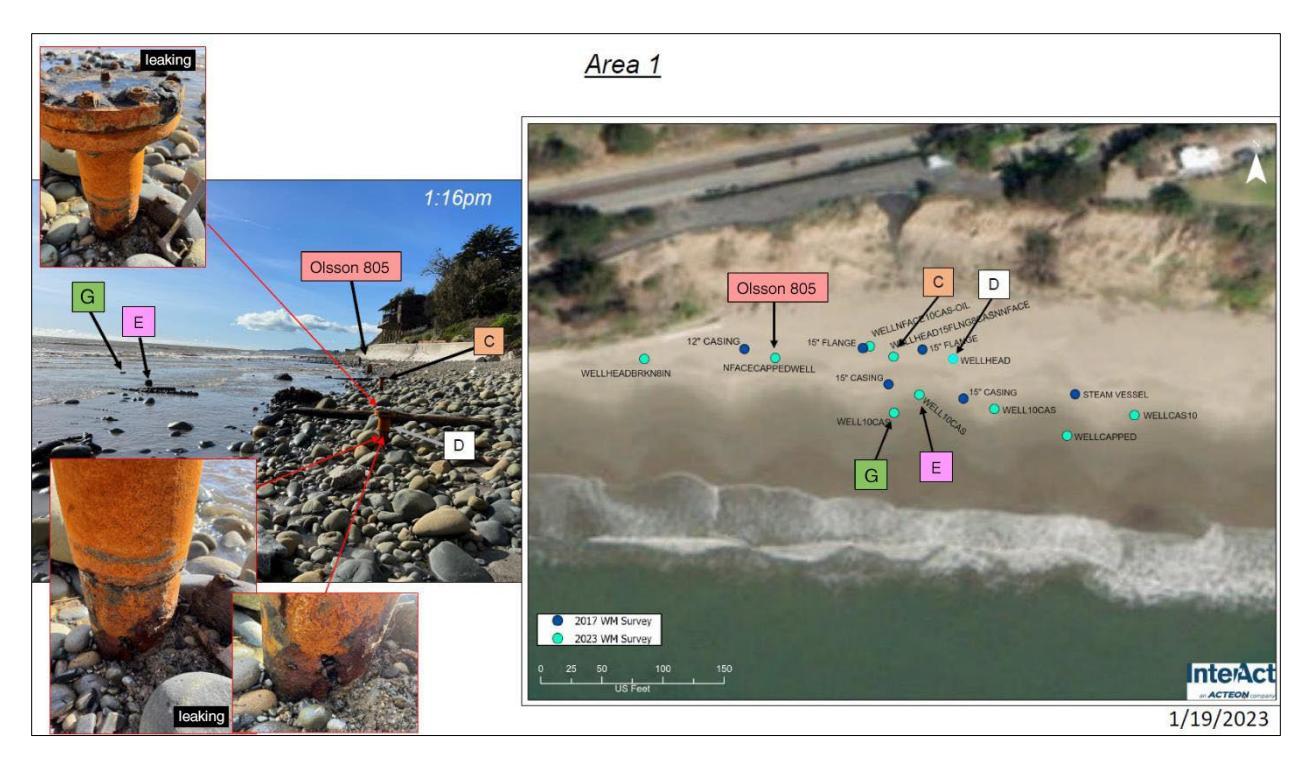
Figure 7. Area 1 photos and survey locations at low tide looking west (photo by 2H).

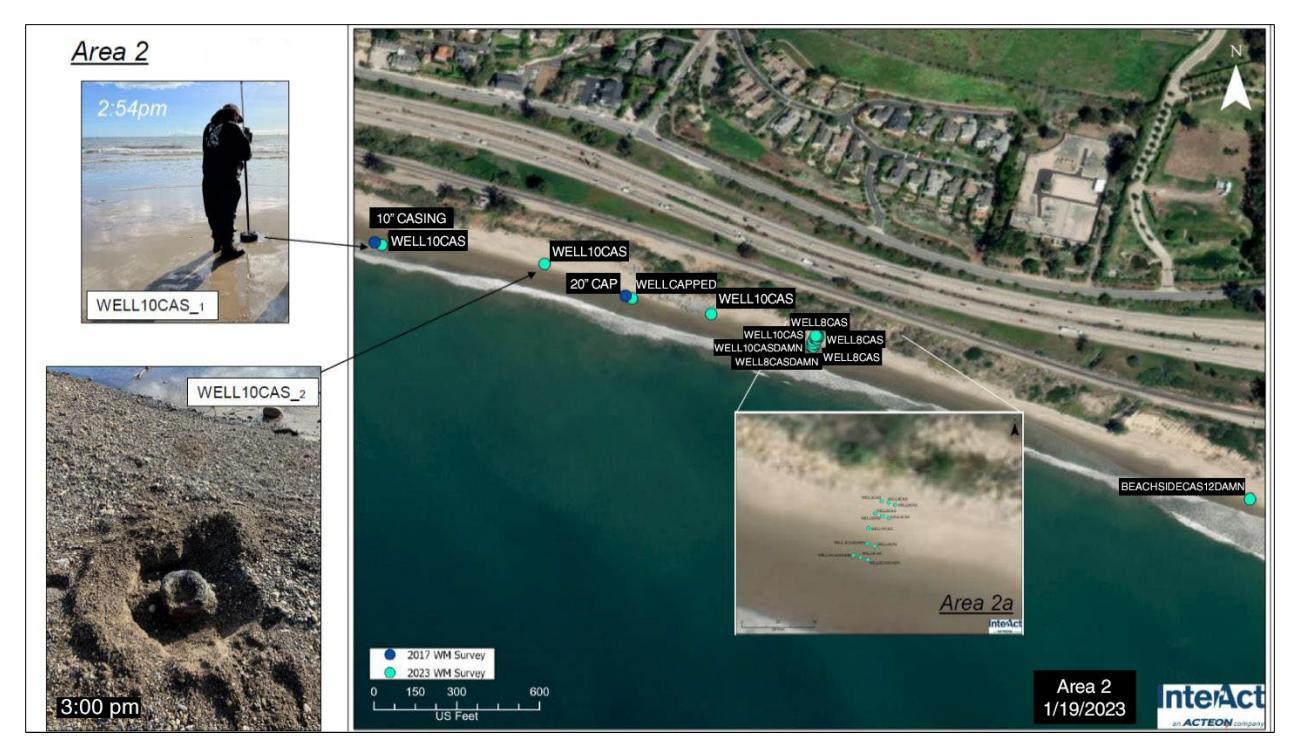
Area 2 includes 19 surveyed locations of remnants (well casings, capped wells, and pipelines) of legacy oil field activities. Survey data was collected in 2017 and 2023 and is indicated on the map (Figure 8). The Duquesne 910 capped well is in this area and included in Figure 9.

Figure 8. Area 2 photos and survey locations at low tide (photo by 2H).

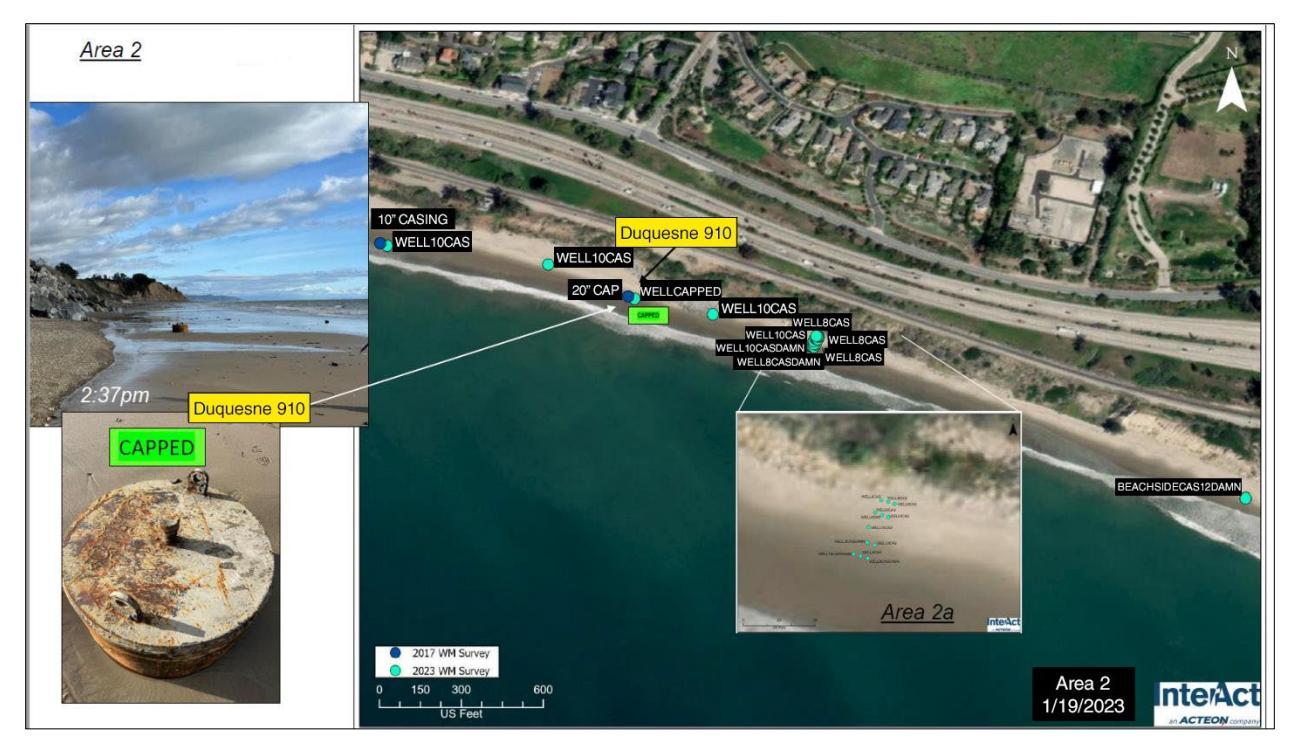
Figure 9. Area 2 photos of Duquesne 910 capped well at low tide looking east (photo by 2H).

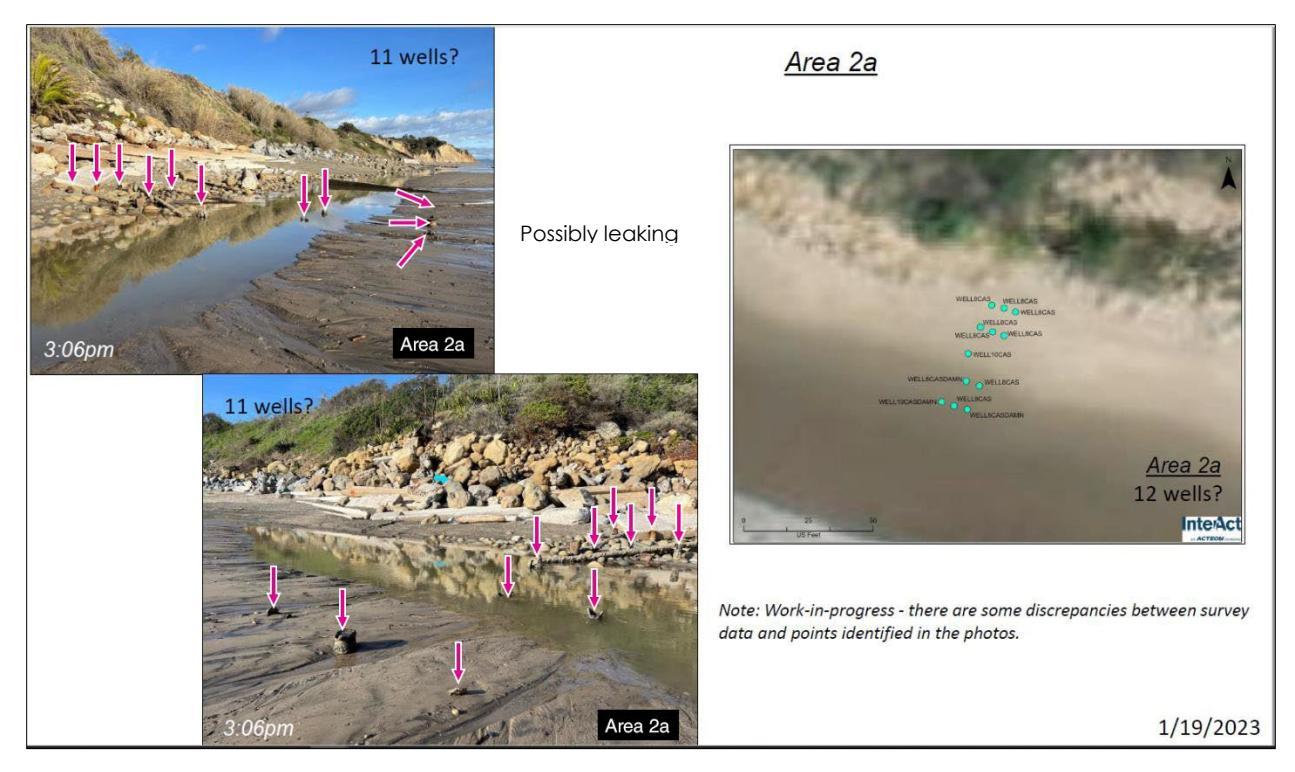
Area 2a consists of a concentration of 12 survey sites that were measured and then matched up with the photos. The remnants were a combination of metal, wood objects and concrete blocks that appear to be old piers, pilons, or oil facilities.

Figure 10. Area 2a photos and survey locations at low tide (photo by 2H).

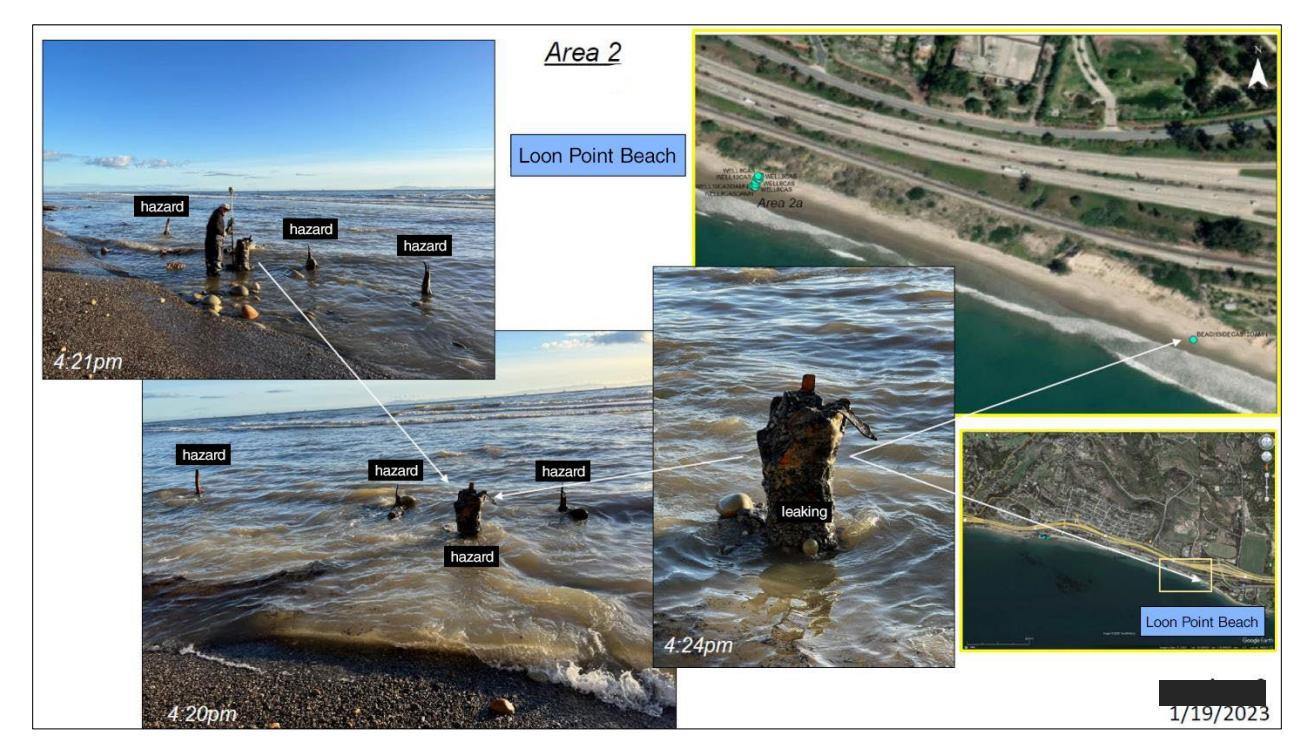
Loon Point Beach is the eastern most surveyed site and includes one legacy well casing along with three metal objects that were protruding above the beach surface. There is one object that appeared to be a legacy well casing. Three other metal objects were above the surface, and it was difficult to know whether they were legacy wells or part of the former infrastructure (Figure 11).

Figure 11. Loon Point Beach photos and survey locations just after low tide (photo by 2H).

At Loon Point Beach we observed a single well casing and associated infrastructure that was severely damaged and protruding approximately three feet above the mudline. This poses a potential environmental and safety risk to the public.

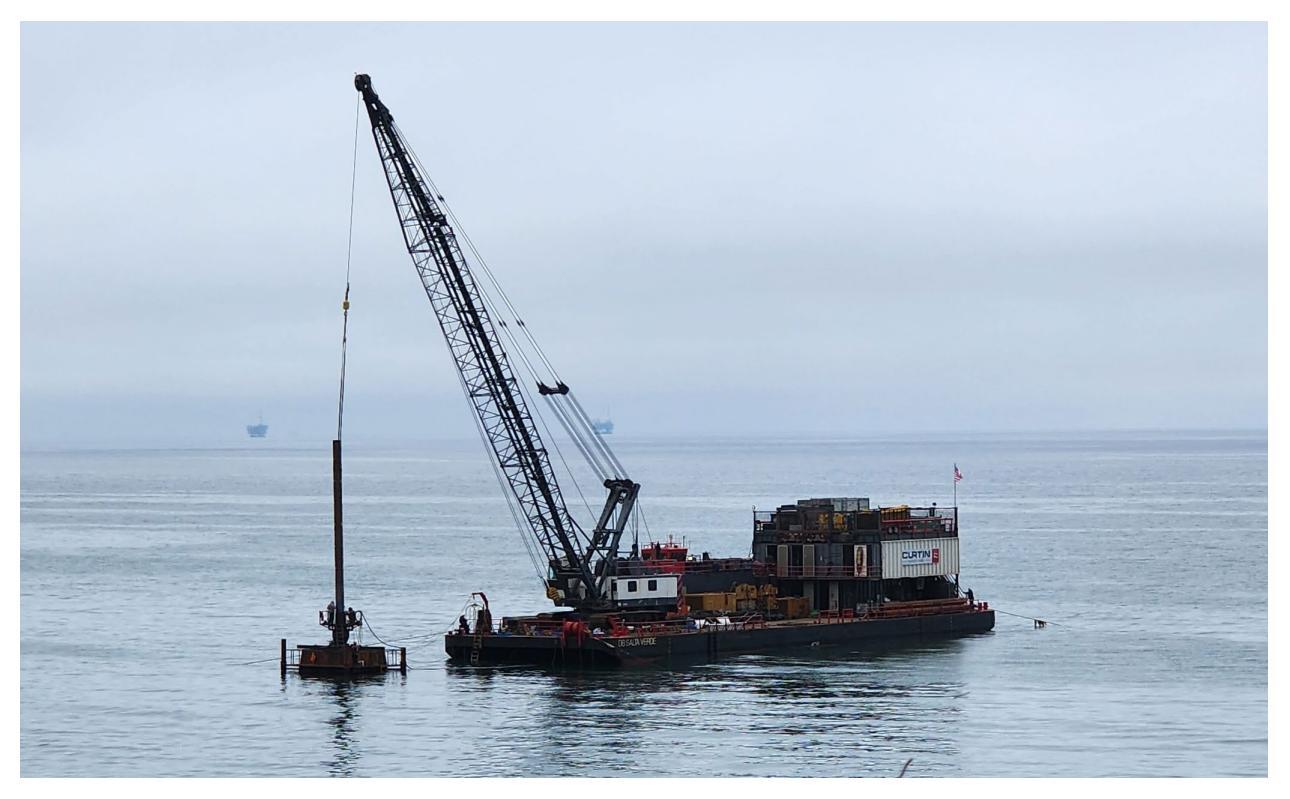
After the storm passed and it was deemed safe to continue the T1 operations, the barge set its anchors again near the well. The temporary cap was removed from the pile and the team pumped out seep oil from inside the pile into containment totes. The following step was to pick up and stab the third pile into the second pile and splice around the two piles. The subcontractor investigated the swell forecast and informed 2H that the crew should not continue any driving operations on T1 until swells improved due to unsafe conditions. During the standby period, the diving team started excavation around T5. Two days later, after swell conditions allowed continued operations, the third pile was driven until meeting ultimate refusal at 68 feet below natural bottom. The team pumped cement into the well casing and inside the pipe pile. After the cement was cured, the 24-inch pile was cut 2-feet above natural bottom, and the final cap was welded on top. There were six weather related standby days because of Hurricane Hilary and turbulent swells.

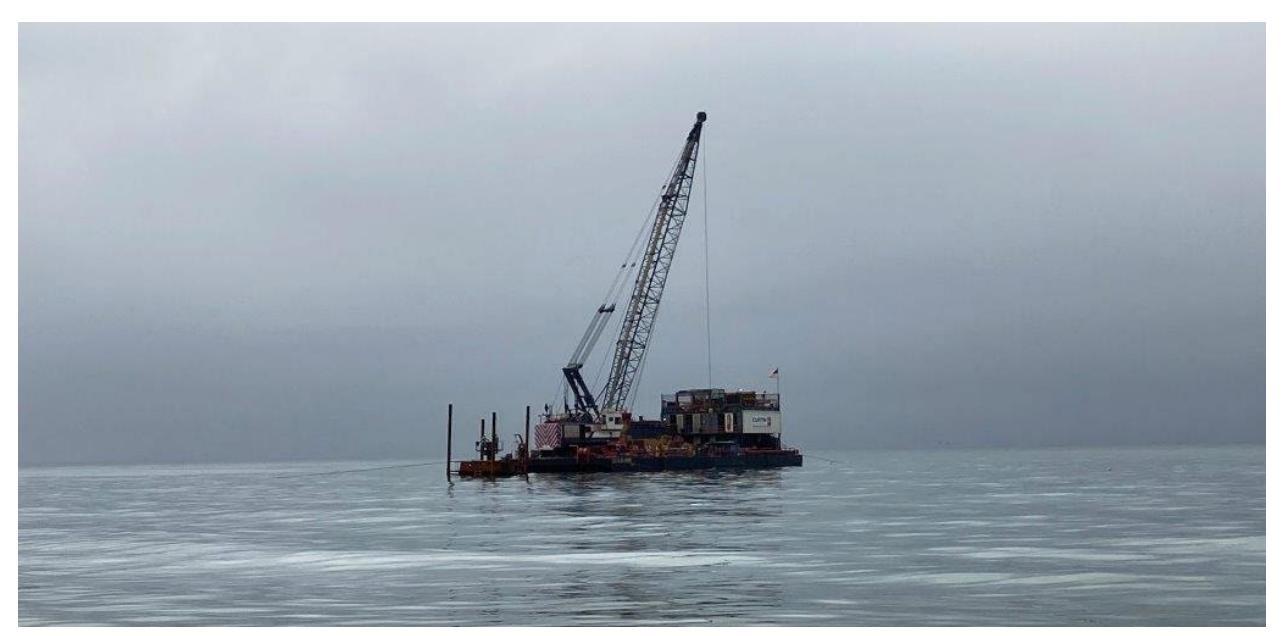
the 9-inch and 6-inch casings. The first 24-inch pile was placed and centered over the casing stub. The second pile was placed on top and spliced. After using the vibrohammer and diesel hammer shortly after, the team reached ultimate refusal at 38 feet. The excess pile was cut and prepped for the remedial cementing processes to begin. After the cement finished curing, the cut was made 2-feet above natural bottom, and the well stub was prepped for welding of the final cap. Once the cap was welded on, we removed the pin piles and recovered the containment unit. The barge anchors were removed the following day during high tide and departed for Long Beach.

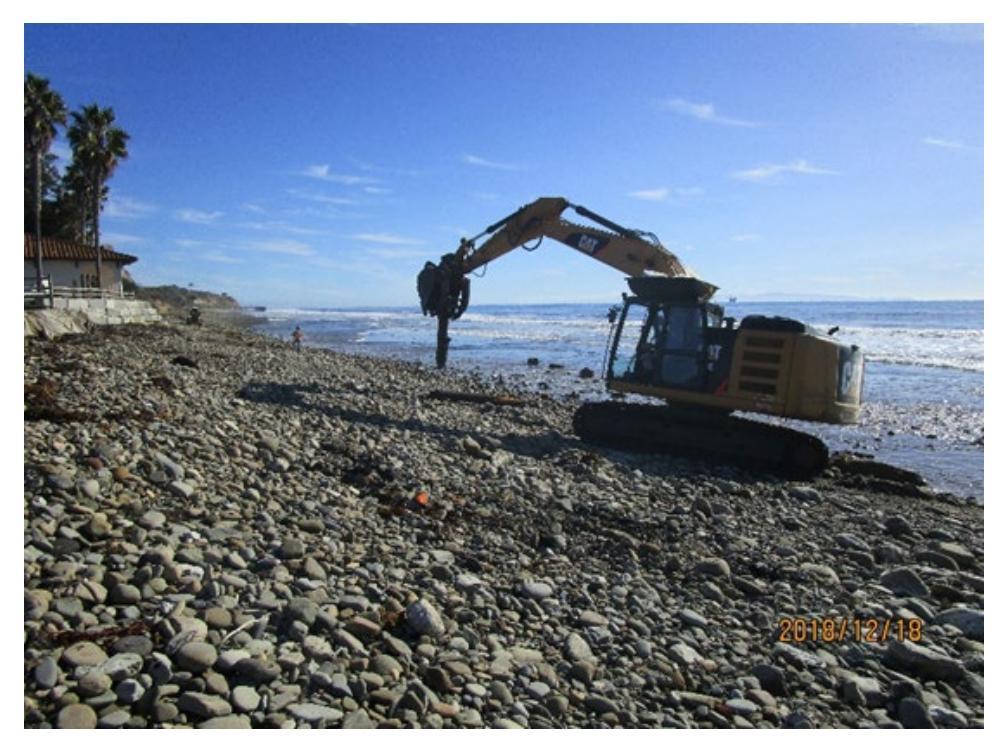
Figure 15. H Beam being extracted near Bacara Resort in 2018 (photo by the Commission).

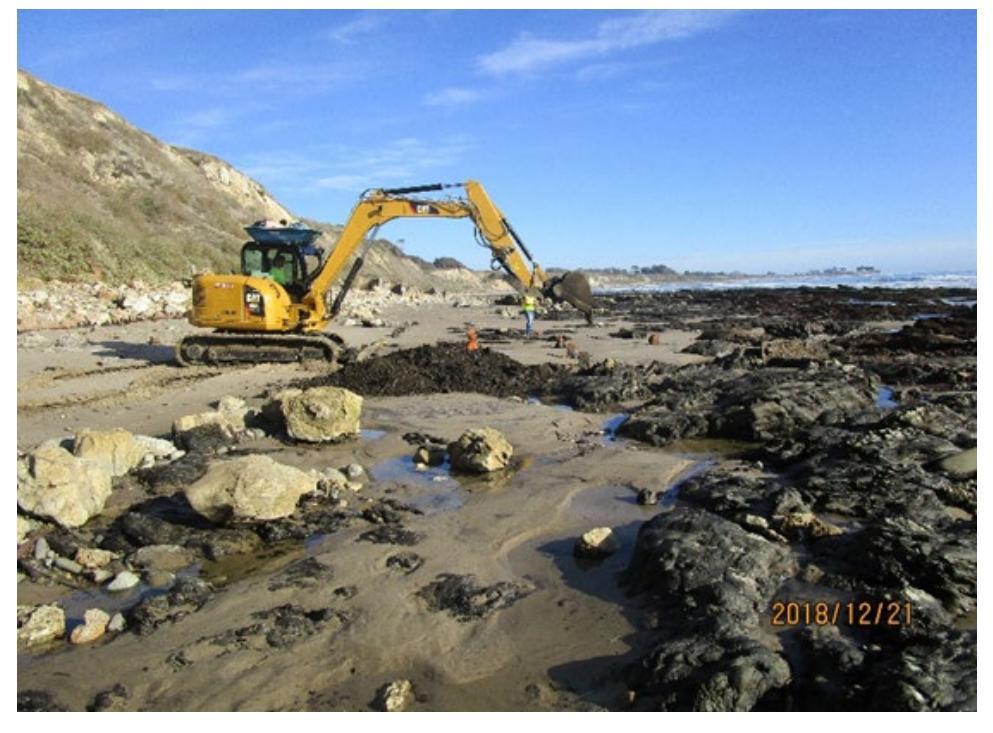
Figure 16. H Beam being extracted near the Bacara Resort in 2018 (photo by the Commission).

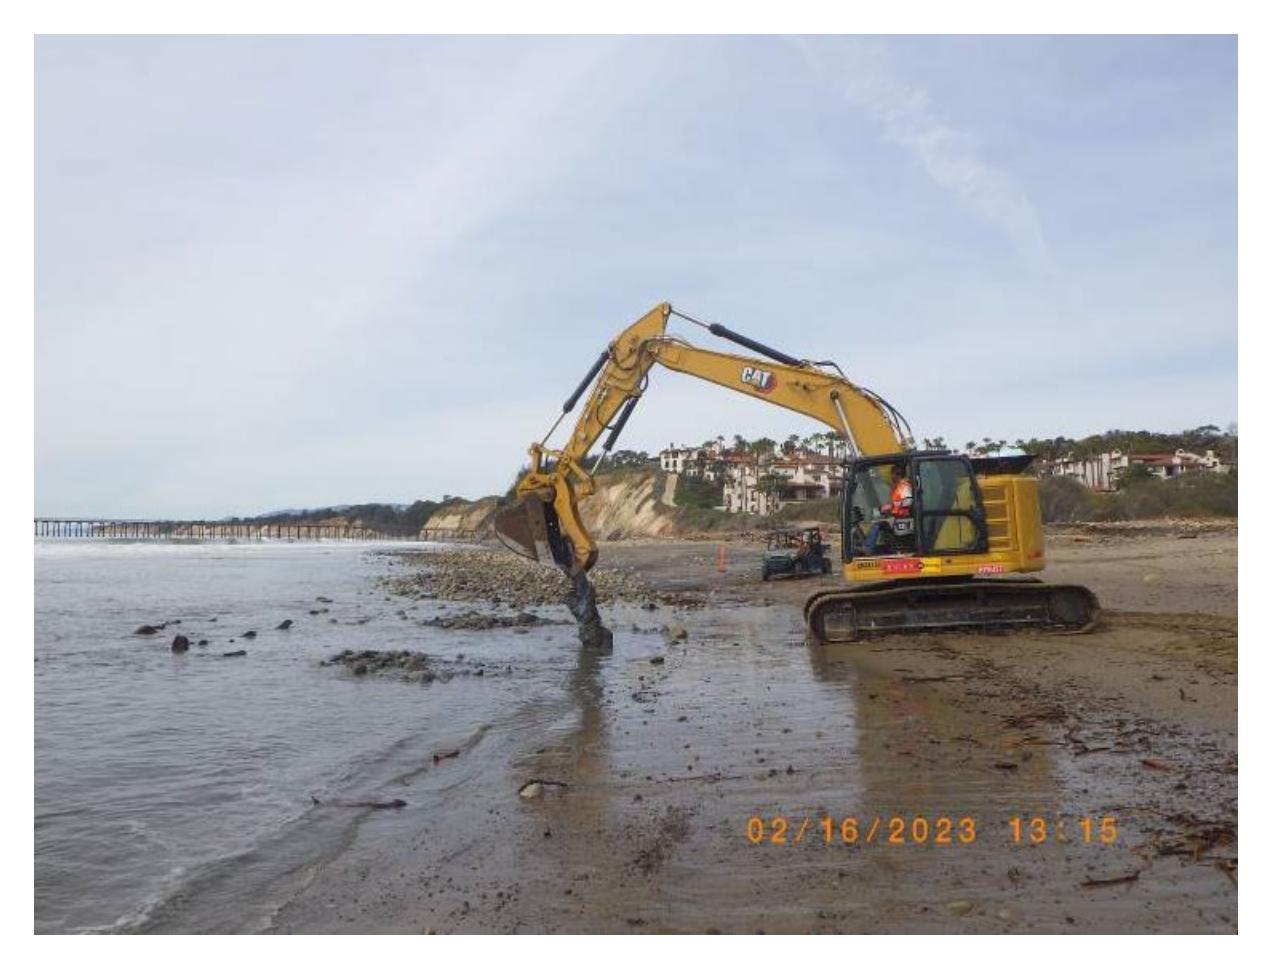
Figure 17. Crews removing wood pile hazard near Tecolote Creek (photo by Padre Associates).

A crew operated by Cushman Contracting Corporation accessed the beach from the Bacara Resort emergency access staging area and used beach sand to construct a usable access ramp from the staging area, no manipulation of the bluff was necessary for access. Crews worked during low tide to remove both previously identified and newly discovered hazards (H beams and wooden pilings). Crews worked on partially or fully removing a total of 17 hazards (Figures 17 and 18) and approximately 8-10 I-beam hazards that were modified to be more flush with the substrate and eliminate them from hazardous obstructions.

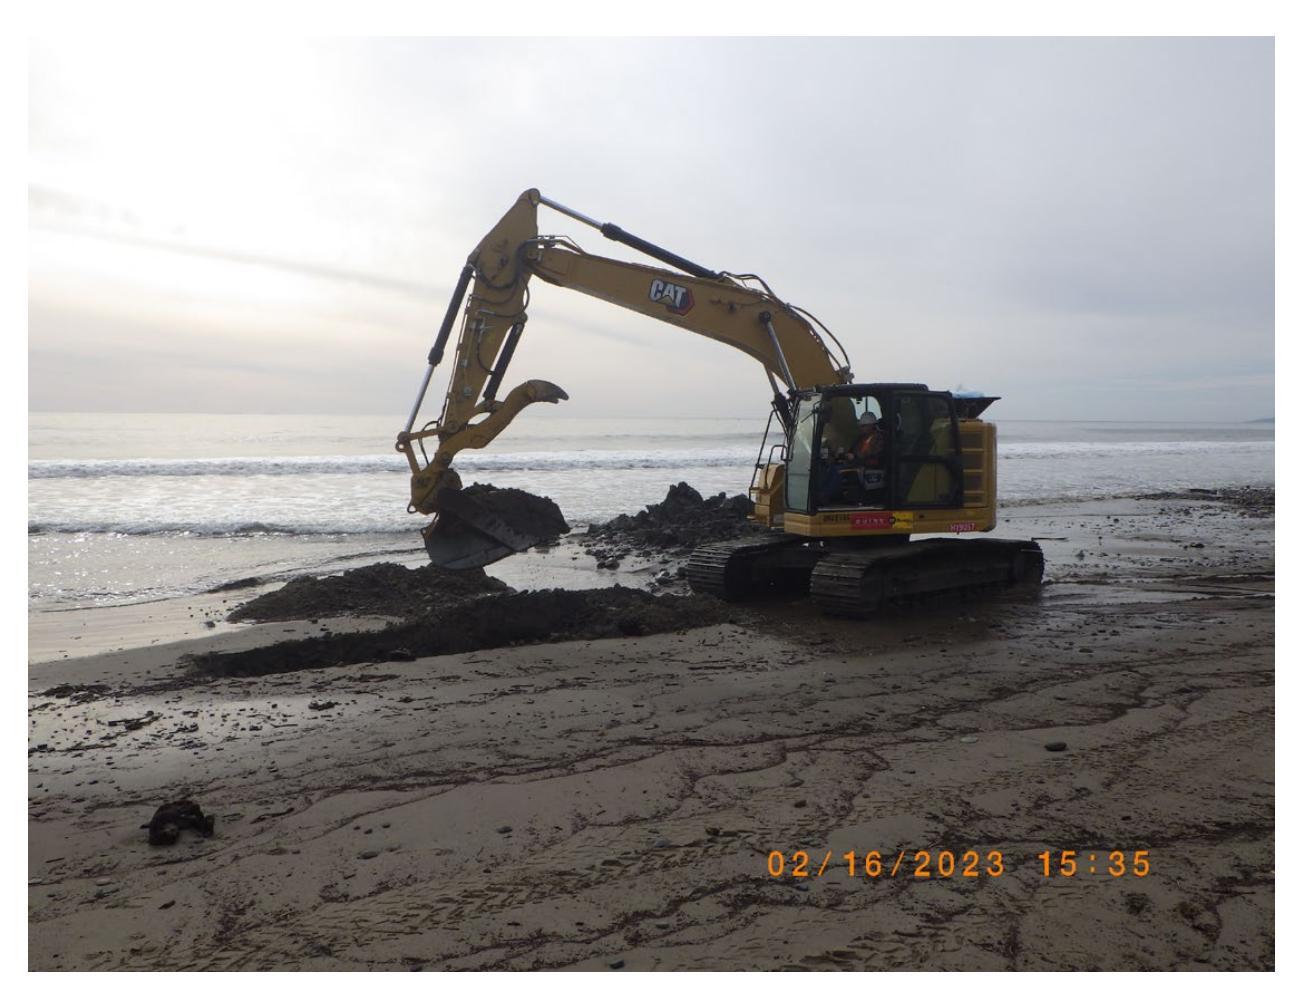
# Figure 18. Crews removing wood piles near Bell Canyon Creek (photo by Padre Associates).

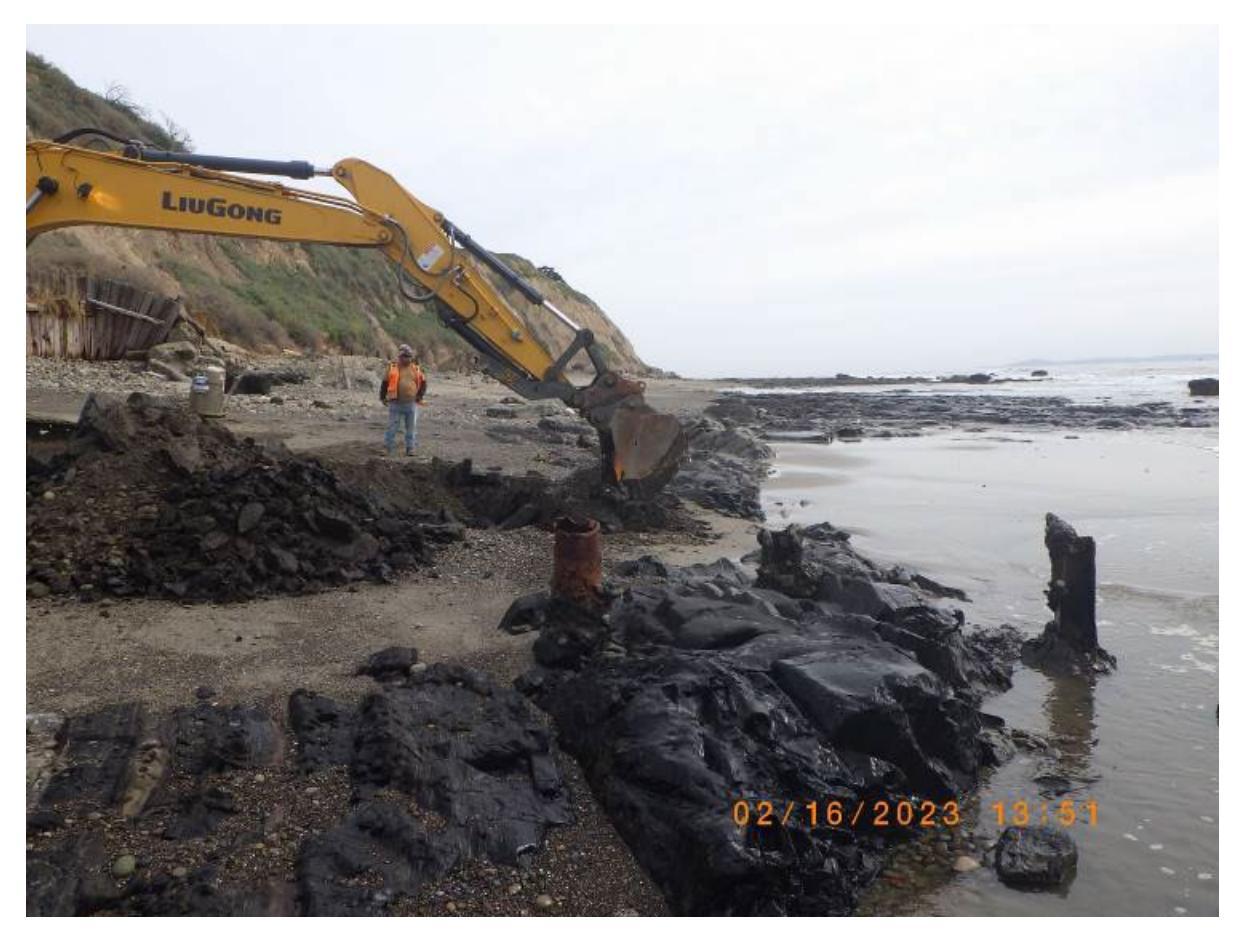
Figure 19. BW crews removing H-beam hazards near the former location of the 421-2 pier (photo by Padre Associates).

Crews operated by Beacon West Energy Group accessed the beach from an existing access ramp east of Bell Creek. Crews worked near the former 421-2 pier, removing existing and newly documented hazards (primarily H beams). Crews partially or fully removed a total of 44 hazards (Figures 19 and 20). Approximately 51 metal objects including H-Beams and railroad ties were removed or broken significantly below the cobble line. The removed or partially removed in the hazards inventory database.

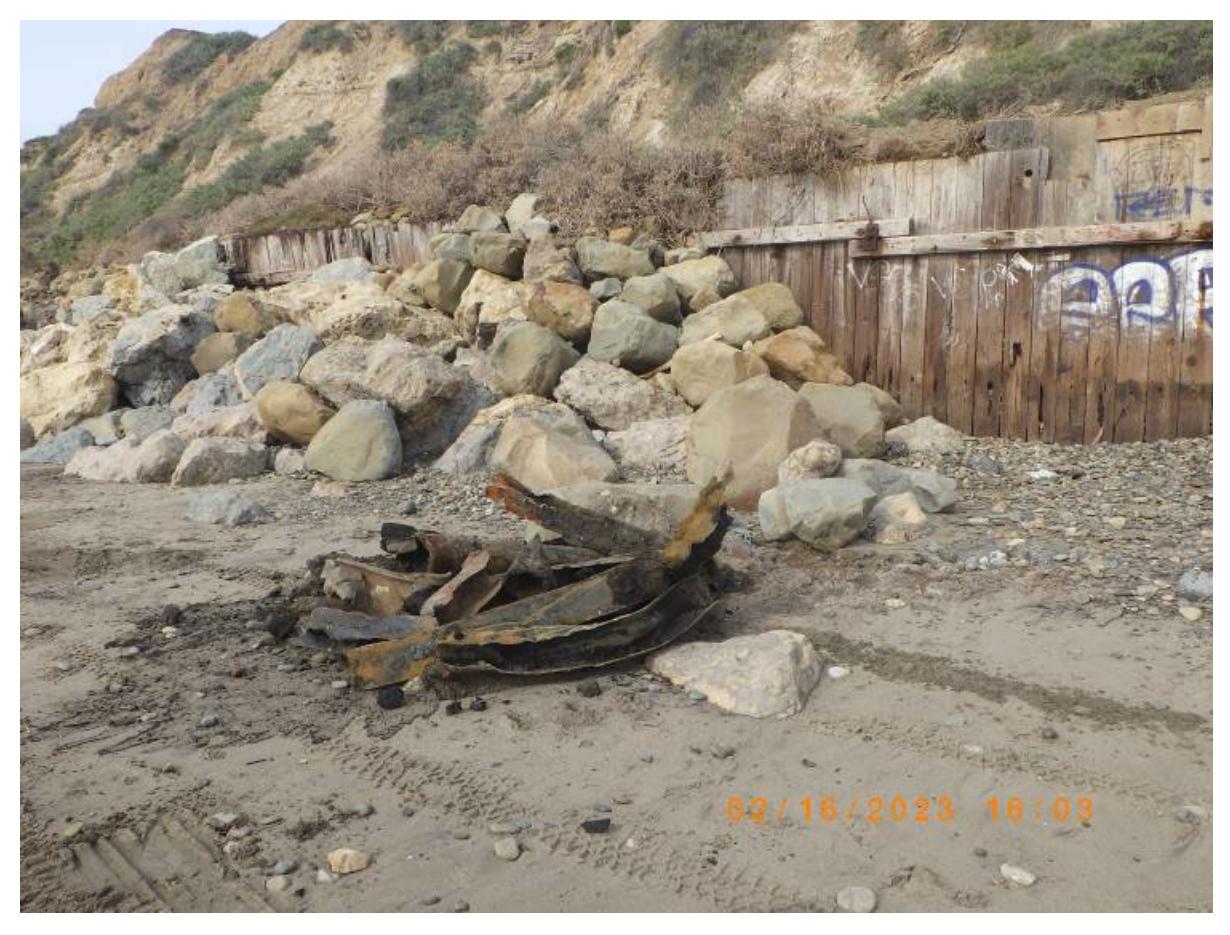
Figure 20. H-piles removed by BW crews, temporally stockpiled near the former location of the 421-1 pier. All material was removed from the beach at the end of the day. (photo by Padre Associates).

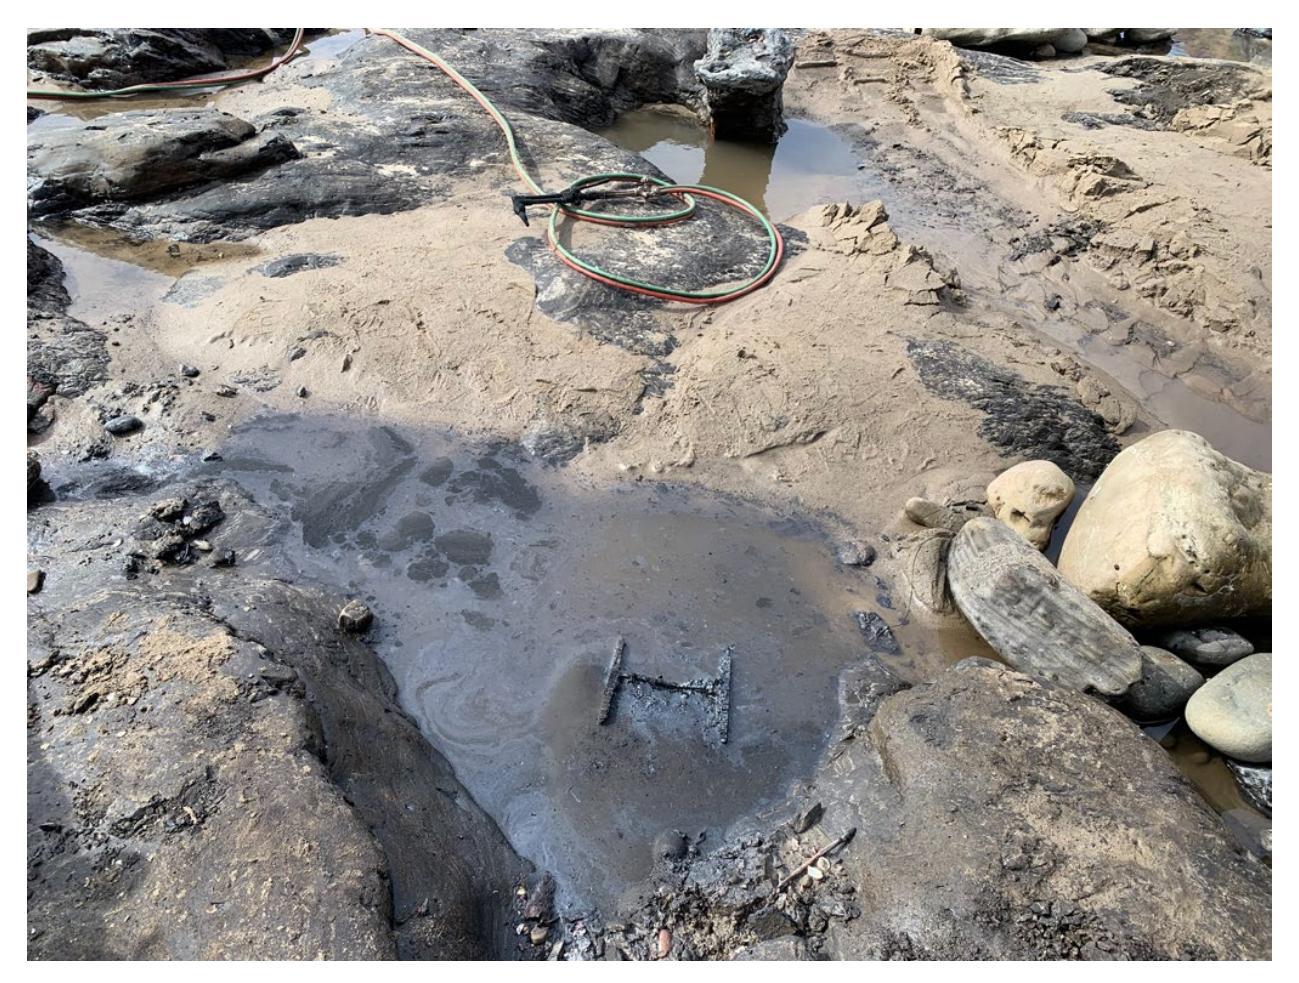
Figure 21. H-Beam Flush with Surrounding Substrate (photo by Padre Associates).
