## **REPORT OF SITE ASSESSMENT ACTIVITIES**

### **RINCON ONSHORE FACILITY STATE LEASE NO. PRC 410 RINCON OIL FIELD VENTURA COUNTY, CALIFORNIA**

December 22, 2021  
Project No. 2002-7861

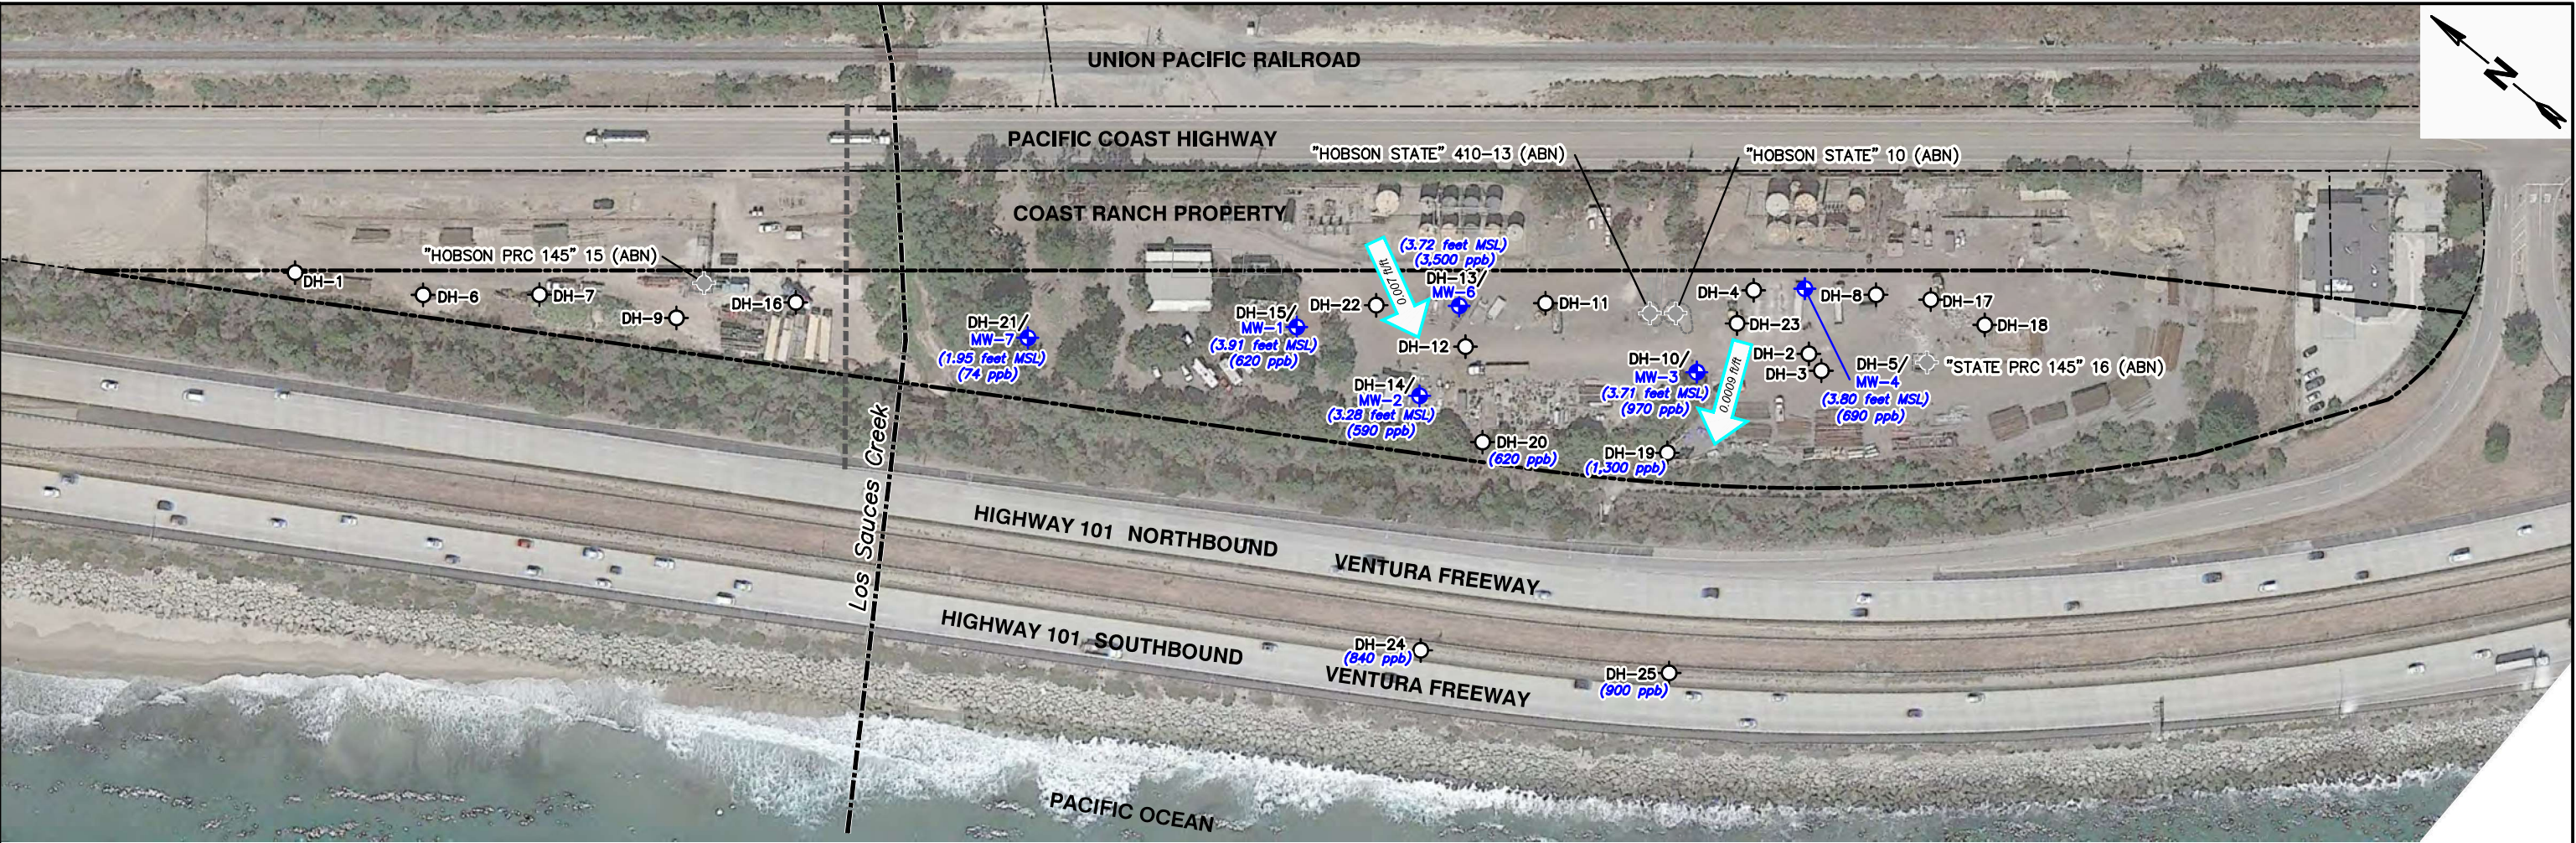
PETROLEUM HYDROCARBON  
CONCENTRATIONS IN  
GROUNDWATER

The scope of work completed at the Project Site included construction of six groundwater monitoring wells (MW-1 through MW-4, MW-6, and MW-7). Groundwater monitoring activities completed by Padre at the Project Site indicated depths to groundwater that ranged from approximately 10.17-feet to 13.85-feet bgs, which correspond to groundwater elevations that ranged from approximately 1.95-feet to 3.91-feet msl. The hydraulic gradient is estimated to range from 0.007 feet per foot (ft./ft.) to 0.0009 ft./ft. towards the Pacific Ocean to the southwest.
