REPORT OF SITE ASSESSMENT ACTIVITIES

**RINCON ISLAND, LEASE 1466
6687 BREAKERS WAY
VENTURA COUNTY, CALIFORNIA**

Prepared for:
CALIFORNIA STATE LANDS COMMISSION

December 18, 2021
Project No. 2001-7861

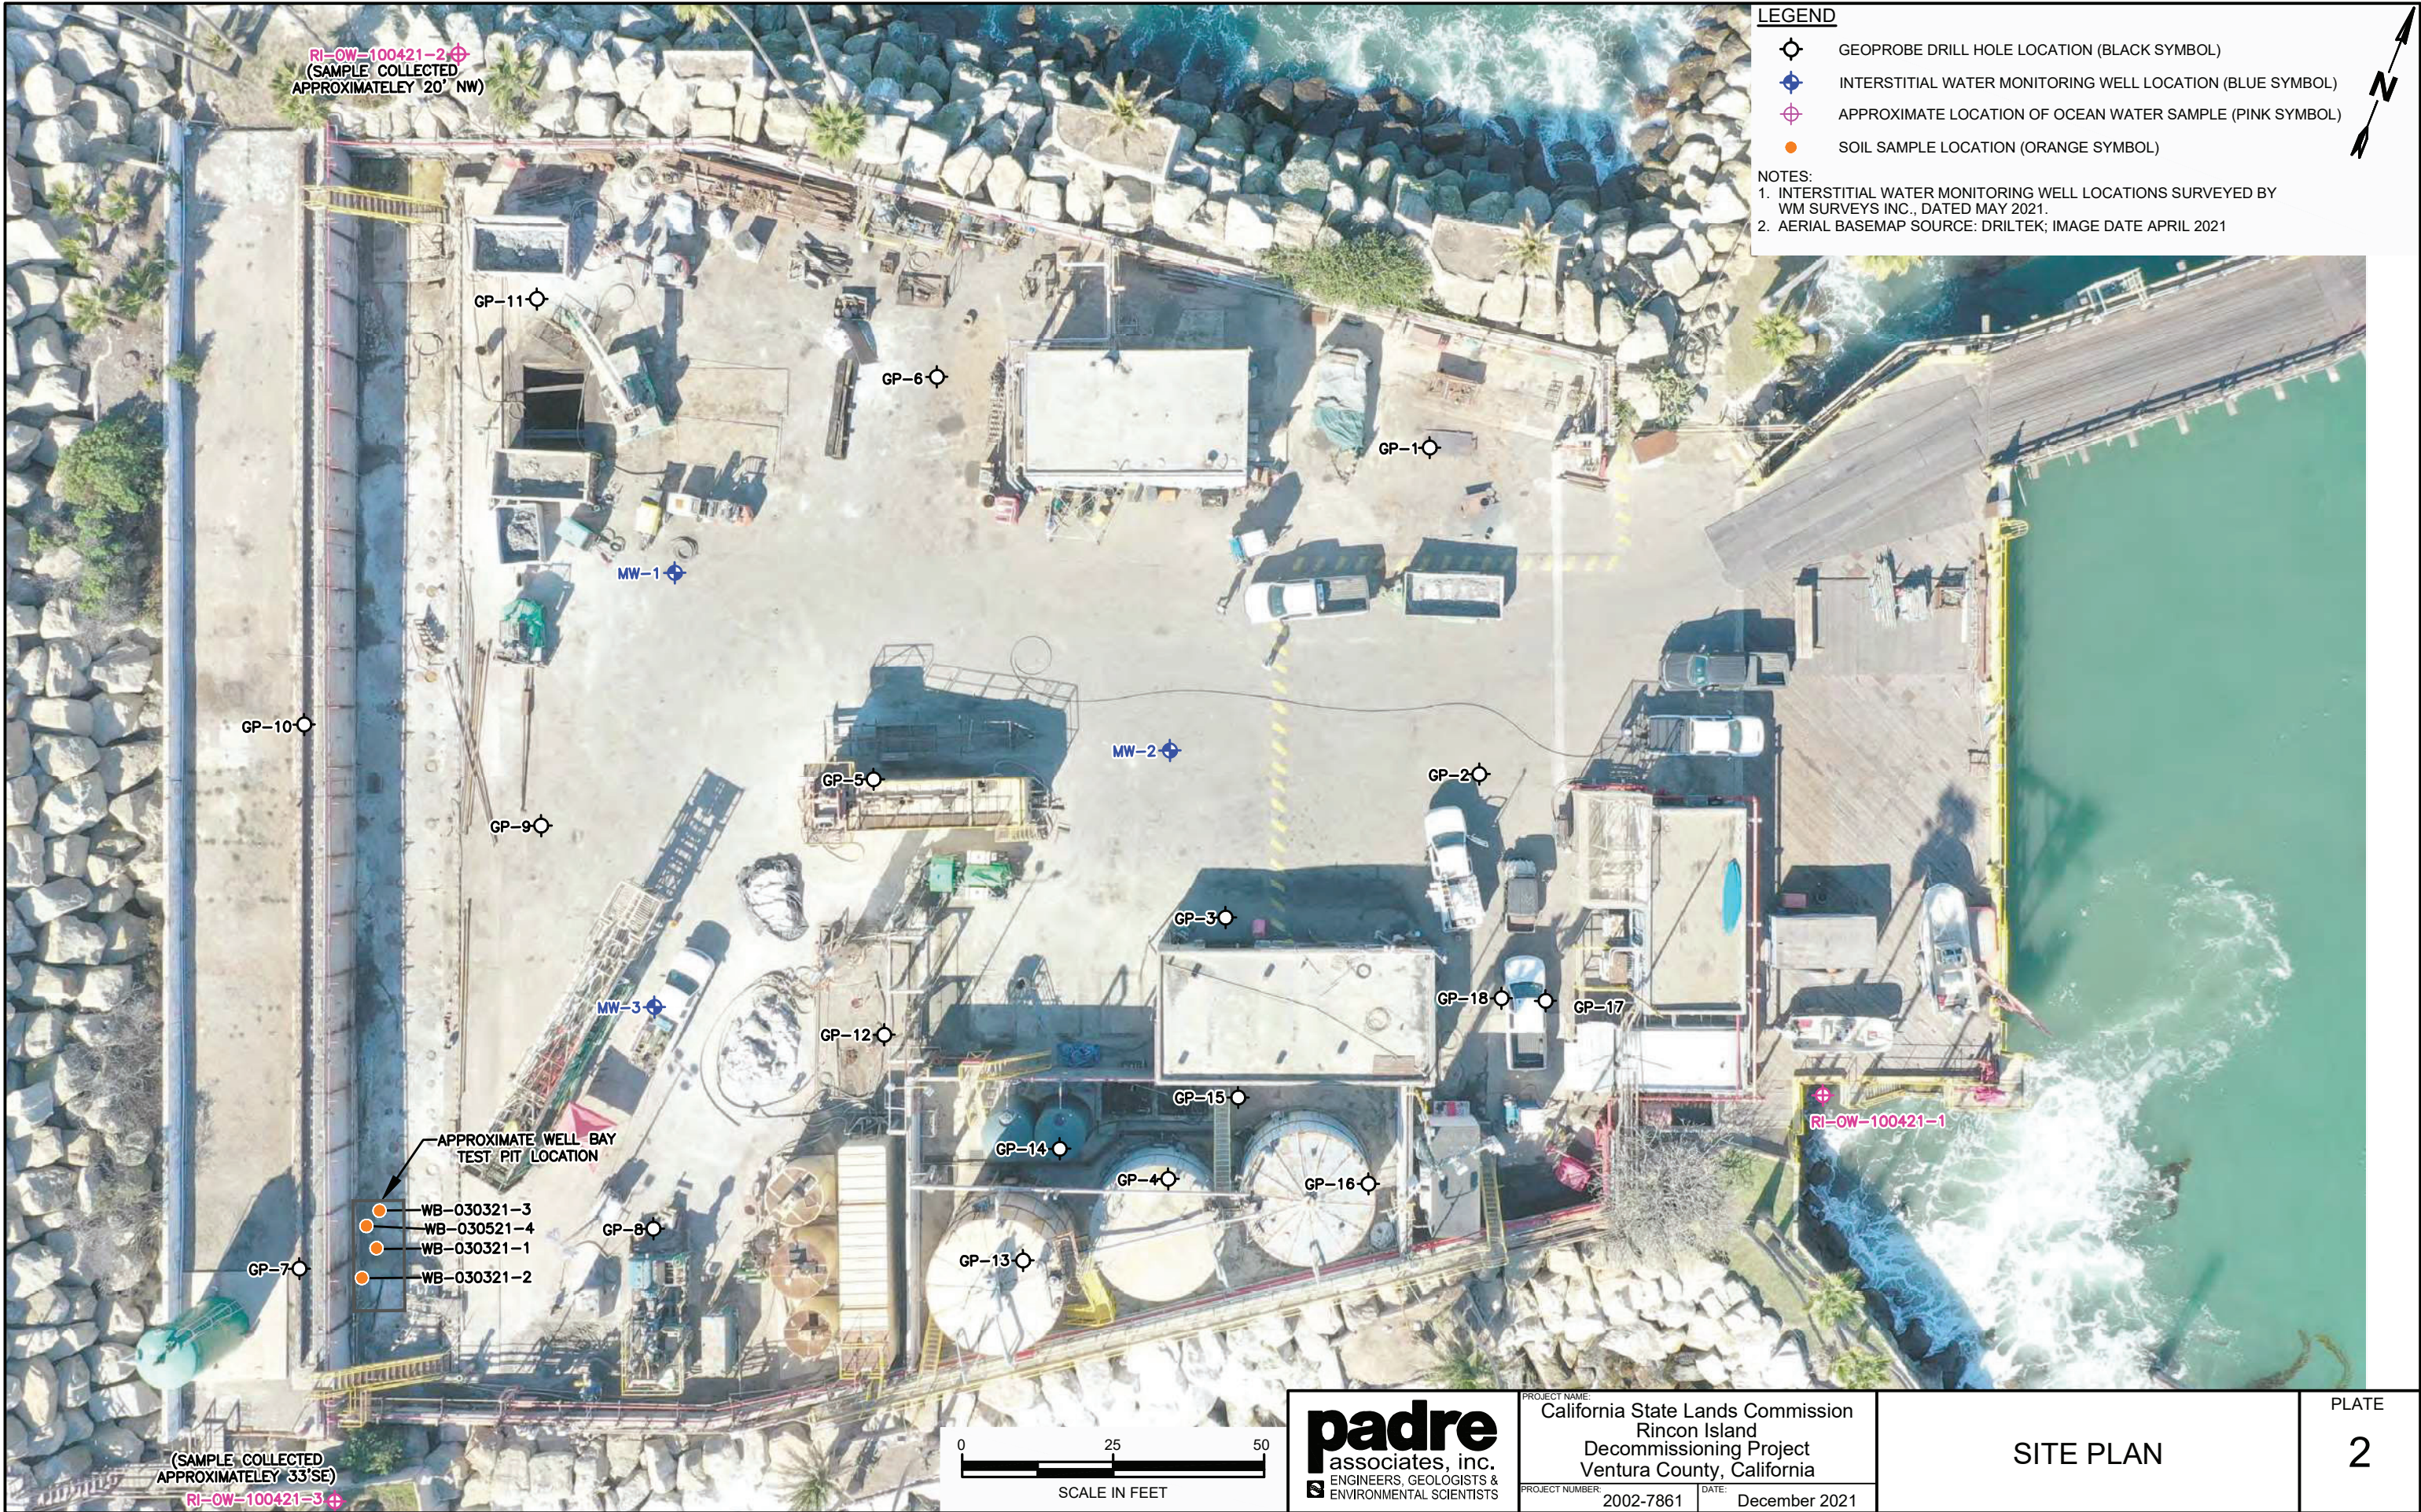
Padre was escorted by representatives of Driltek to the Project Site on March 3 and 5, 2021 to document the subsurface materials encountered beneath the concrete slab within a portion of the well bay area located at the southwest corner of the Project Site. Padre observed the excavation test-pit area to extend approximately 10-feet north to south and 4-feet east to west along the rear cellular concrete wall of the well bay area. The excavated test-pit extended to an approximate depth of approximately 4-feet below the concrete floor of the well bay. The excavation area also extended towards the south along a narrow section of the well bay floor between the concrete cellar and the rear cellular concrete wall. Padre collected four soil samples from the well bay area test pit excavation for chemical analyses. Refer to Plate 2 - Site Plan.

On May 4 and 5, 2021 Padre utilized the hollow-stem auger drilling services of S/G Drilling Company (S/G) of Lompoc, California. S/G maintains Contractors State License Board C-57 license number 611394, which is valid through January 31, 2023. S/G advanced a total of three hollow-stem auger drill holes to facilitate the collection of discrete soil samples for chemical analyses and construct three temporary interstitial water monitoring wells (MW-1, MW-2, and MW-3) at the Project Site. Discrete depth soil samples were collected from each drill hole location at approximate 5-foot depth intervals from the surface to the total depth of each drill hole, which were submitted for chemical analyses. The locations of the temporary interstitial water monitoring wells constructed at the Project Site are presented on Plate 2 - Site Plan.

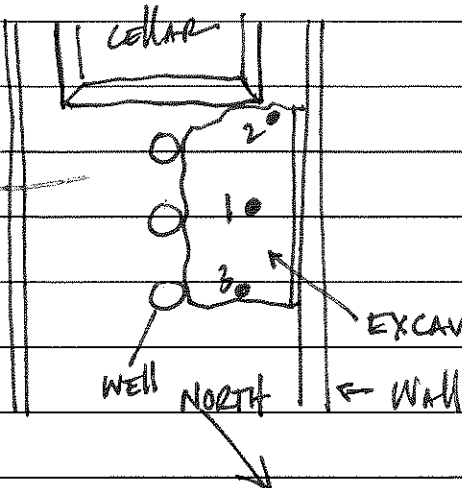
OBSERVED A SMALL EXCAVATION AT THE SOUTHERN END OF THE WELL BAY - NORTH OF THE SUMP PLT TO CONTAIN SANDY SOIL, WATER, AND PETROLEUM HYDROCARBONS. THE SOIL WAS STAINED GRAY TO BLACK WITH A MODERATE TO STRONG HYDROCARBON ODOR. THREE SOIL SAMPLES WERE COLLECTED.

WB. 030321. 1	3' DEEP	1409	633 PPM
WB. 030321. 2	2' DEEP	1415	1600 PPM
WB. 030321. 3	2' DEEP	1420	109 PPM
